PAINTING TREATMENT REPORT

Coca -Cola And Angell's Delicatessen Privilege Ghost Sign

Coca Cola Sign Rehabilitation Project #2009-M2-007

Field Work Treatment Report September 2011

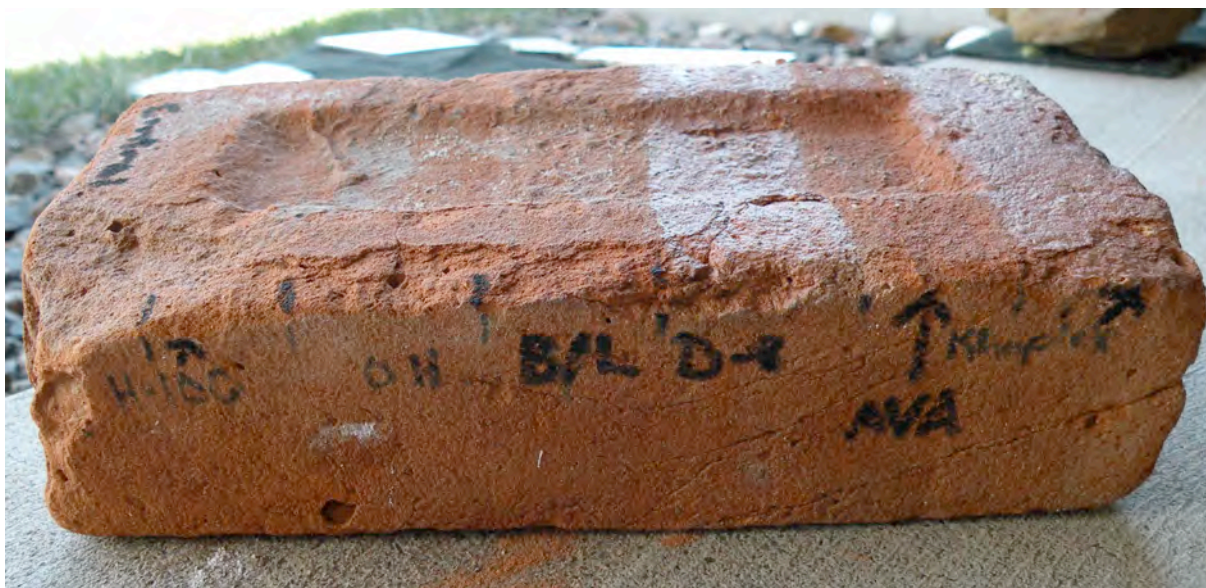
The consolidant chosen for the project is labeled AVA second from the right edge

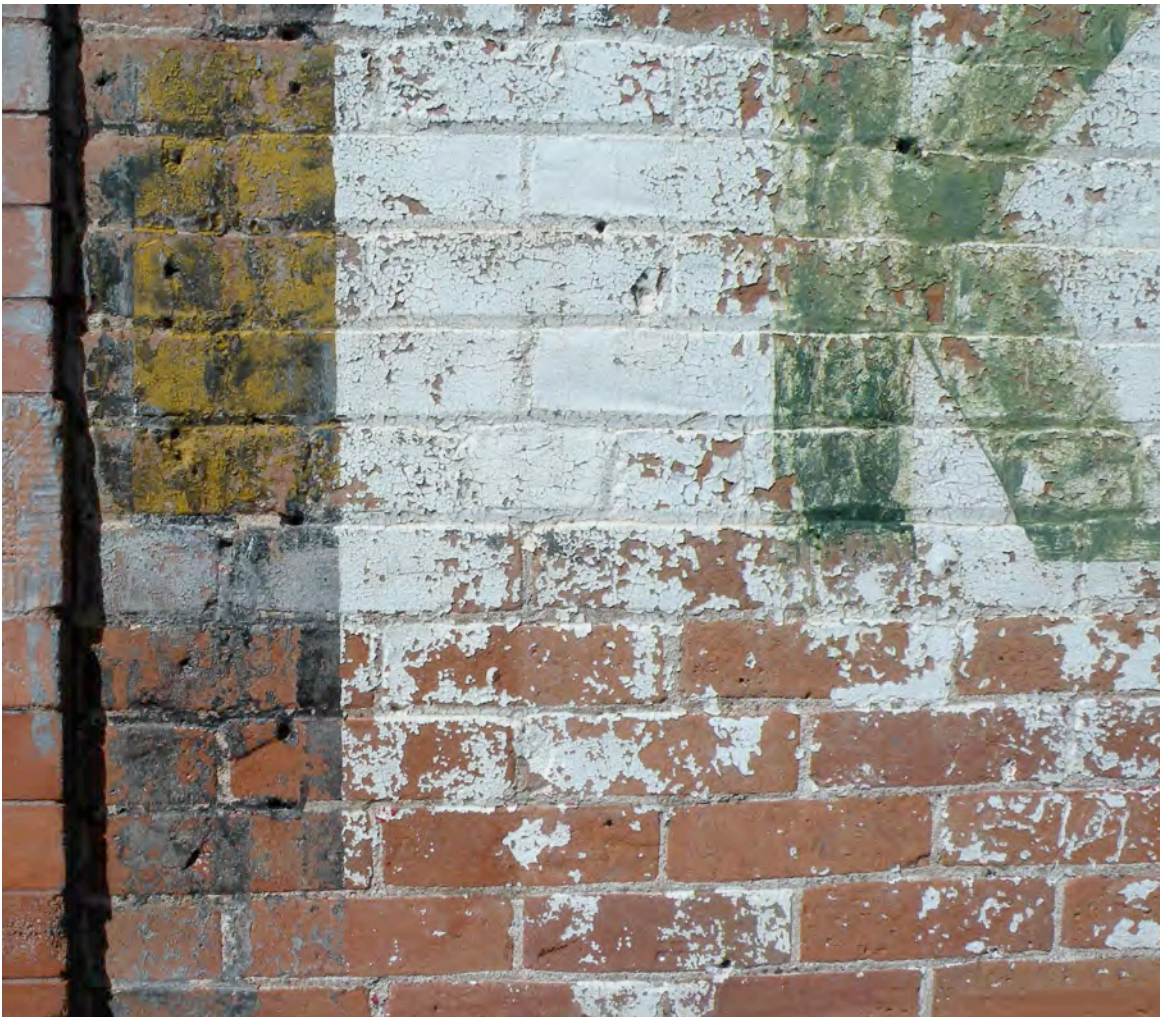
Test areas along black left edge. Avalure was used in the lower three bricks below the gray

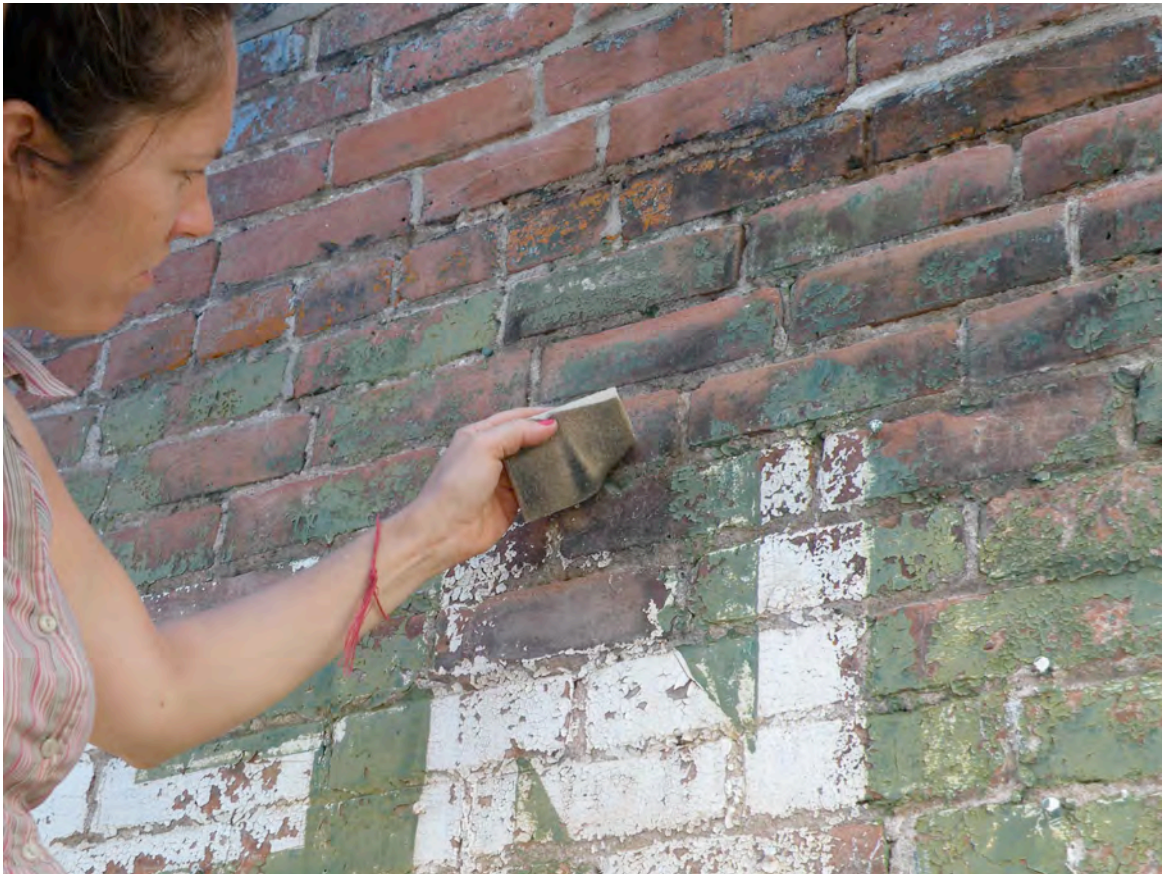
Cleaning soot using a neoprene sponge in the upper right corner of the Deli sign

Cleaning tests were performed along with consolidant tests. The fragile paint was too friable to be cleaned off with anything other than a soft bristle brush and a nose aspirator to blow out loose particles behind the flaking paint. Only the soot covered area in the upper right was cleaned more aggressively. A dry cleaning sponge was used in this area to reduce the soot. Most of the soot was not removable due to its penetration into the masonry substrate.

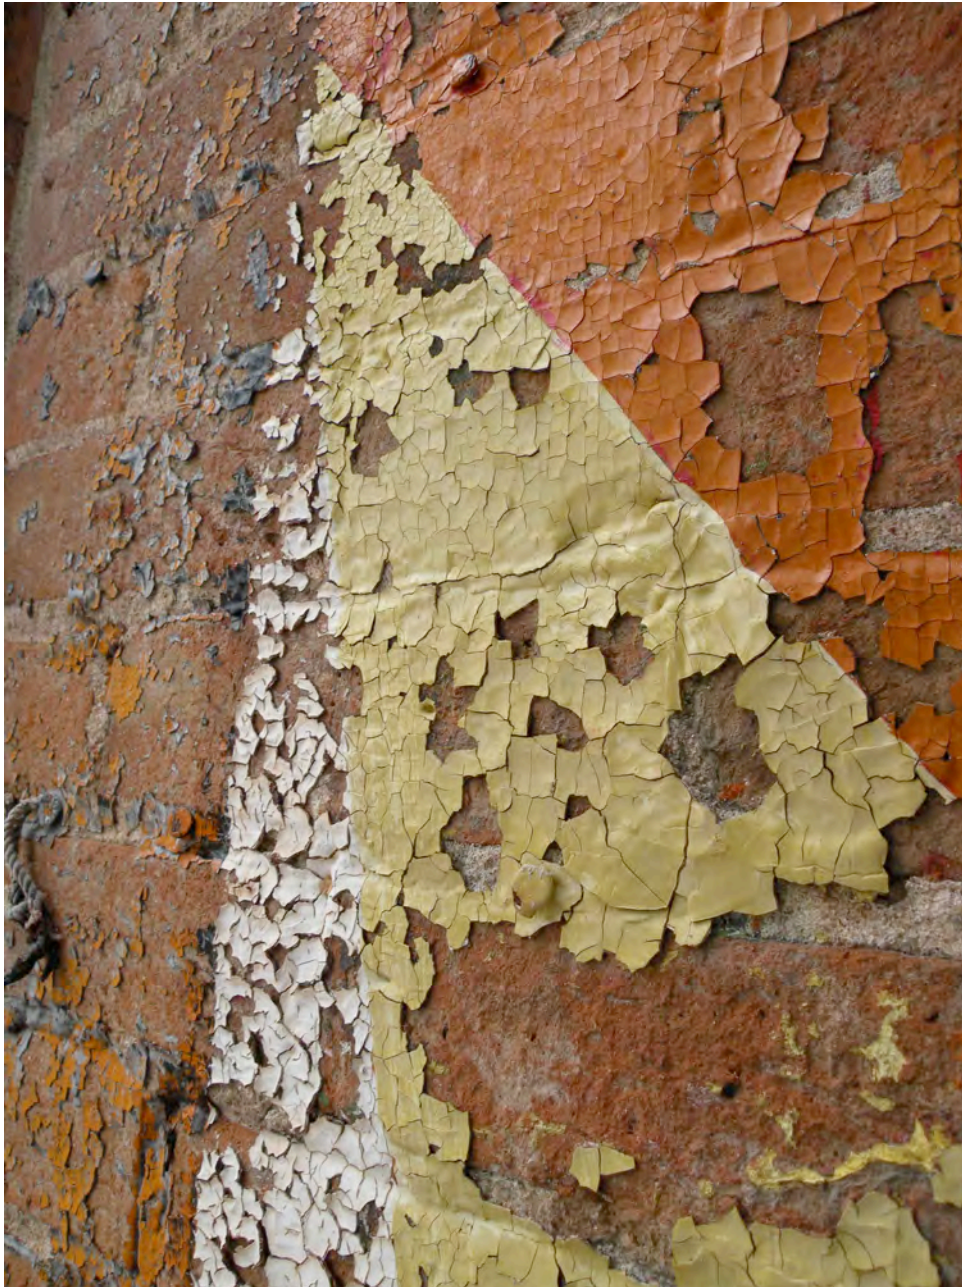
The treatment was conducted from the top right down to the lower scaffold levels. Observing the sign up close provided new insight into the creation of these two sign as well as the signs that preceded it. Along the Angell's Delicatessen sign there were numerous metal tacks in the mortar that had been painted over with each successive sign. Many tacks were strung in a row while others were haphazardly placed. The tacks had 3/8" wide heads and were 1/2" long. They certainly did not perform a structural role. There were too many to count throughout the two signs. My assumption would be that before the painted signs, banners were attached to the wall with tacks. We also found longer nails, two of which had rope wound around them. These short 2" sections of rope were also painted over by a number of layers of paint. Many of the tacks were not well attached to the wall despite being painted over.

Painted tack heads protrude through and remaining rope is visible on the far left

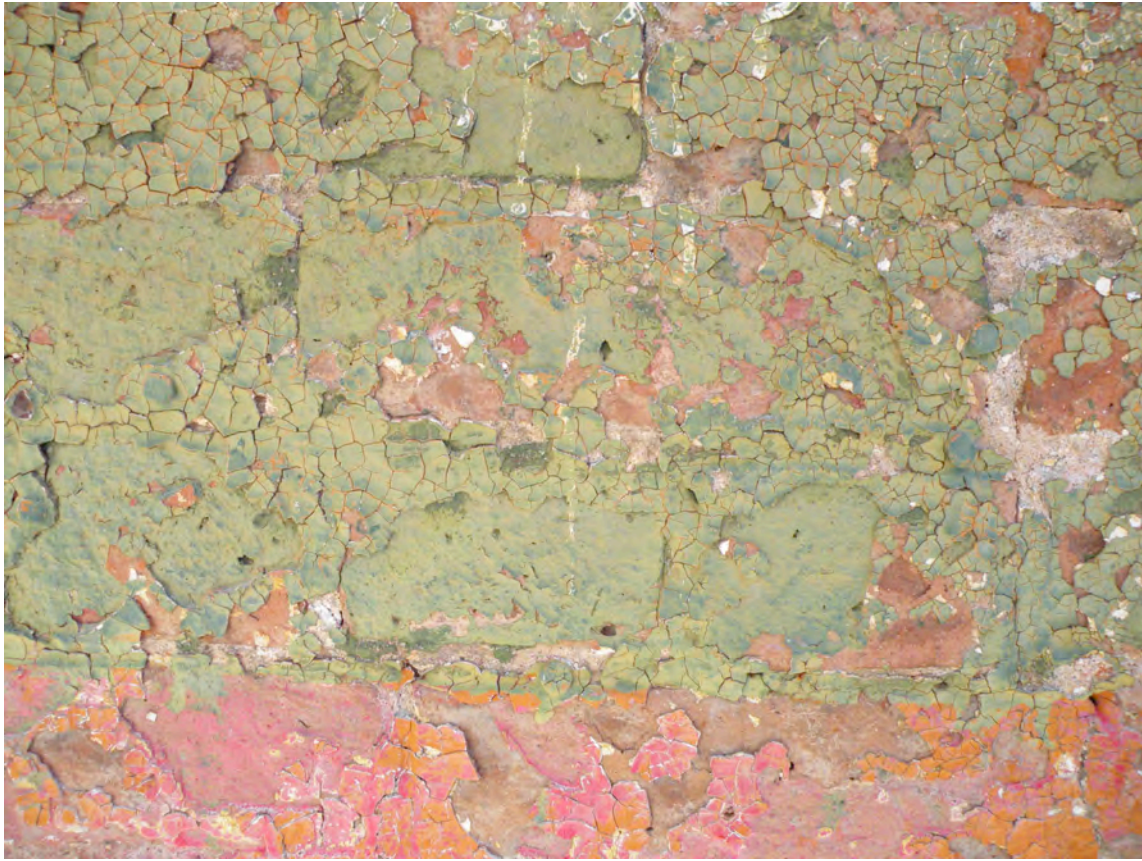
Another interesting insight into the sign painter's process was the layering of paint over flaking paint. Both signs had original paint that was painted over numerous paint layers as deep as $\frac{1}{4}$ " in many places. Then this 1958 paint was painted right onto the brick in other areas. It seems that the sign painters did little preparatory work to the wall before they began painting a new sign on top. This also gives evidence that the paint did not start flaking off this wall in the past 30 years but that it has been flaking off the wall for at least 60 years if not longer.

The historic paint was thinly applied over layers of old paint or directly on exposed brick

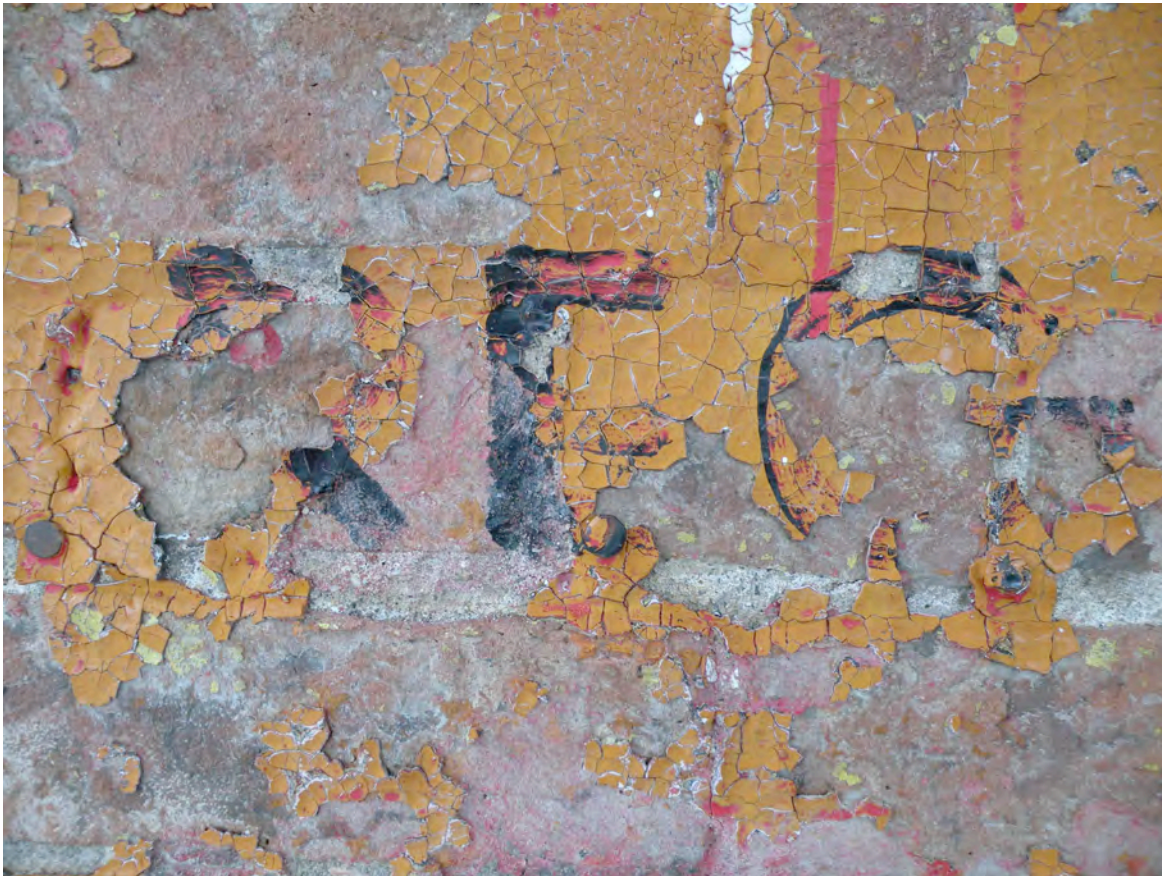
The 27 layers of paint found during our paint analysis along with the remnants remaining on the wall reveal that at least 4 signs were painted on this section of this wall. As oil paint ages on exterior walls, it can degrade and fall off like the red paint did on this sign. The oil paint that remains becomes more transparent over time which allows the viewer to see the underlying paint layers. In the Deli sign, the white paint is more visible beneath the green paint. Don Brown first painted a white rectangular box to contain the lettering. Then he painted the dark green and cut in the lettering. Essentially he created the letters by painting in the negative space rather than painting letters! In the Coke sign, the red has completely degraded into powdered pigment that has been washed away in the rain. Beneath the red, we are able to see how the sign was outlined as well as seeing into the sign below the Coke sign.

*The black of REG PAT OFF was painted over the orange sign and directly onto the brick.
The red has degraded below the black often taking the black along with it.*

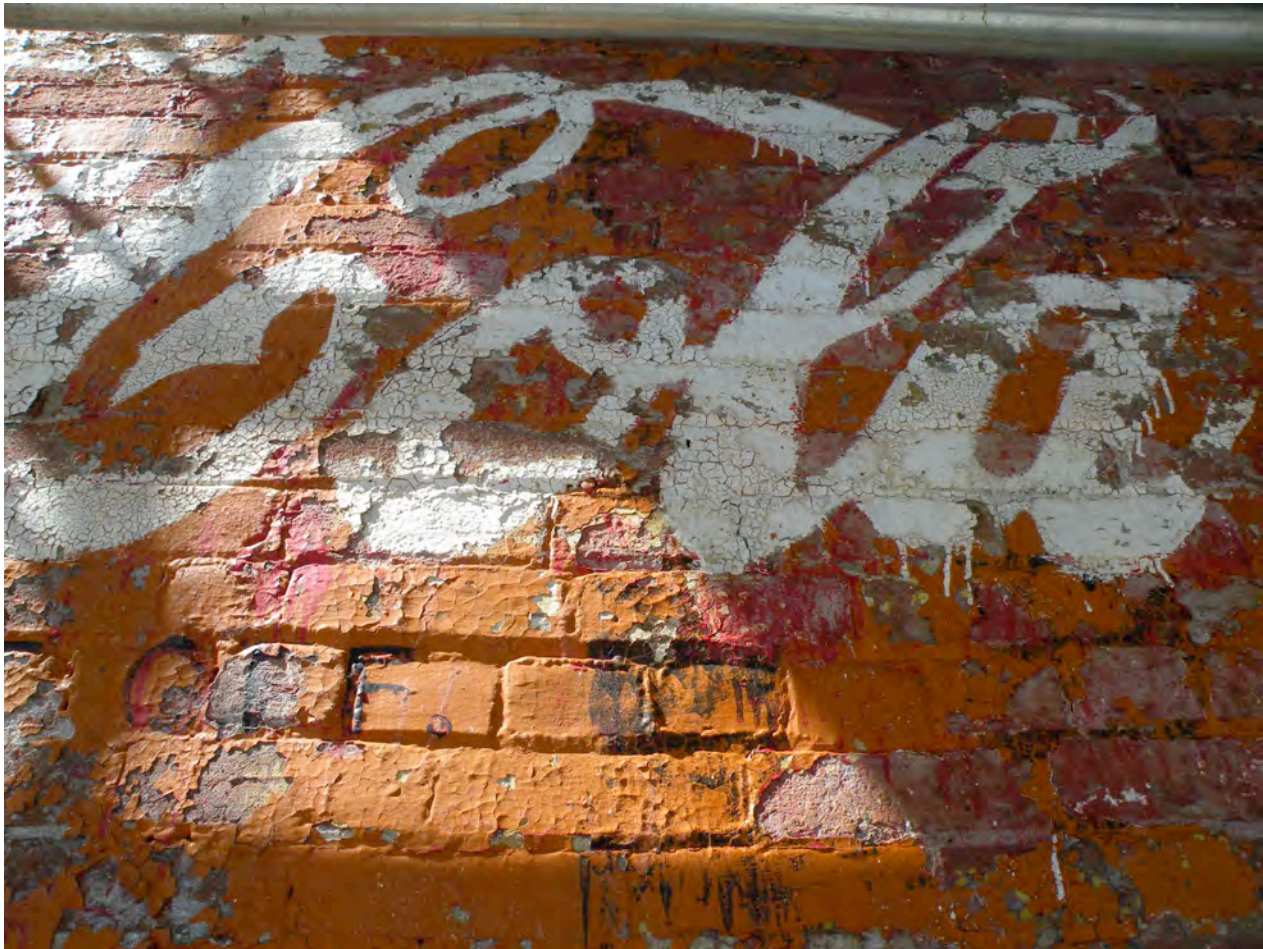
The white Coke lettering was painted first very thinly. It was painted so thinly that drips were created under every letter. Don Brown didn't bother to clean up the drips because he knew that his red paint would cover up the drips when he finished the sign. What he must not have known was that he did not have enough binder in the red to allow it to last very long on the wall. Because he wanted a bright deep red, he would not have included much if any white lead in his paint mixture. He also probably figured a new sign would be painted over it in a few years anyway so longevity was not an important issue.

*White drips visible once red degraded on right side; inpainted on left;
black lettering from underlying sign visible below*

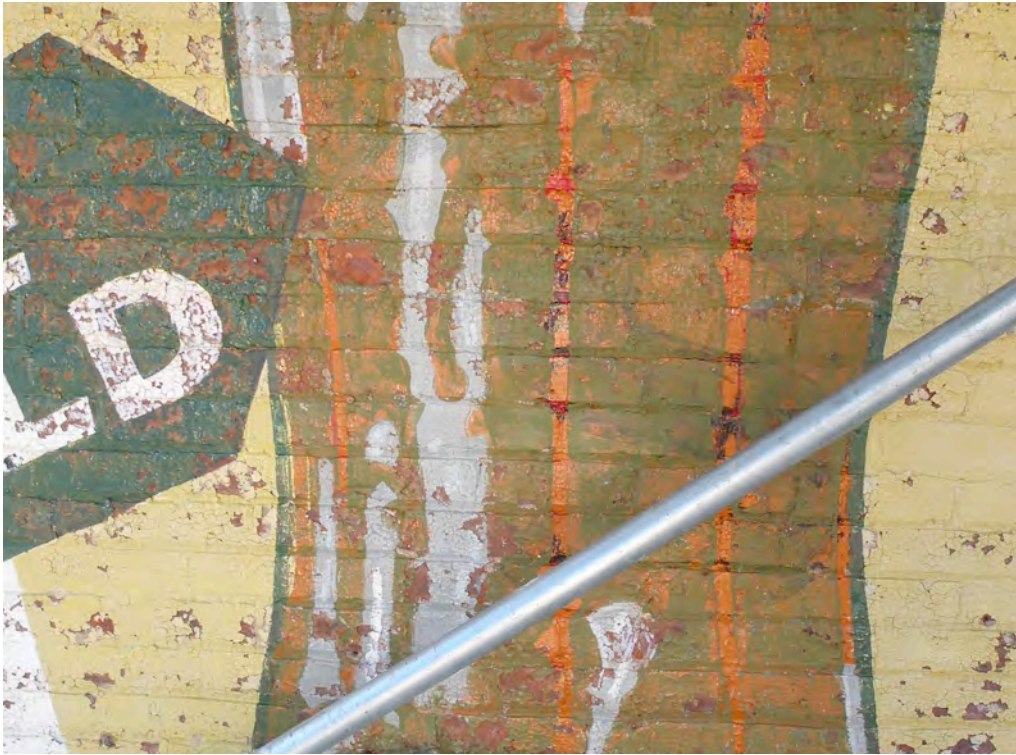
Black S is visible to the right of ice cold arrow behind the metal bar

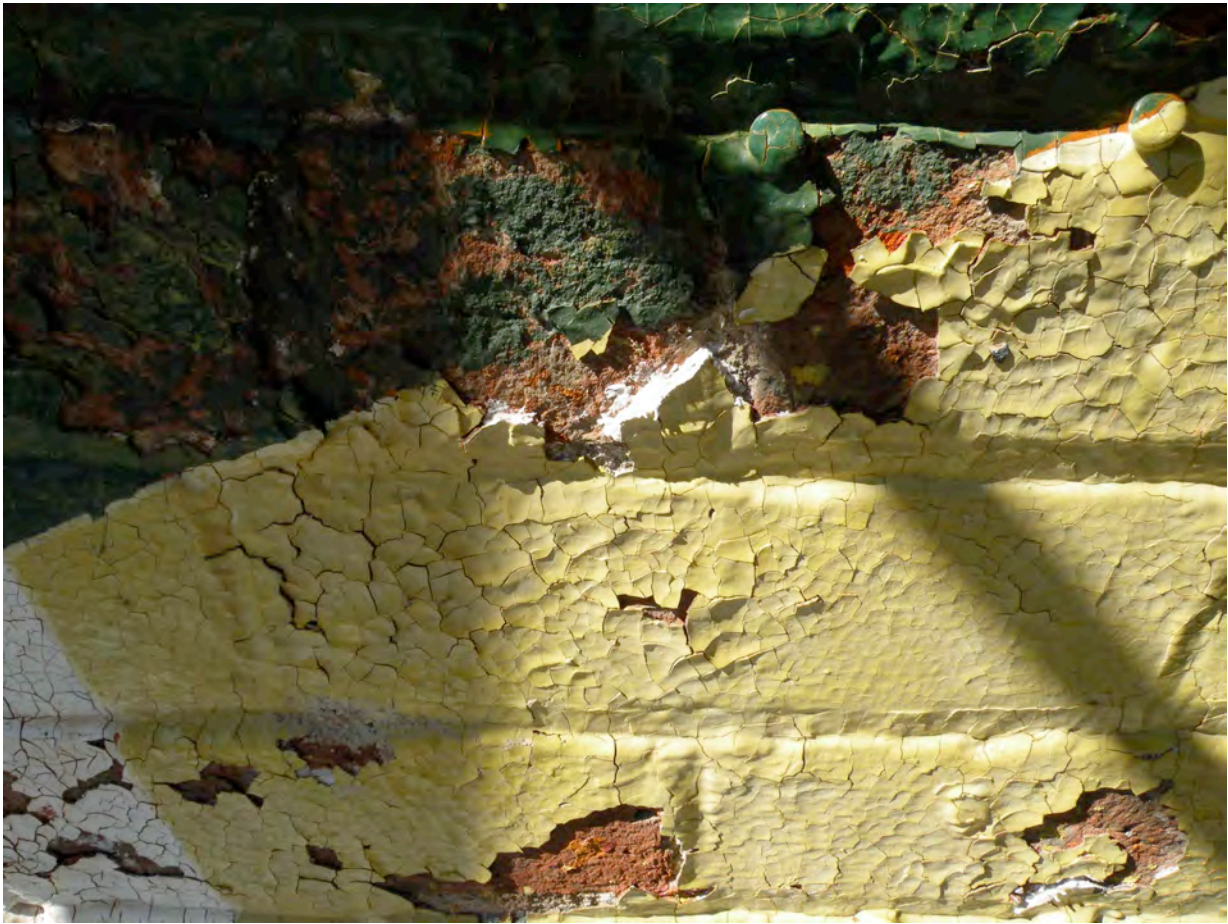
The consolidation process worked well to adhere the fragile paint to the masonry especially after each area was set down with heat and pressure. The flaking paint took on a different craquelure pattern in each of the differently colored regions. The white areas were extremely brittle and these flakes were not as flexible due to their high lead content. The white flaking paint did not set down very well but it appeared structurally stable nonetheless. The yellow areas had large aperture flakes that were protruding out far from the wall leaving wide gaps between the brick and the paint up to 1/3" deep. Beva Gesso fill material was used in a few select areas that would have easily gathered and trapped moisture throughout the year.

Beva Gesso was used in select areas to keep moisture from collecting behind wide gaps

7. A few local areas in the yellow and white backgrounds required additional consolidant to adhere the paint to the masonry. Beva Gessoⁱⁱⁱ was applied with a spatula to these local areas. There were large gaps between the brick and the paint that would have continued to collect moisture if these gaps were not filled.

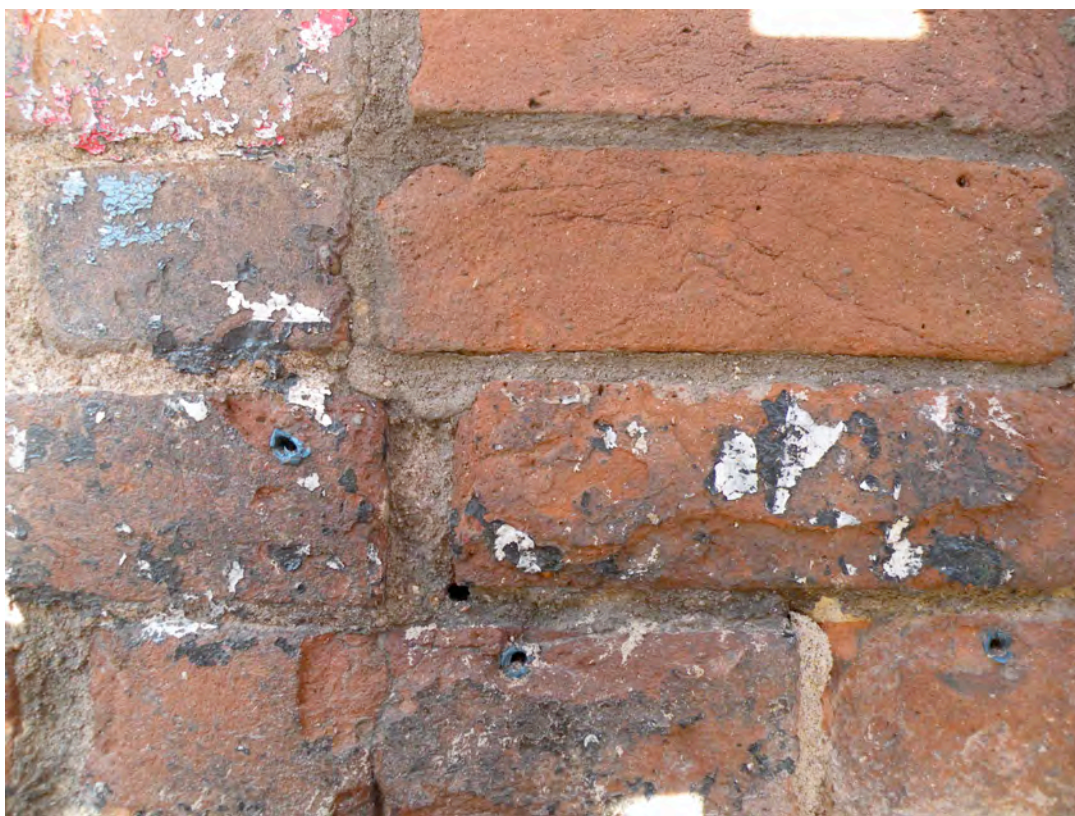
Remnants of the signature block along its left edge with later added bricks above

Once the original paint was consolidated and deemed stabilized, we were able to turn our attention to filling in some areas that have been lost. Our first priority was to reinstate the signature block. Don Brown was a historically significant Wall Dog in Fort Collins past since his sign company had been located right off Old Town Square and he haad painted many signs in the area. We felt that reinstating his signature was important in telling the story of this sign and its creation. There were remnants of black and white paint remaining in the area where the signature block had been. By counting bricks in the historic photograph, I was able to identify the proper placement and dimensions of the block. Photographs were taken before during and after the signature block was reinstated. All attempts were made to design the hand painted letters as Don Brown had originally despite the fact that the contours of the bricks have changed with the replacement of a few bricks.

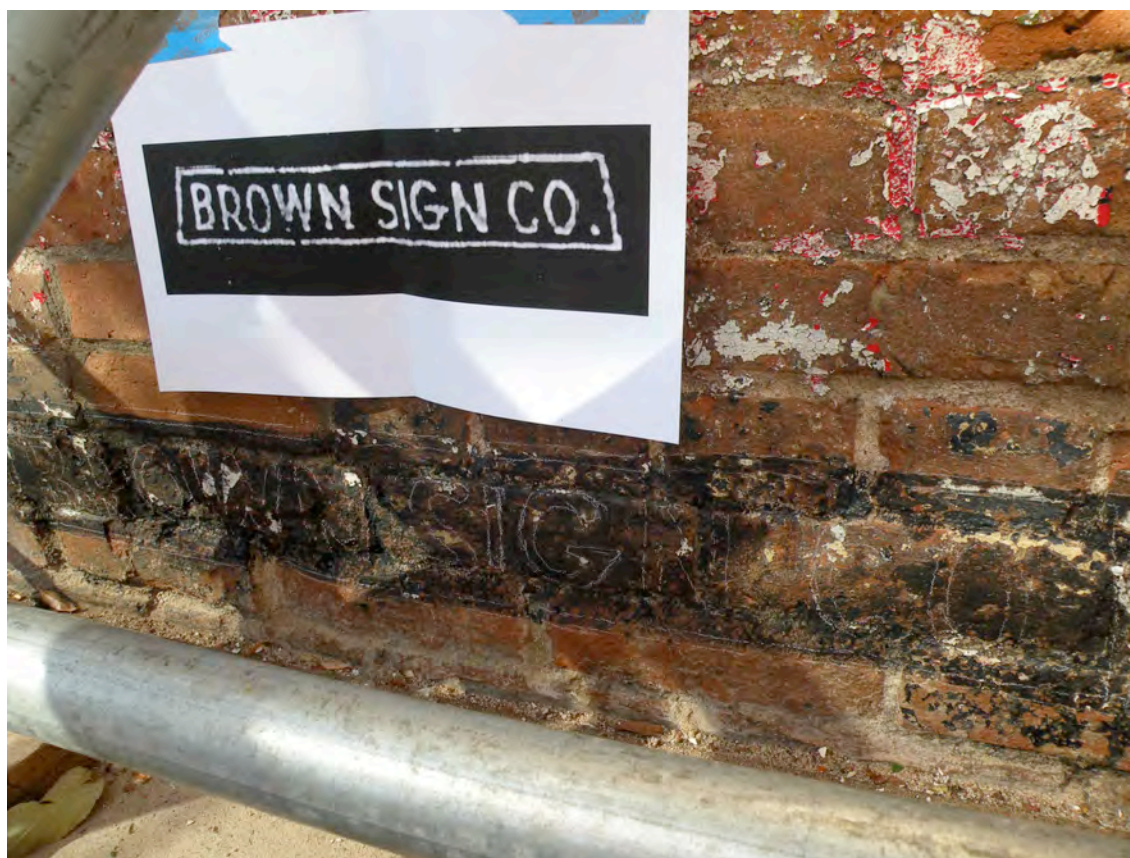
Signature block background reinstated; All white paint is original paint

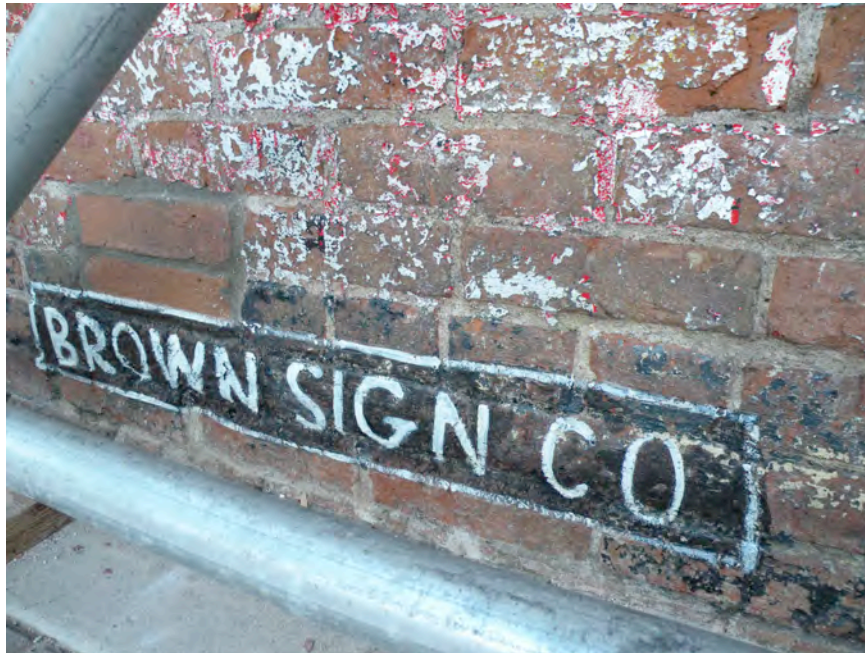
Signature block after reinstatement

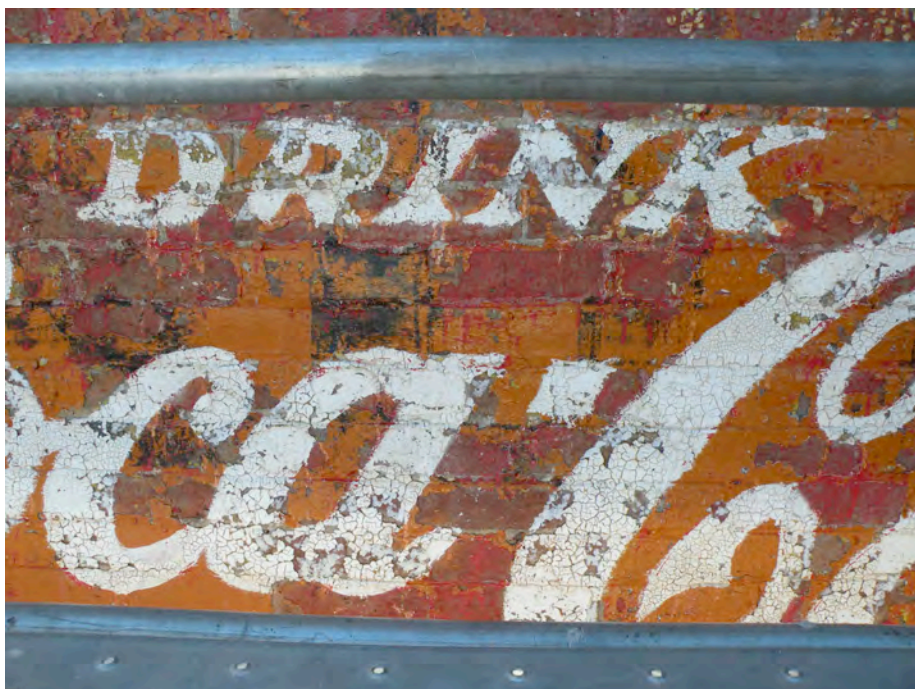
After inpainting the drips the words and the black lettering below the sign becomes more legible

Our next inpainting priority was to paint over the white drips under the lettering to return the sign to a state that was intended by the sign painter. Don Brown would not have expected those drips to be visible and we felt that it was distracting to the viewing of the sign in its entirety. Don Brown was a good craftsman and the drips would have been confusing to one's reading of the image and its history. Inpainting the drips also allowed the words to become more legible for a better reading of the advertisement as a whole.

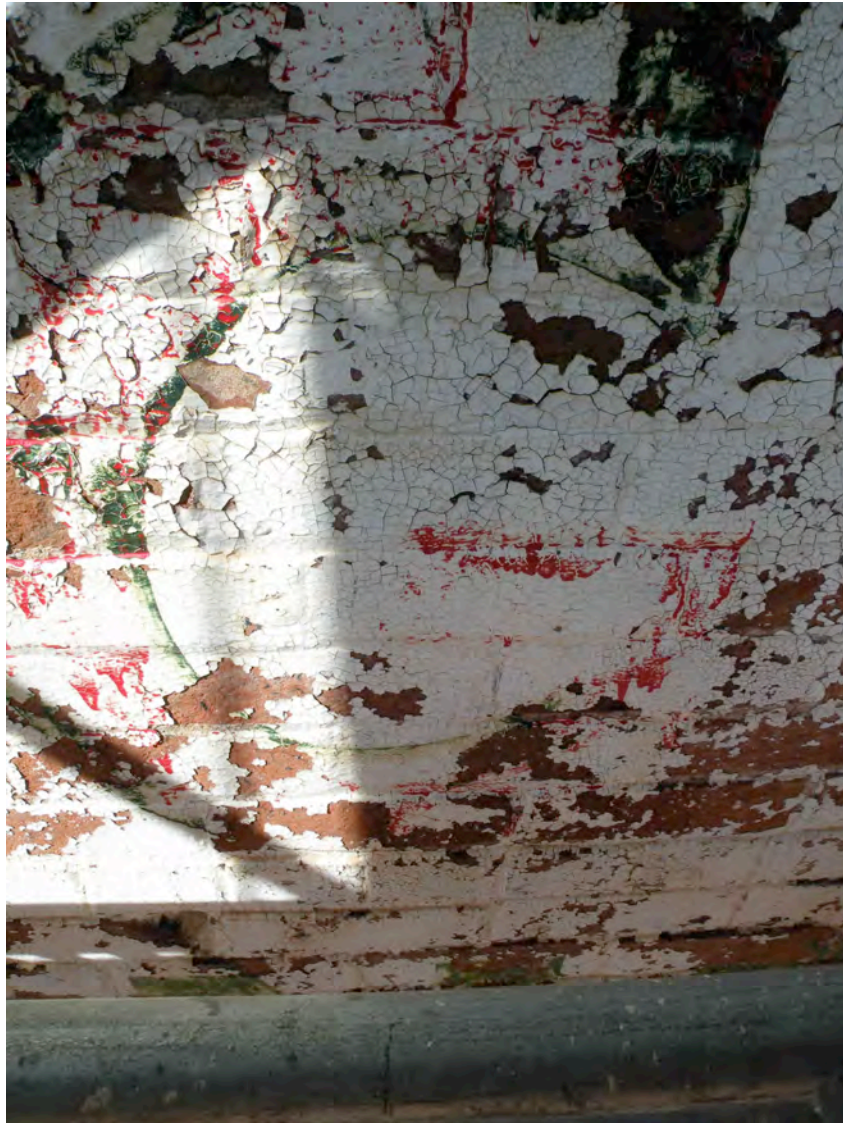
G in BIG before reintegration using casein paints

Our next priority with inpainting was to address the missing letters and numbers in the lower section. Because the intention of this Coca-Cola advertisement was to announce the new 12 ounce bottle, we felt that it was historically important to bring these lost "G 12 oz" back into the image. These letters had been painted in red and then painted over very thinly in green on top. Because the red paint was so unstable, it degraded taking the green over top with it. Only small remnants of red and green remained where each letter or number had been. The BI have held up over the years which is an interesting anomaly. 1958 was around the time when paints were beginning to be produced commercially but it is most likely that Don Brown was still mixing his paints on site as he worked. It may be that the red and/or green he used on the BI had more linseed oil binder mixed in compared with the letters that had worn away years ago

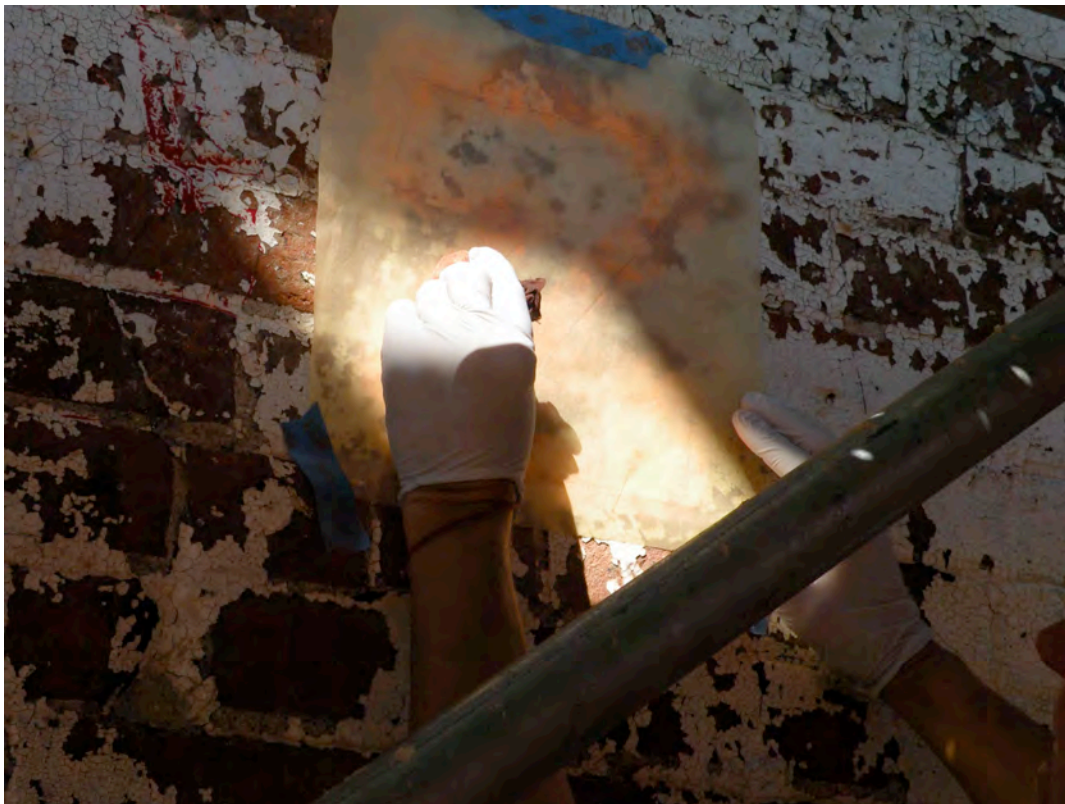
A dramatic view of the pouncing process daubing chalk through the pounced tracing

Before the inpaint could be applied, the outlines of the letters and numbers had to be established. The outline of the G was still slightly visible on the sign. The 1 O and Z were traced from other letters and then a chalk outline was created using a pounced tracing. The 2 was drawn out from the historical photograph. Once the outlines were created, the casein paints were hand mixed to match the historical colors closely but slightly bluer in tone so they could be distinguished upon closer inspection of the sign.

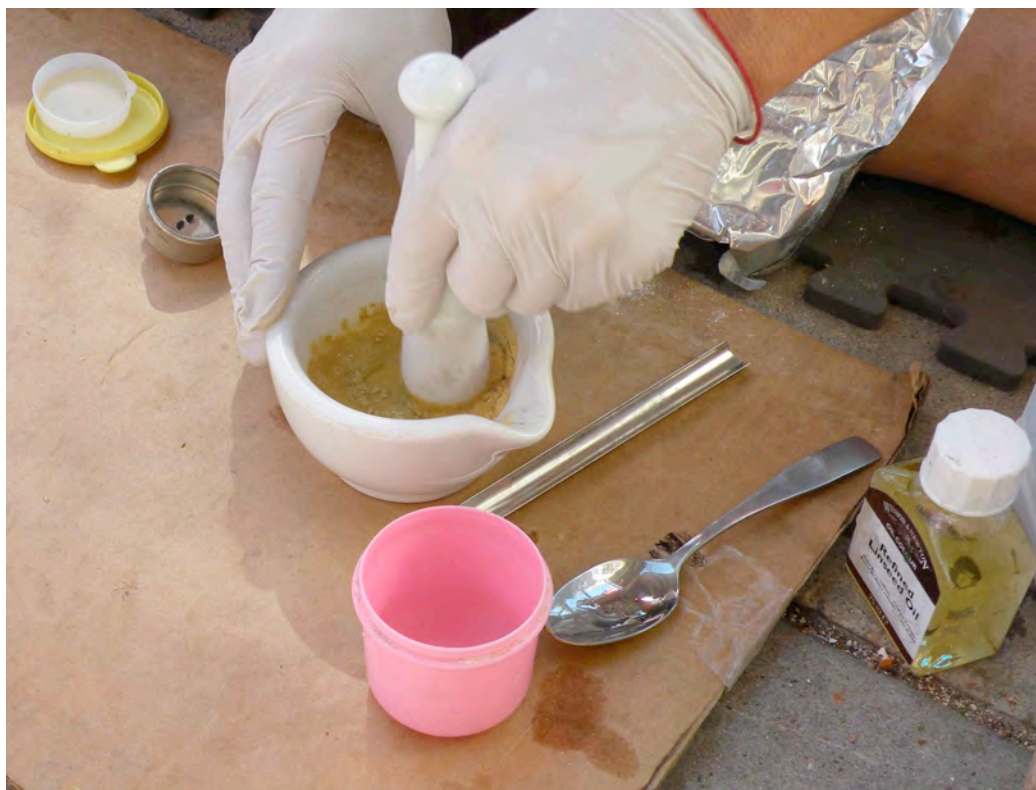
Mixing the casein paints to match historical colors, texture, and sheen

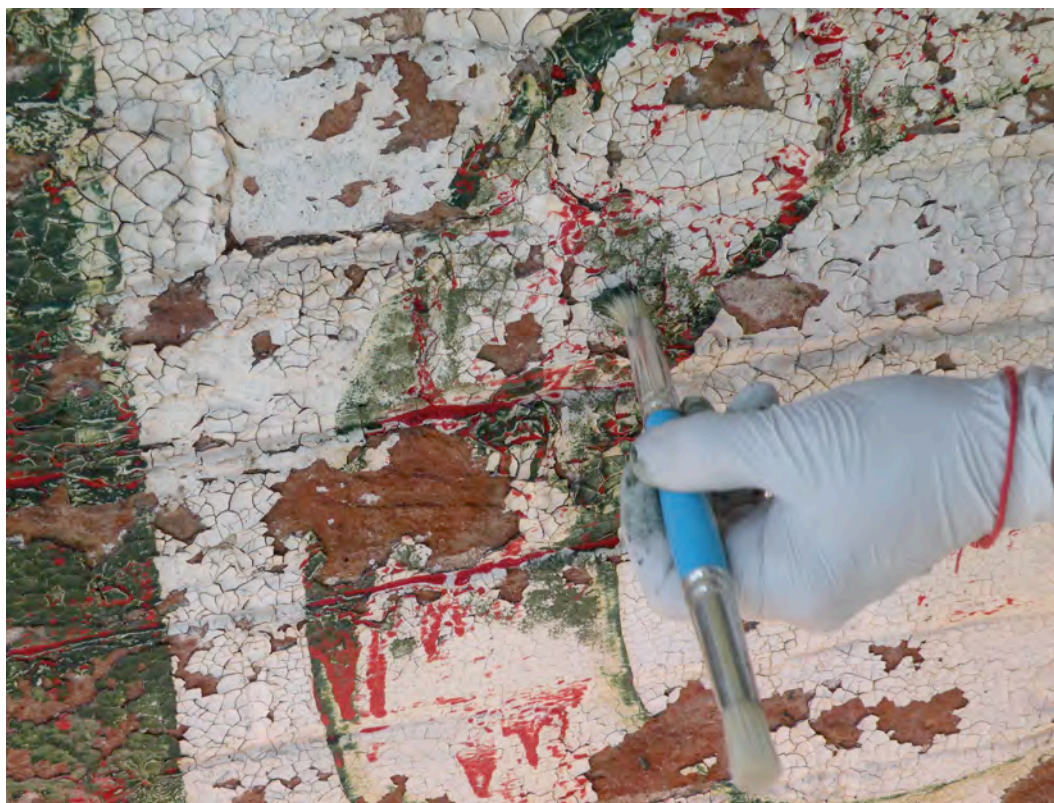
Stippling on the new casein paint to create an aged look to integrate with the historic paint

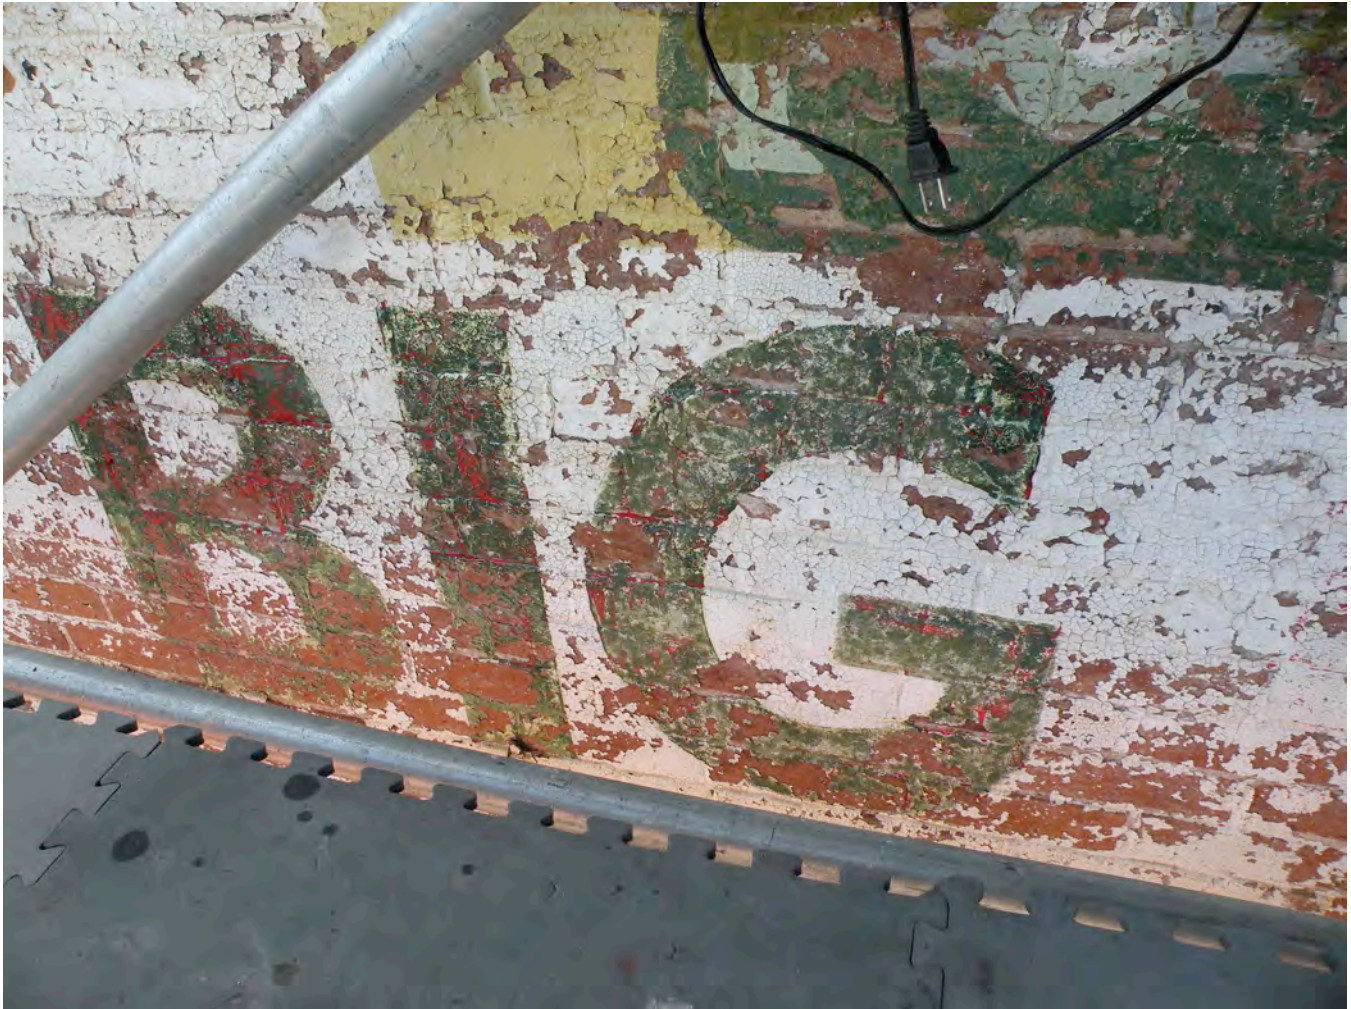
BIG after the G was reinstated
