REPORT OF ALTERATIONS TO DESIGNATED RESOURCE

Site Number/Address: 425 Mathews Street
Laurel School National Register Historic District
ISSUED: November 27, 2019

Re: **Mortar Analyses** for stone foundation and exterior brick wall; 425 Mathews Street, Ft. Collins, CO.

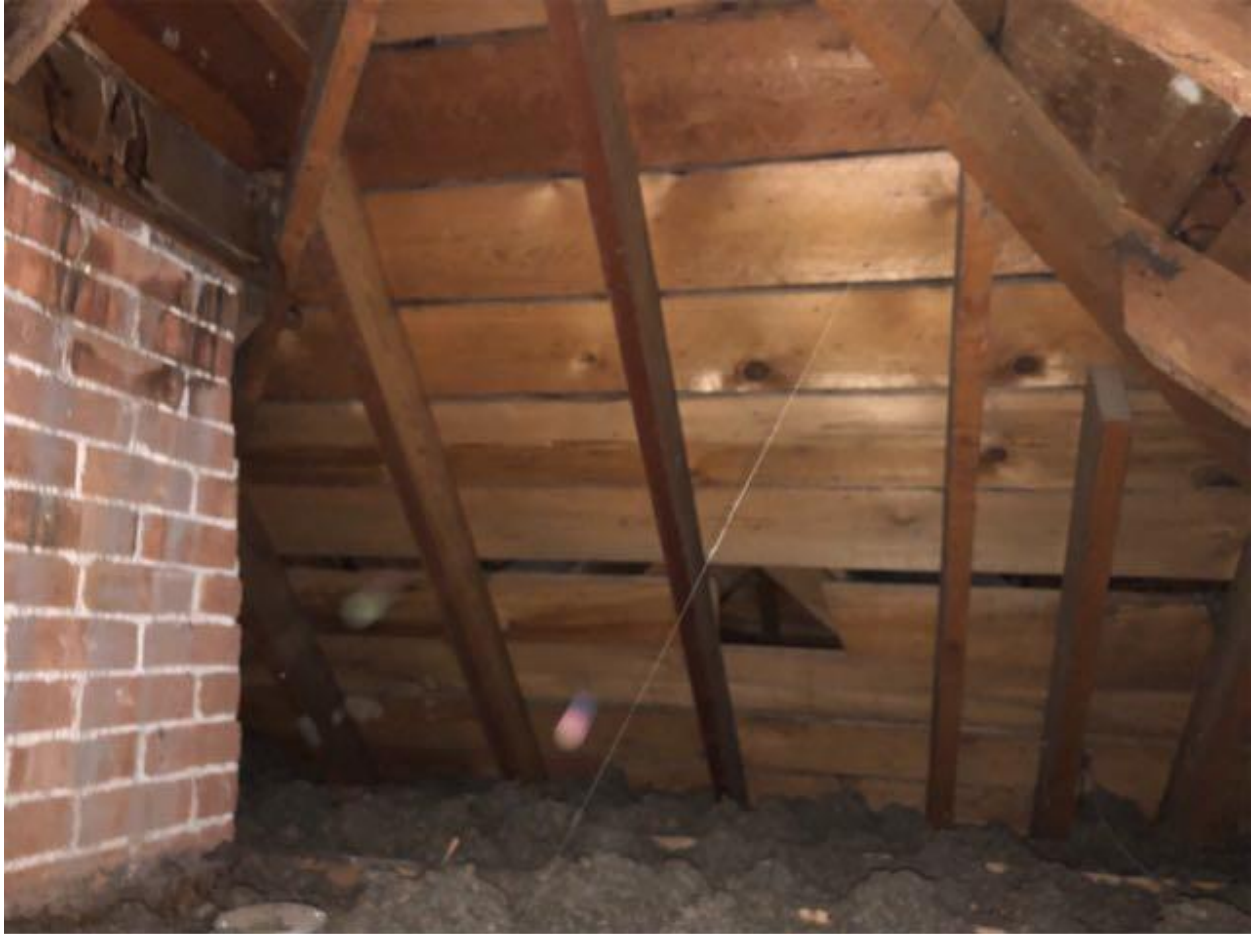
Mortar deterioration attic

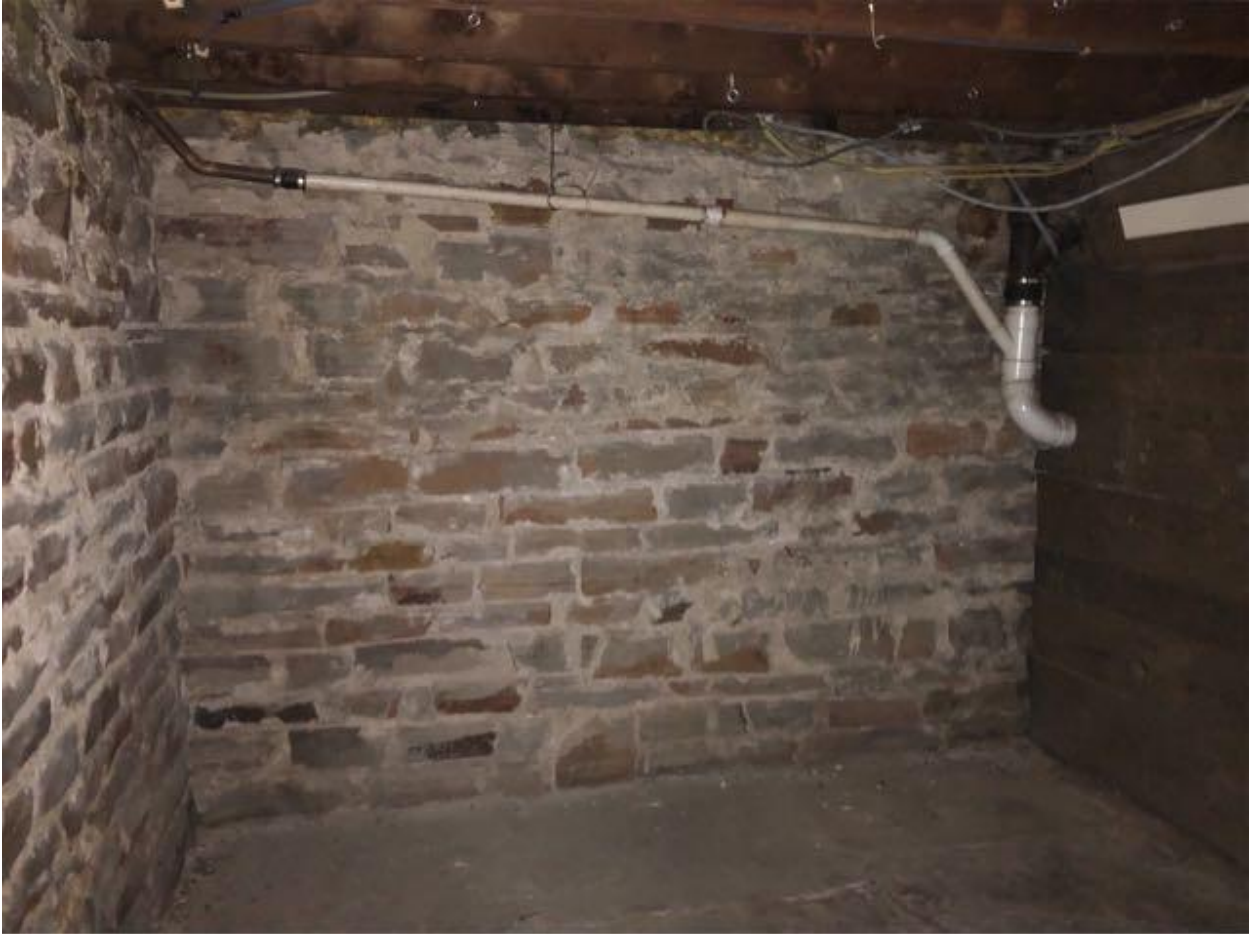
mortar deter. Basement

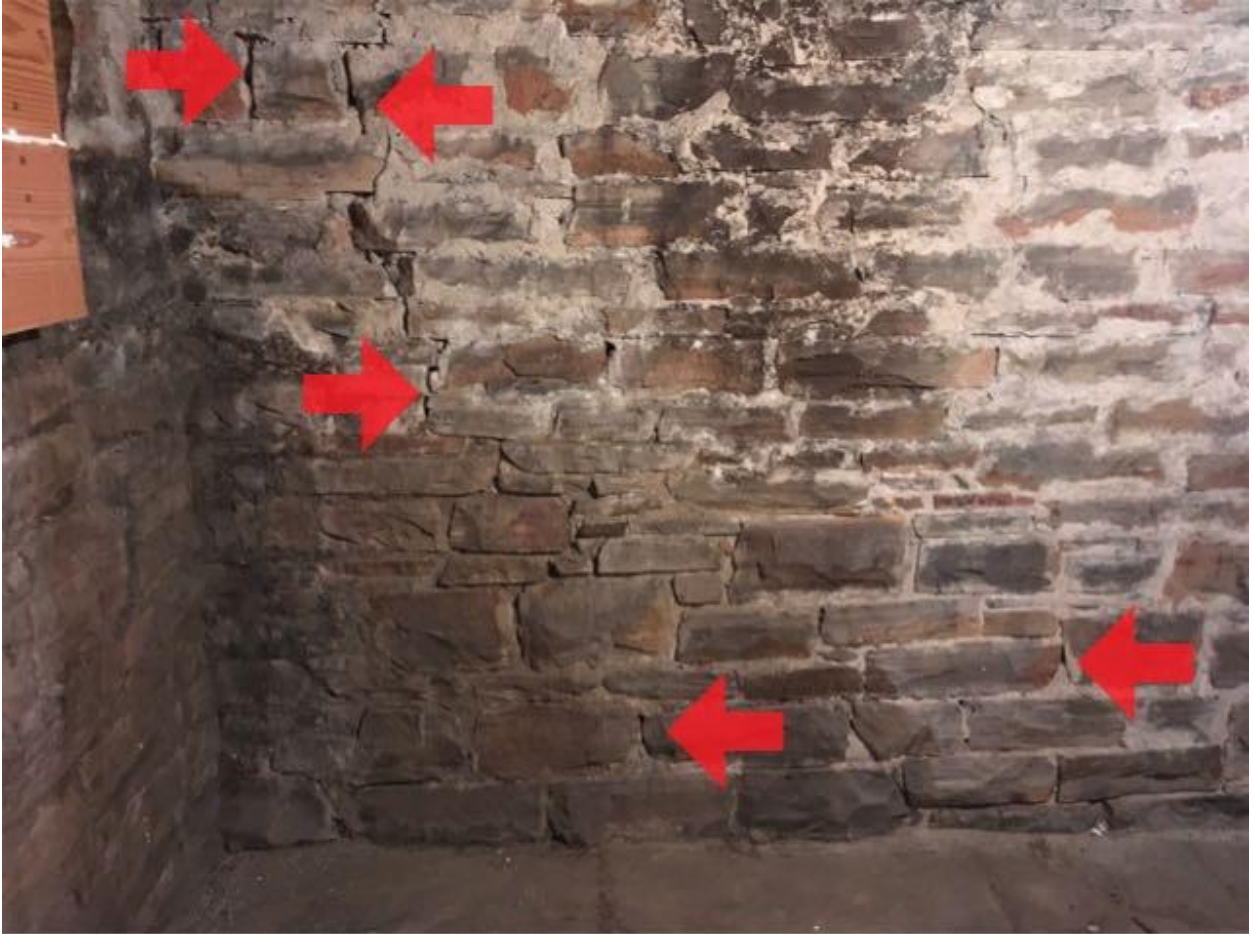
mortar deterioration basement

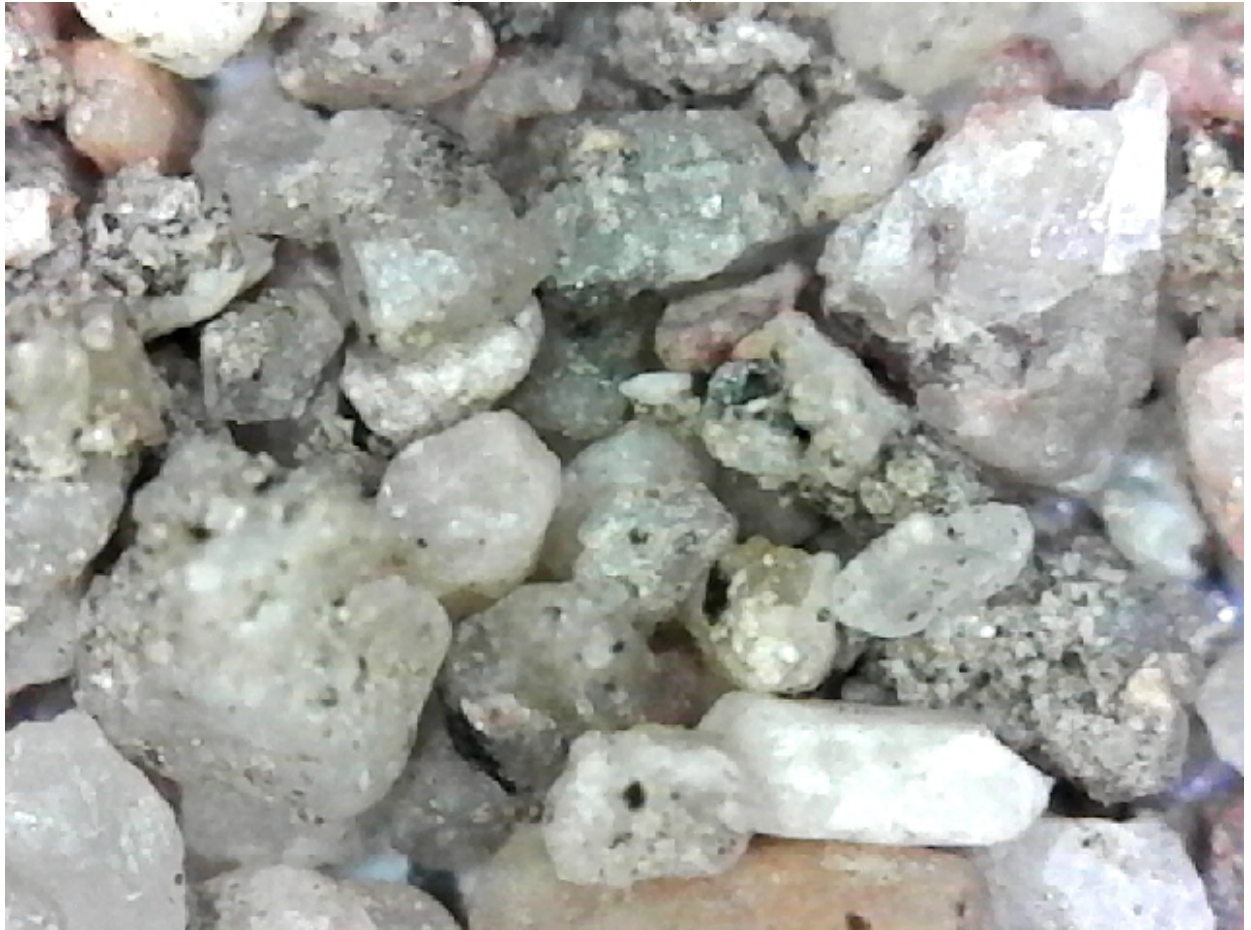
Figure 2: Sand from foundation mortar. Note sand is angular.

The sand was particularly clean, angular and seemed to be sifted with a #10 screen. It seems different that the grains are angular, so most likely not dredged from the Poudre River. The ratio (in volume) was one unit lime per four units sand. Reviewing weight and volume, plus noting the location is toward the exterior of the stone,

Conclusion: The existing mortar is somewhere between a Type O and a Type N. **It's suggested to go with a Type N, to make for a harder edge bead and cap, while being similar to the bedding mortar. Color of cement should be grey.** See Attachment A for Detail.

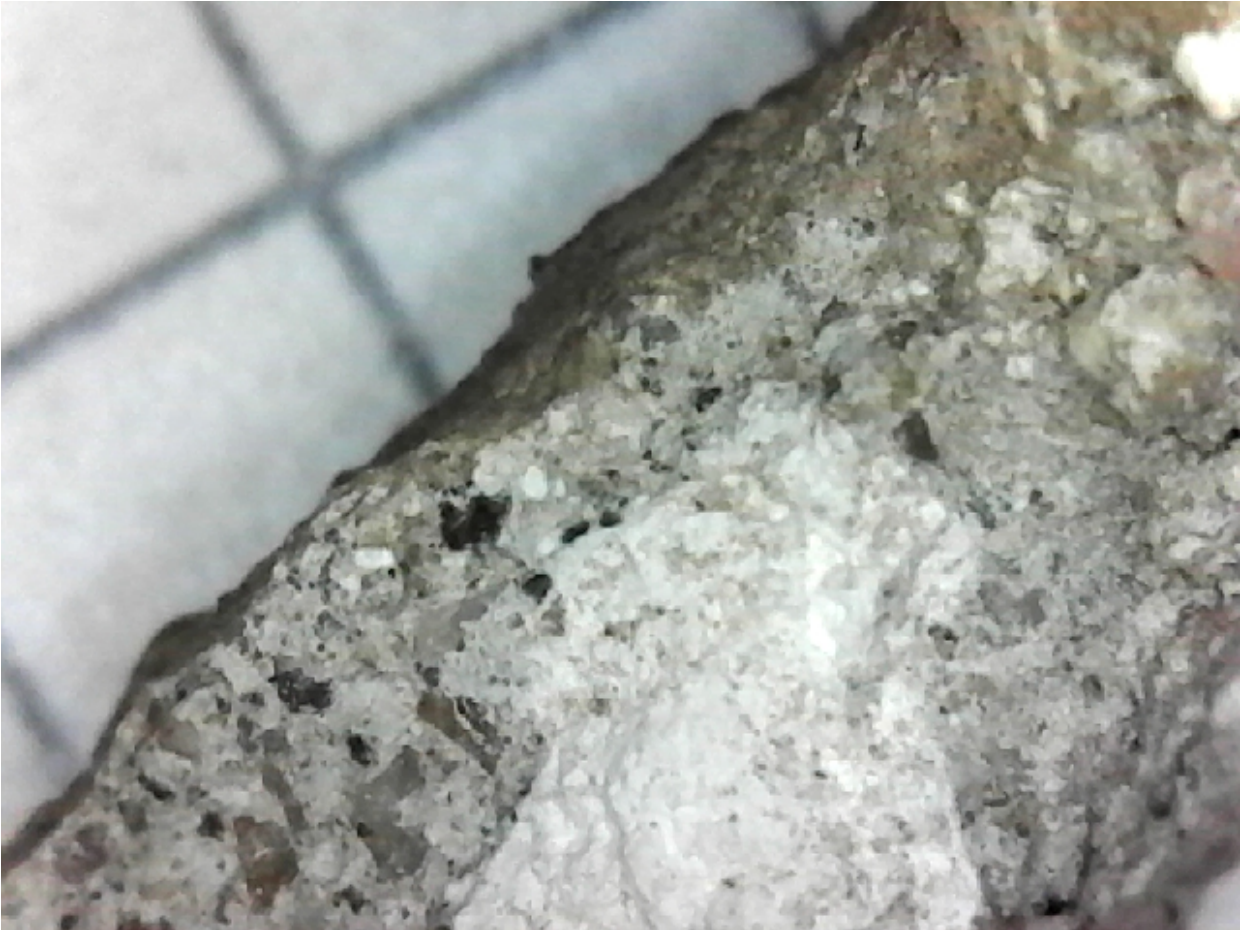
The original bead seems to be grey in color, so the cement should be grey in color. The lime will help lighten the color.

Figure 3: Original back of the bead under a microscope, showing a chunk of lime surrounded by grey portland.

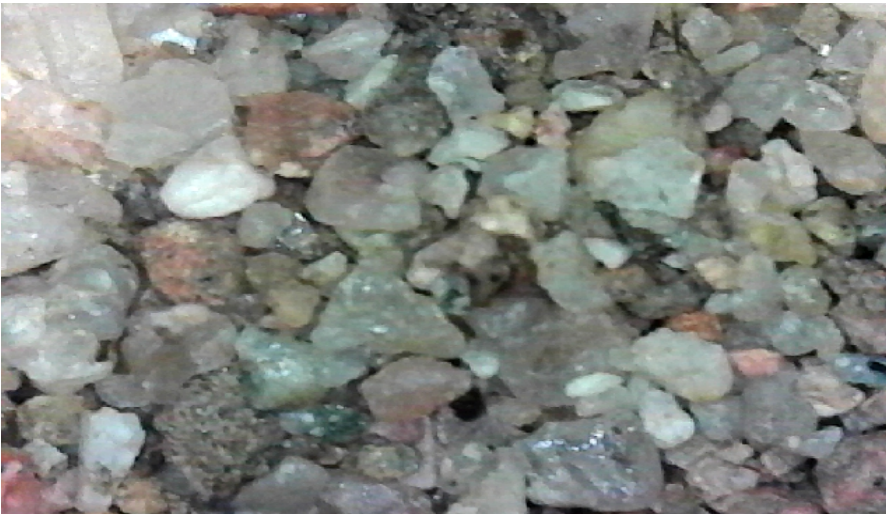
Figure 4: Angular sand found in brick mortar.

The aggregate was again angular, with minimal rounded; most likely not from the River. The aggregate was screened to a lower screen of #35. See Attachment B.

Conclusion: Because of this thin joint, It's believed that a smaller aggregate was required. Also, the amount of lime was almost double that found in the stone mortar, possibly for better adhesion. **A Type K variant should be used for repointing, adding just a bit of cement for strength. Cement added should be Federal Cement (white) for color.** See Attachment B for Detail.

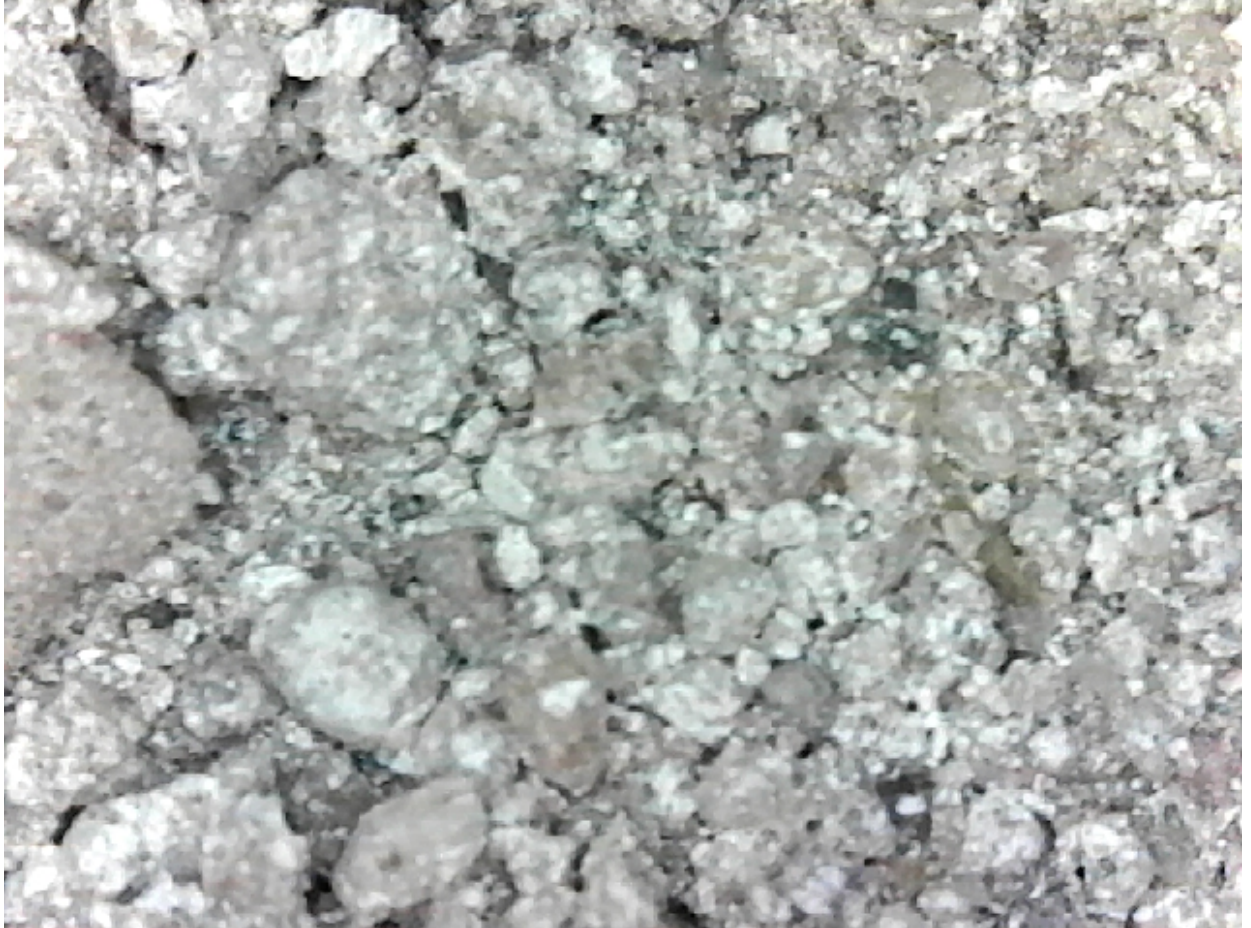
Mortar: The mortar removed came out as a powder, and soft enough to crumble between your fingers. The color was white-to-grey, especially on the outer edge.

Figure 5: Dry brick mortar before dissolution.
