## CERTIFICATE OF APPROPRIATENESS

As you are aware, the Historic Preservation Commission gave Final Design Review approval for the work you are proposing for the Scott Apartments and Garage at 900 S. College Avenue at its January 19, 2022 Regular Meeting.

## The Scott Apartments Before Photographs

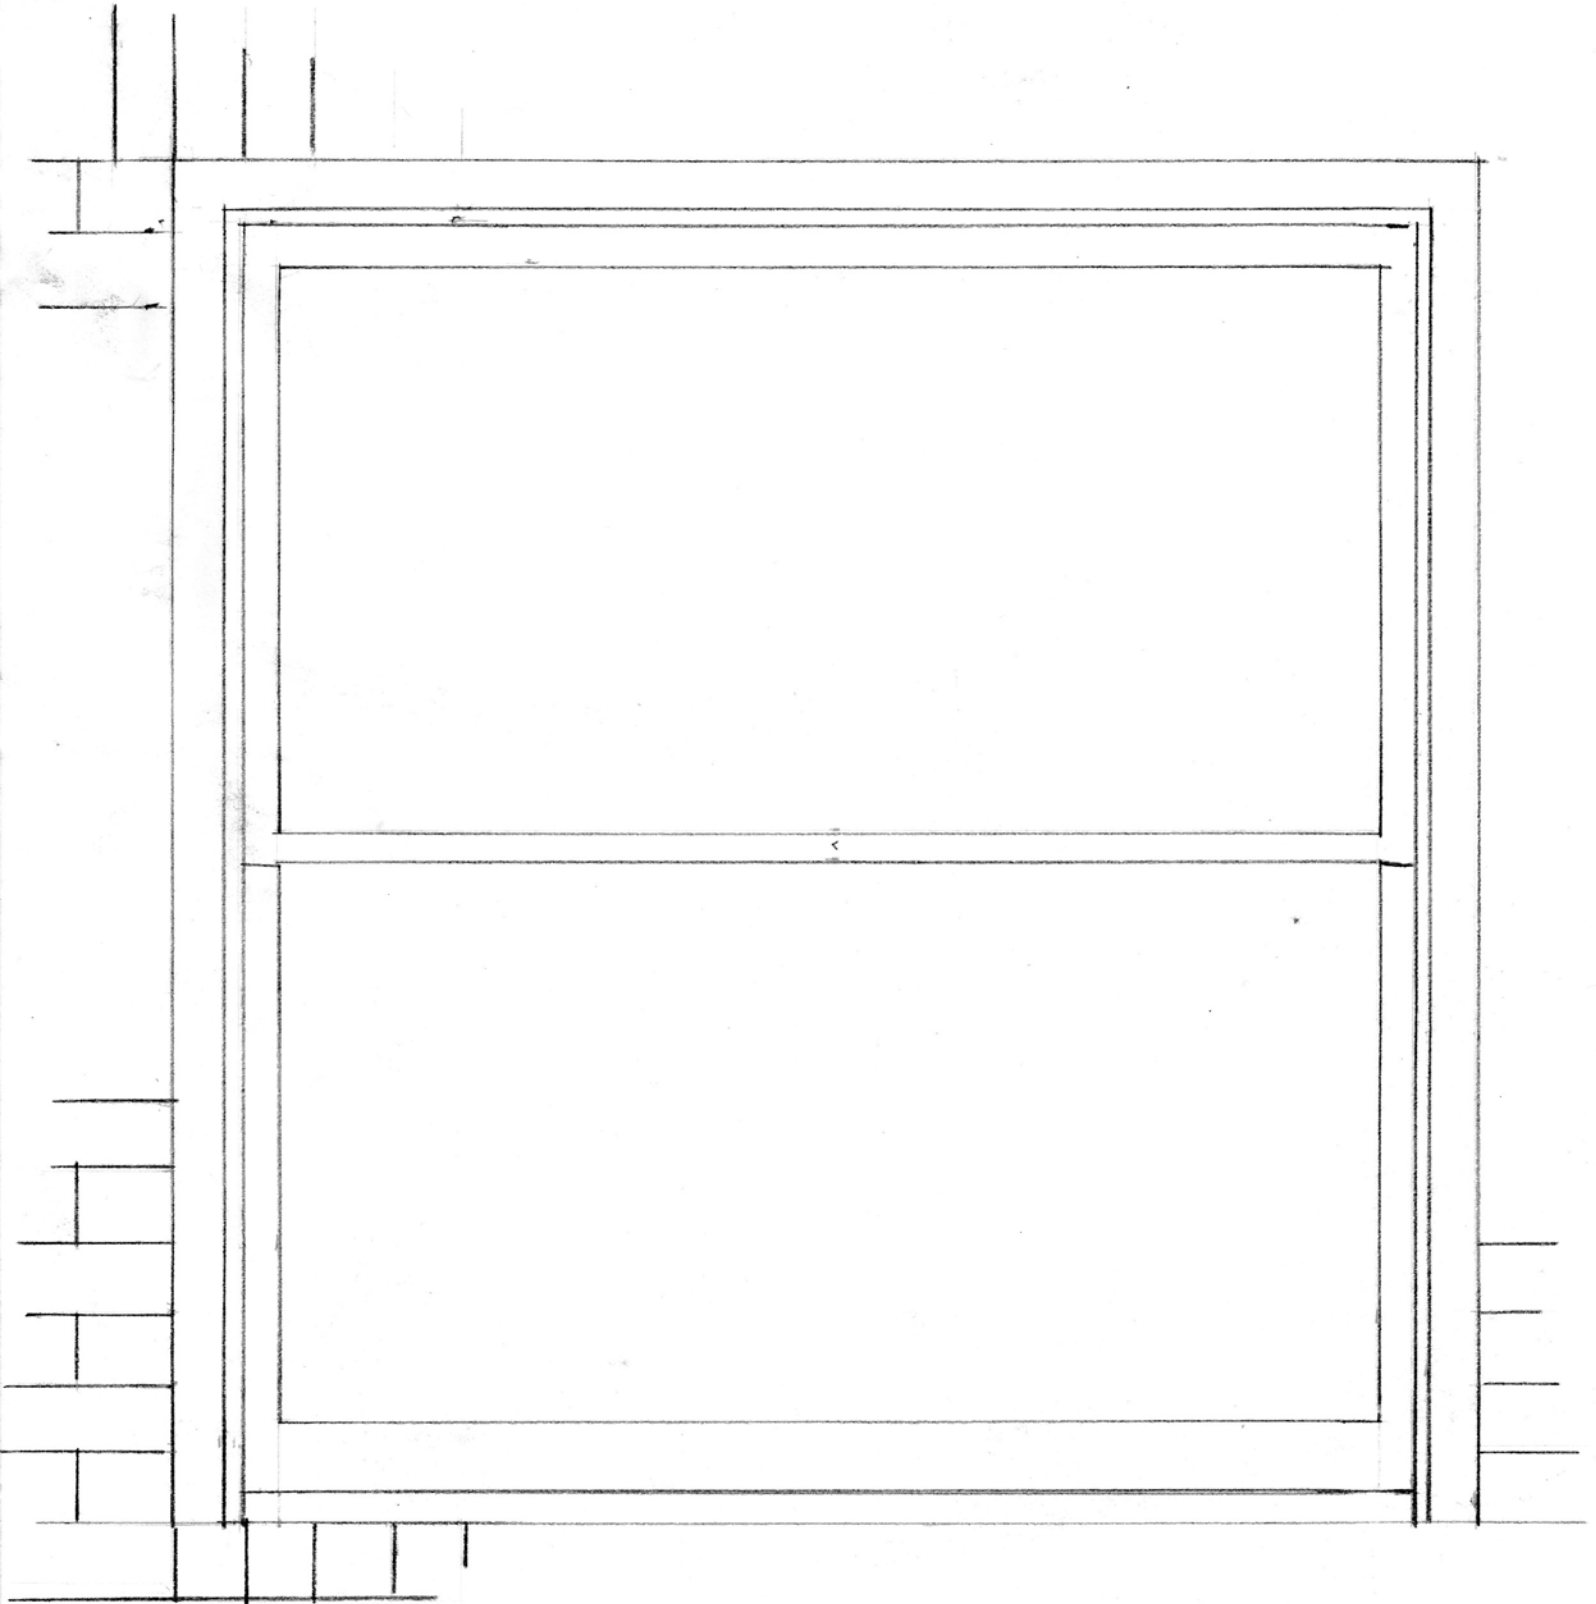
existing 54" x 56<sup>3</sup>/<sub>4</sub>" Window sash & jamb  
scale 1<sup>1</sup>/<sub>2</sub>" = 1'

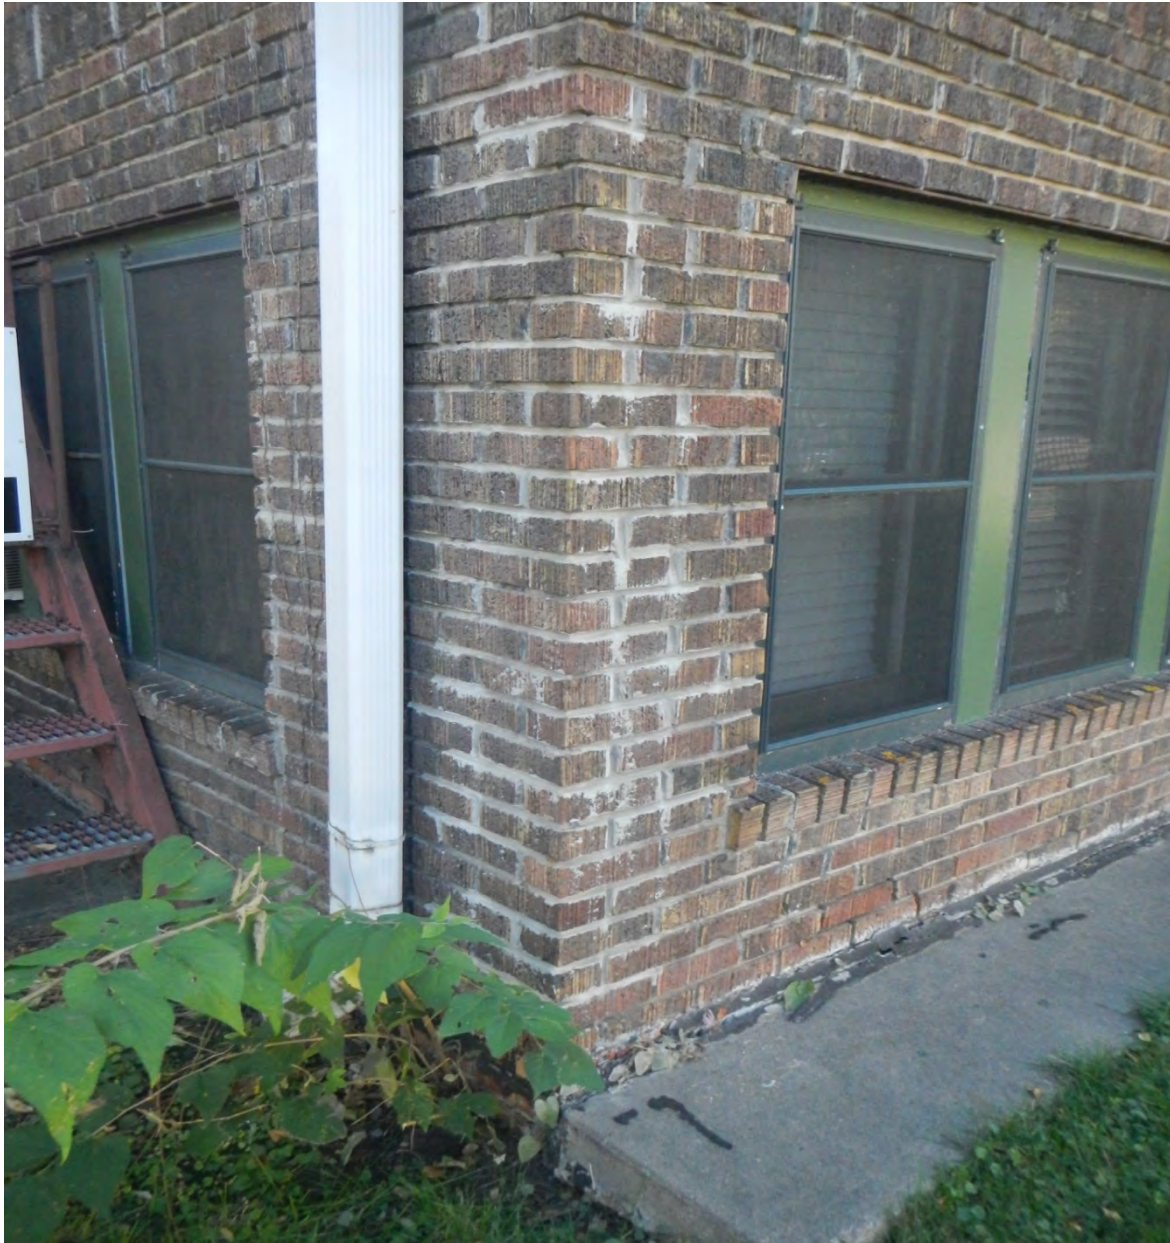
Figure 1: NE corner of Apartments showing incorrect mortar, lower mortar deterioration and wall-to-flatwork failure.

1. Treat deteriorated and shoddy mortar to NPS Preservation Brief #2 standards. Note; Limeworks.us, Telford, PA will provide mortar analysis, matching, and mix for mortar repair.

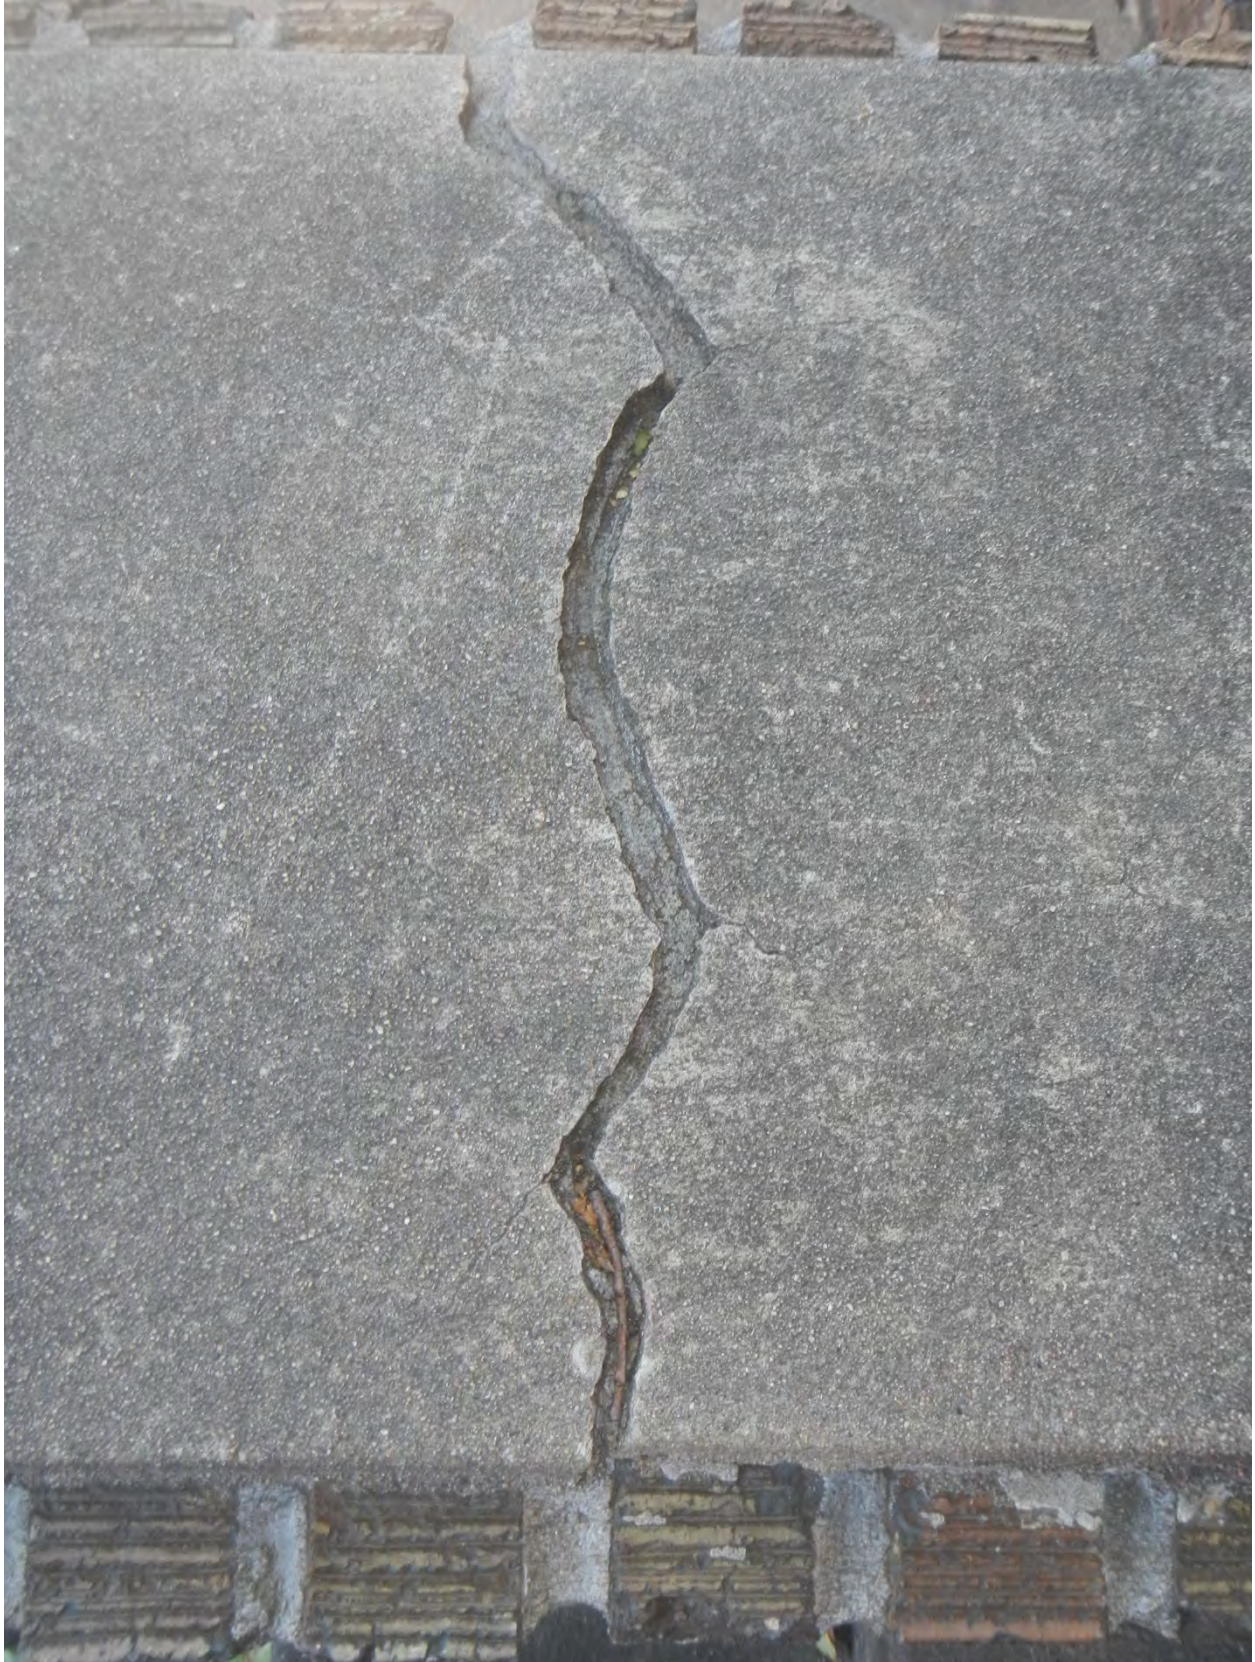
Figure 2: Crack in exterior stair wall. Crack is filled with caulk seal.

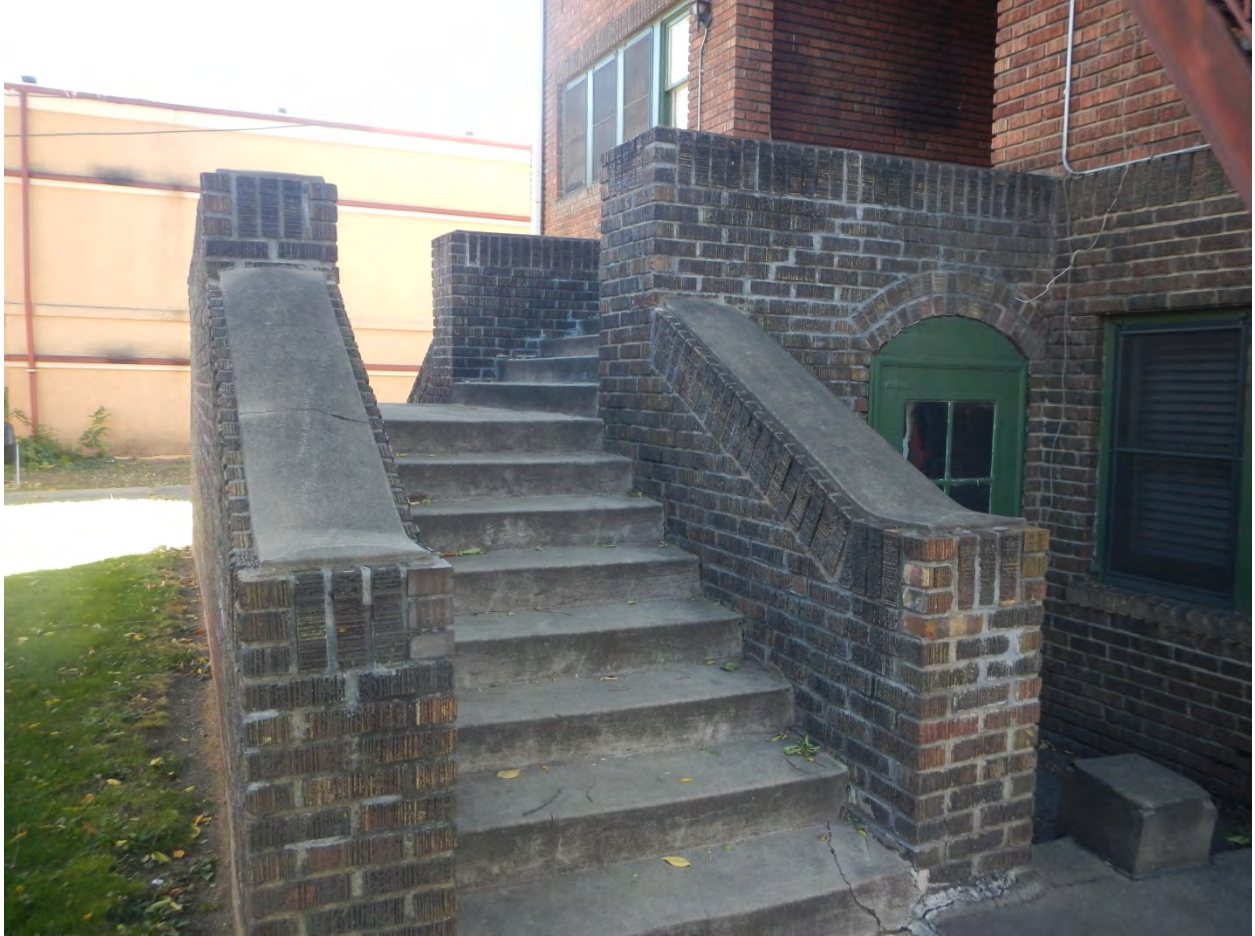
Figure 3: Rear stair system showing failing concrete and redone mortar caused by outside wall movement.

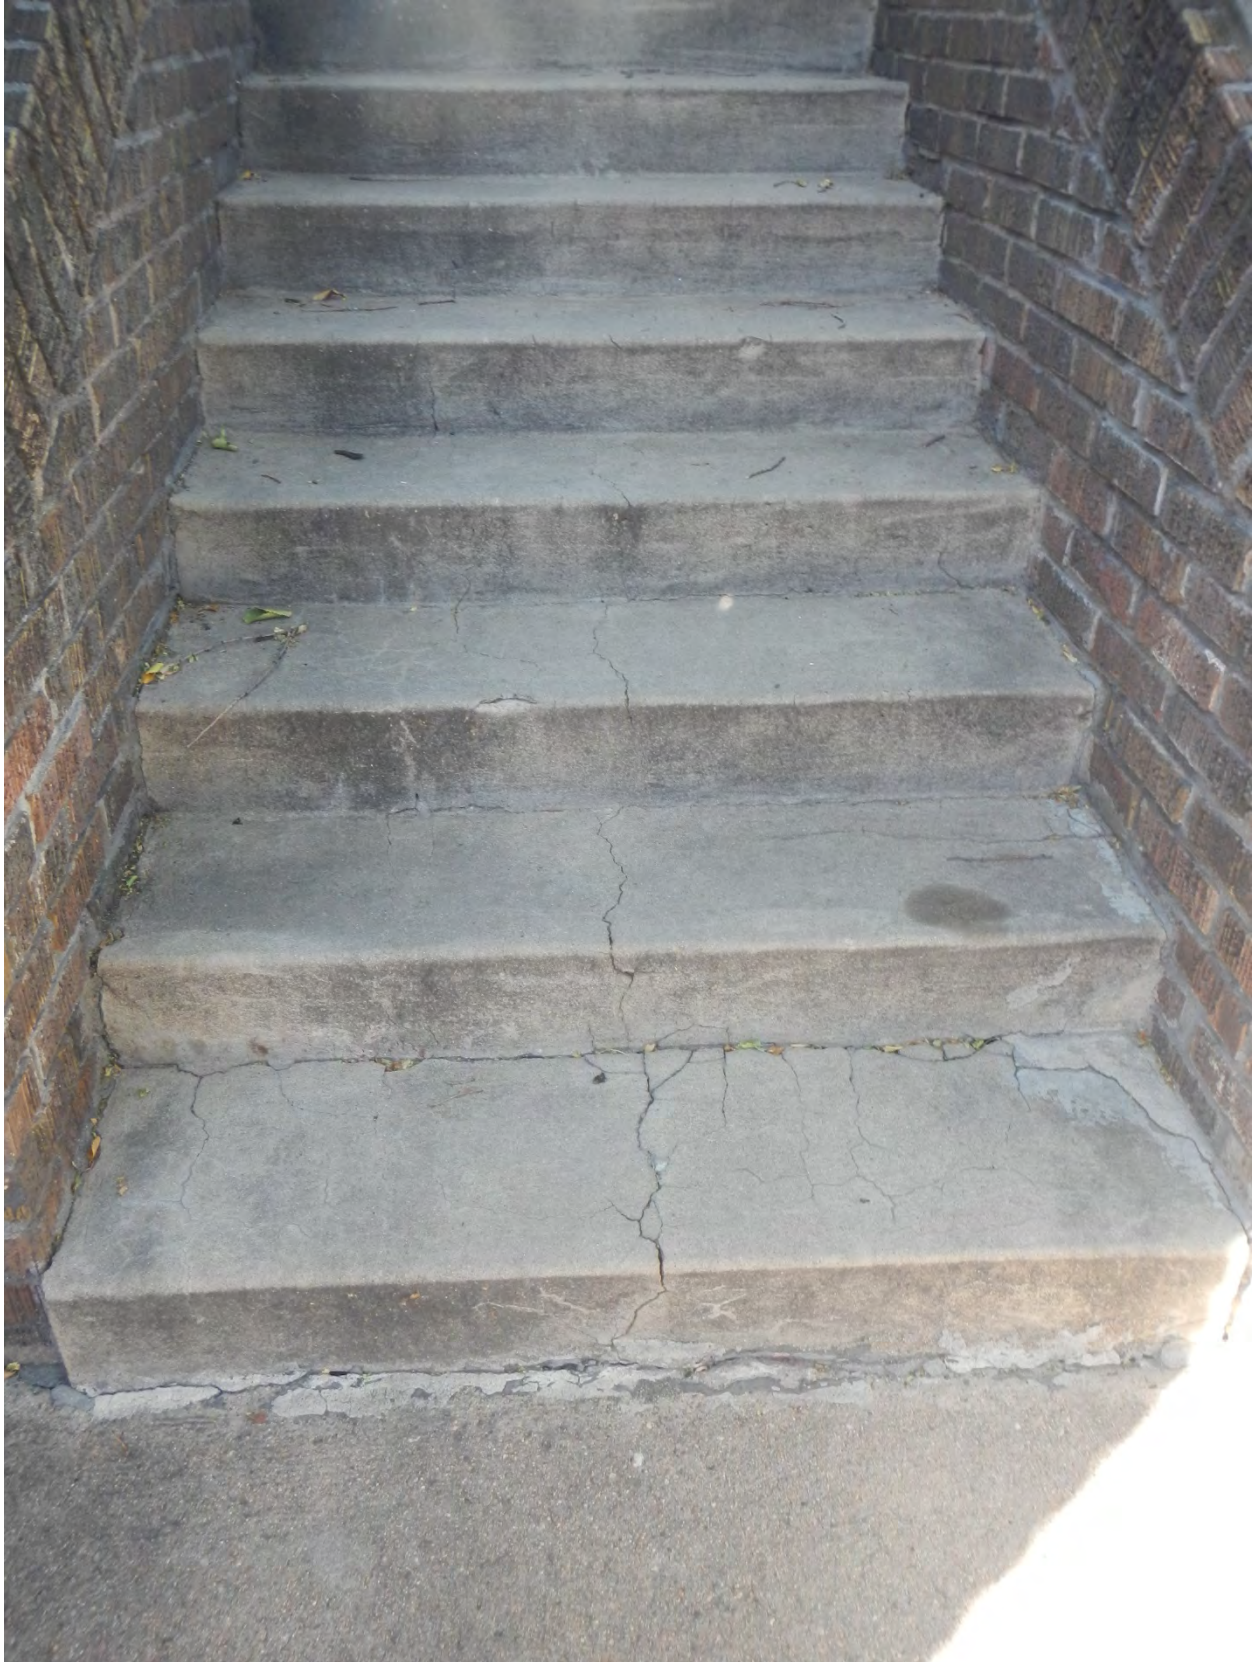
Figure 4: Deteriorating concrete steps.

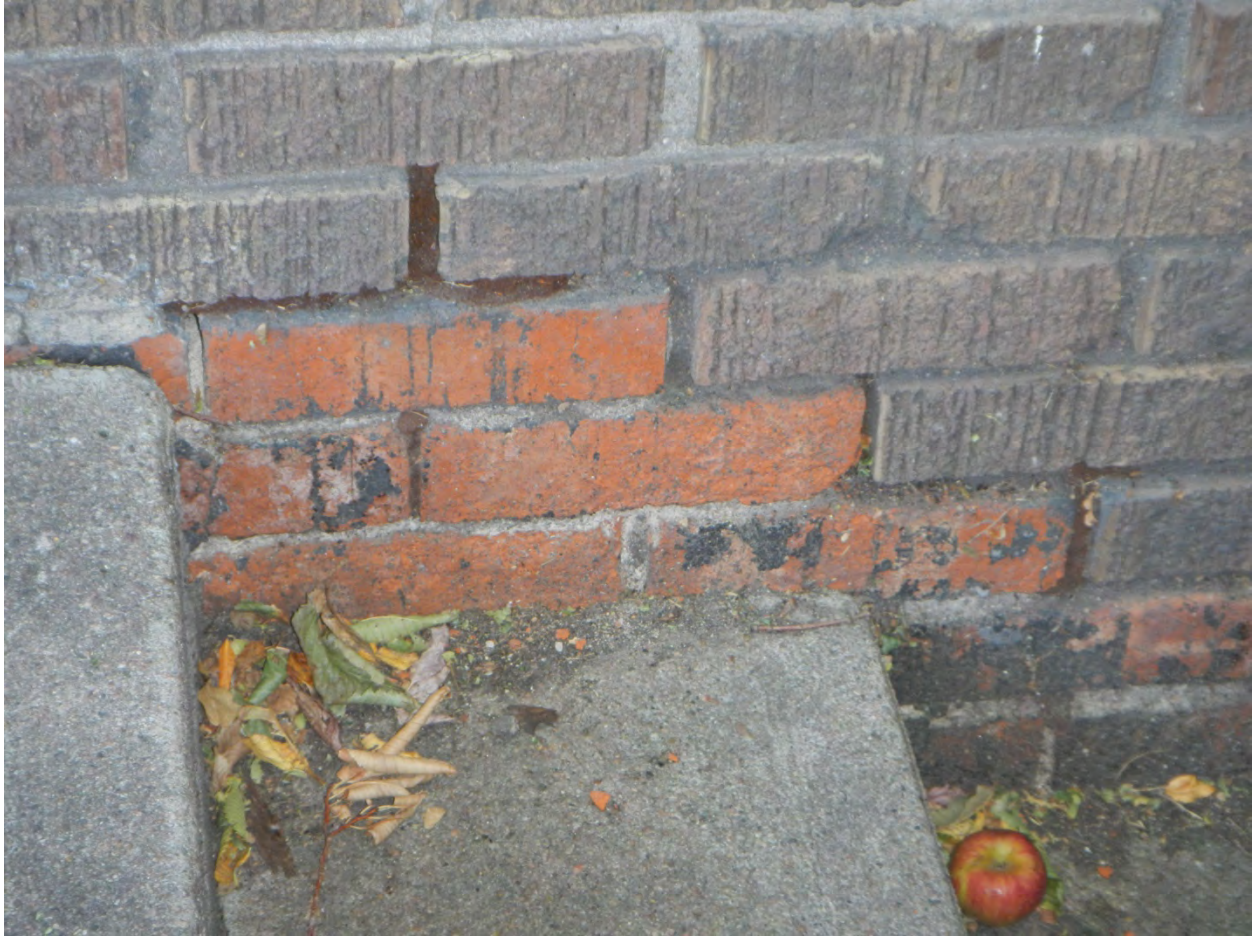
Figure 5: Replaced brick in stair wall.

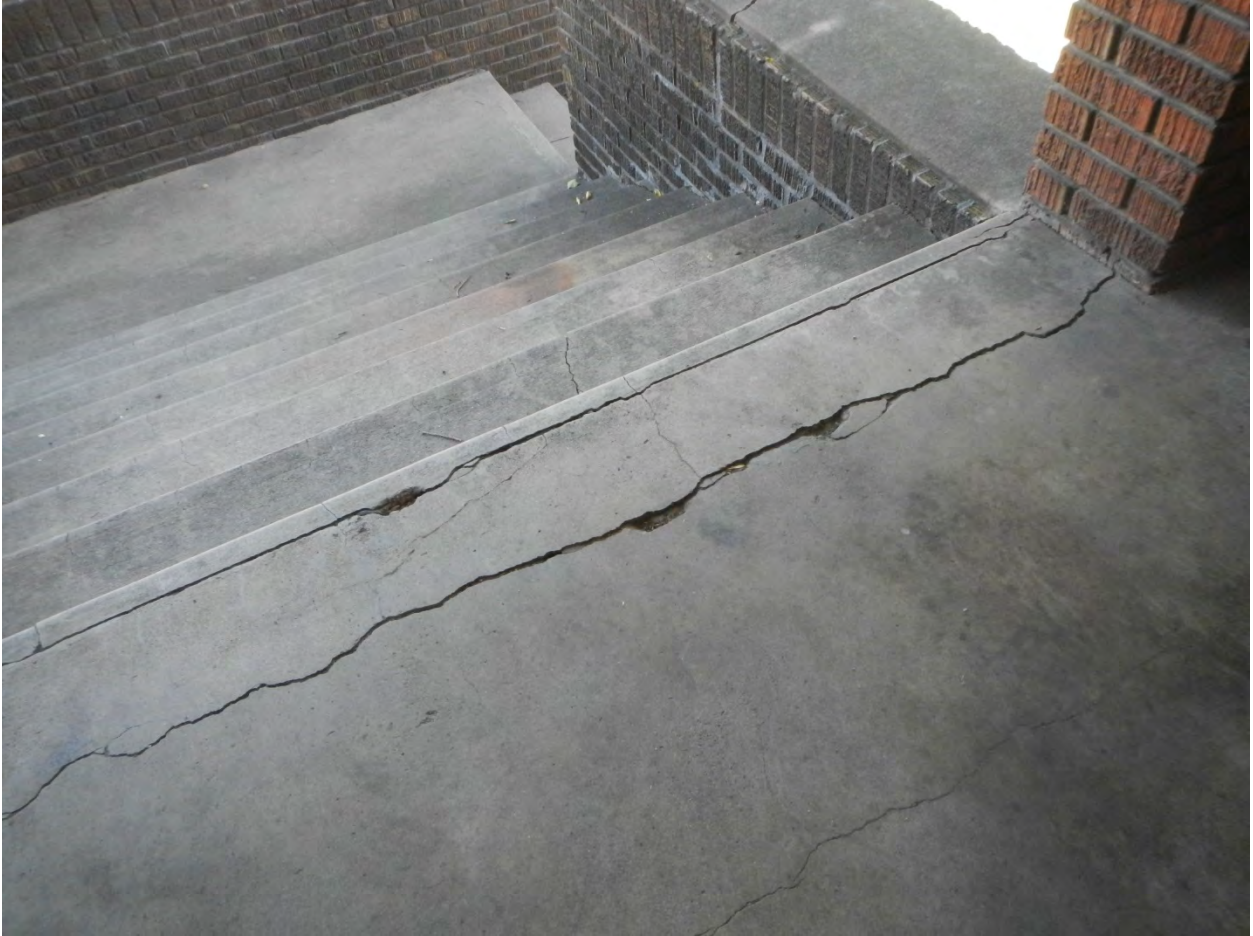
Figure 6: Compromised upper landing on rear steps.

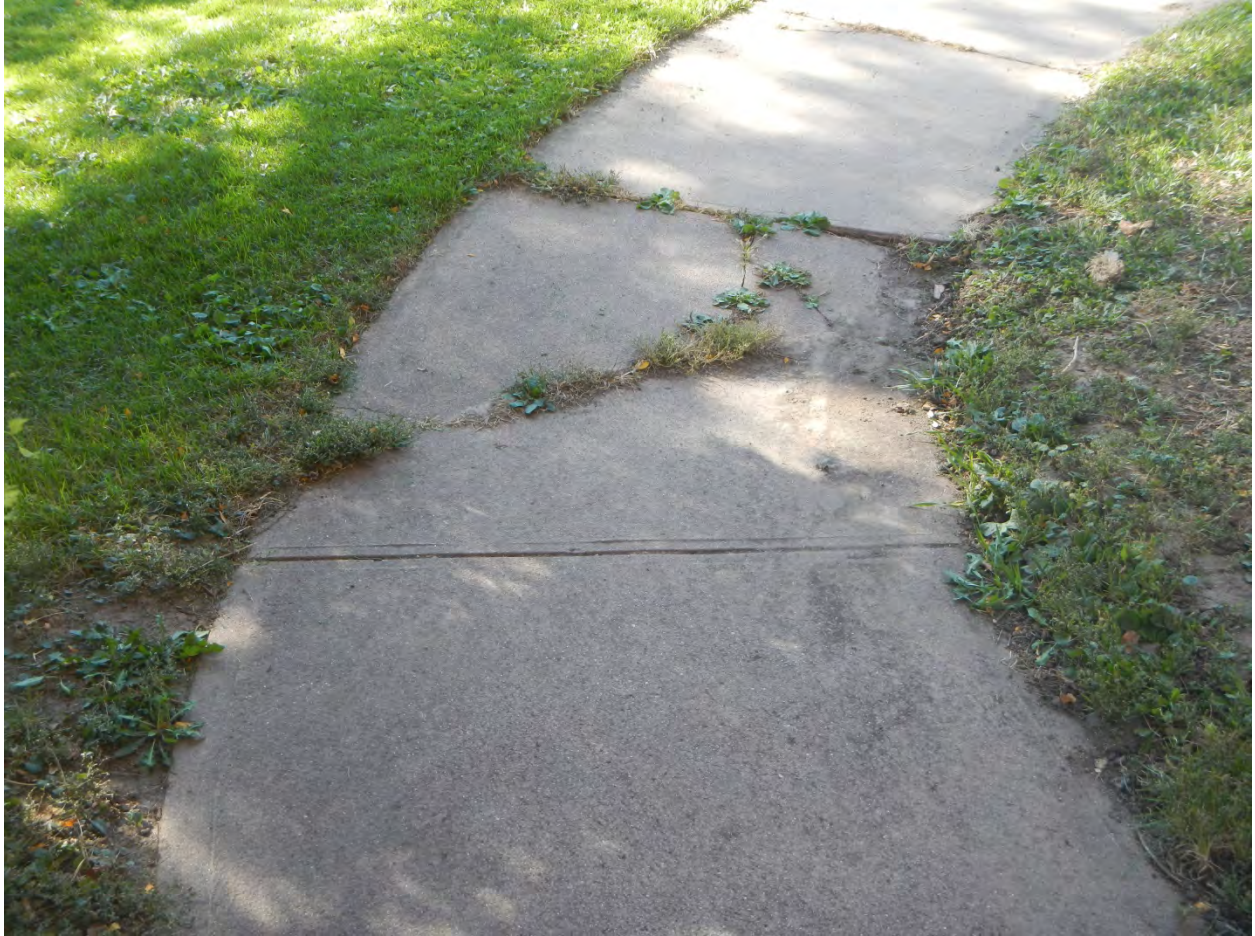
Figure 7: Broken sidewalk on SW of building.

7. Replacement of deteriorated concrete sidewalks

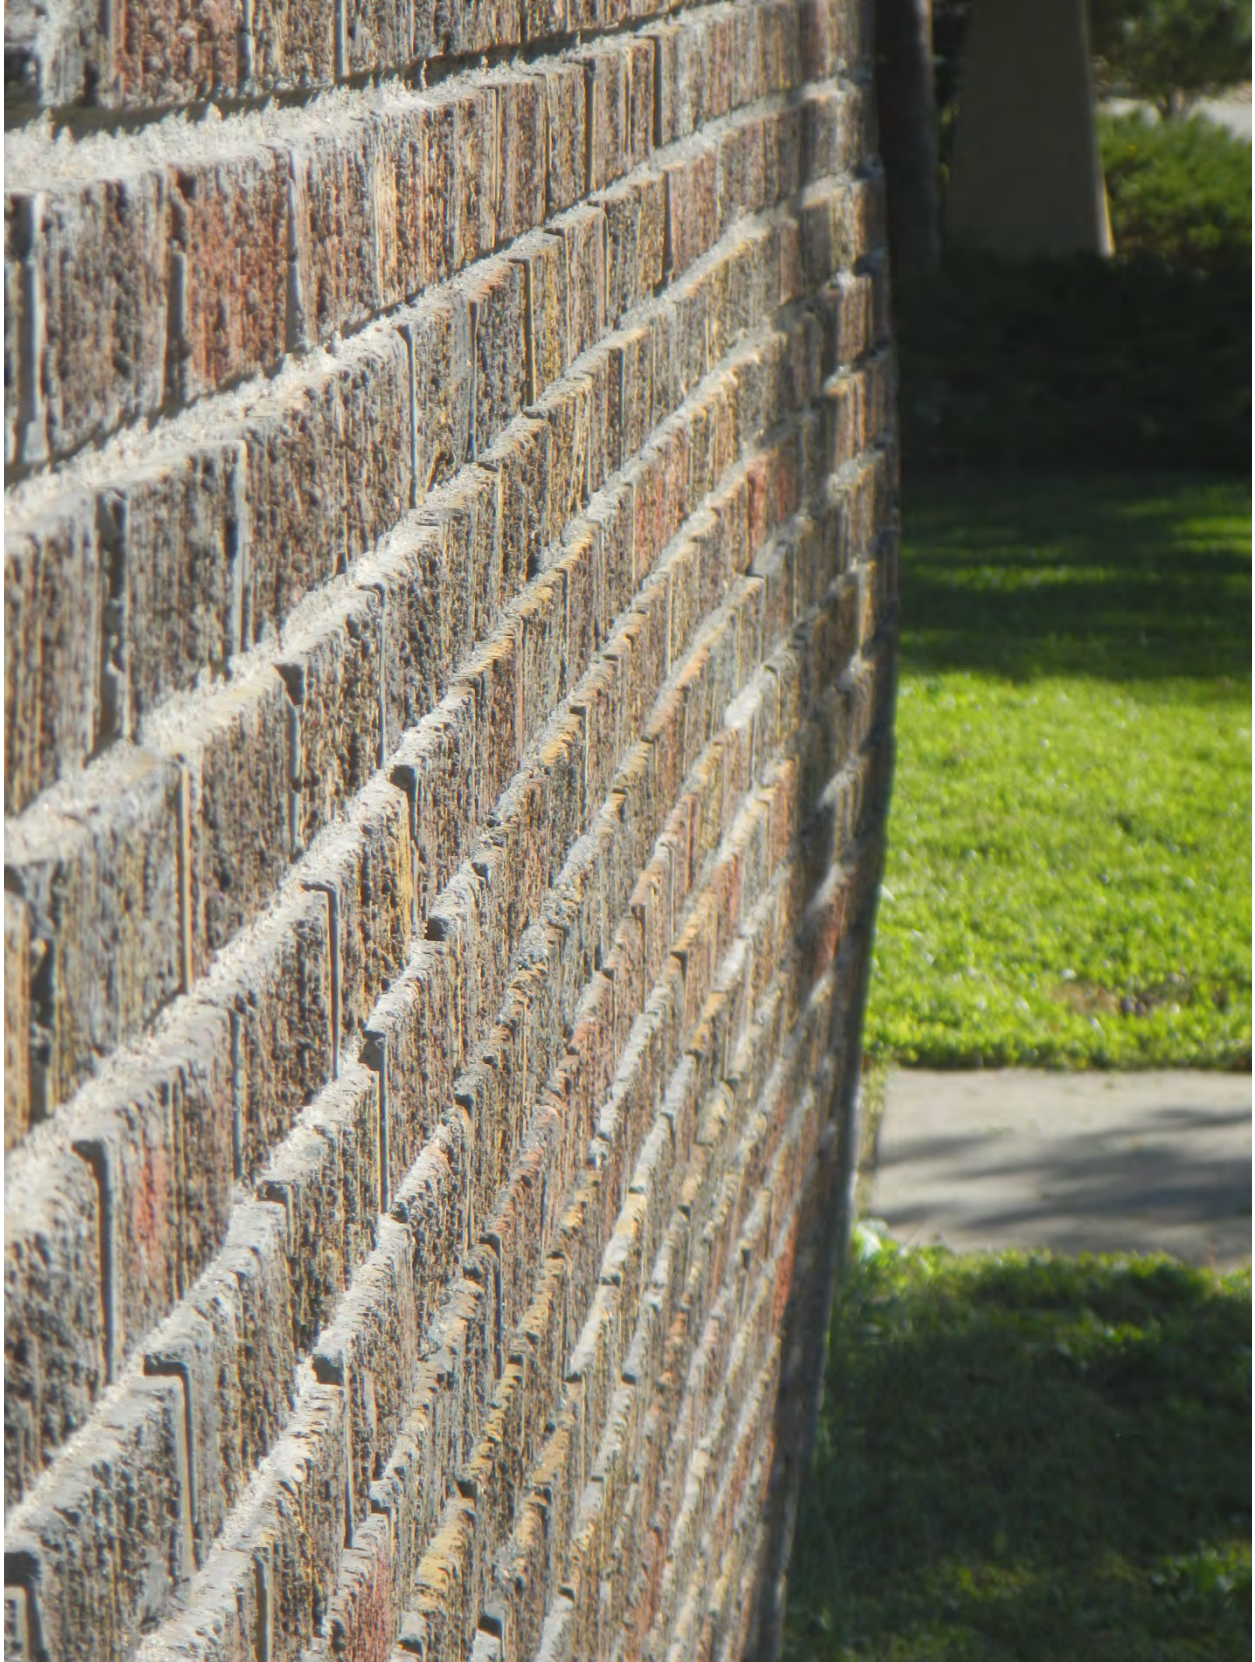
Figure 8: West (Front) stairwell wall showing bulge.

2. Remove all Hedera Helix vine and destroy plant roots.
3. Replace missing or deteriorated brick in kind with closely matched salvage brick
4. Repair bulge in step wall as follows;  
Provide temporary stabilization to the east side of this wall (step side).  
Provide temporary stabilization to soldier course of brick above the bulge  
Carefully remove face brick in and around the bulge area and clean this brick for salvage.  
Remove moisture deteriorated clay tile area of wall that caused the bulge.  
Replace clay tile with new brick or cmu material mortared into existing non-deteriorated clay tile wall.  
Re-lay salvaged face brick over replaced clay tile wall with appropriately matched mortar.  
Remove temporary stabilization.  
Gently clean repaired area with clean water and bristle brush.

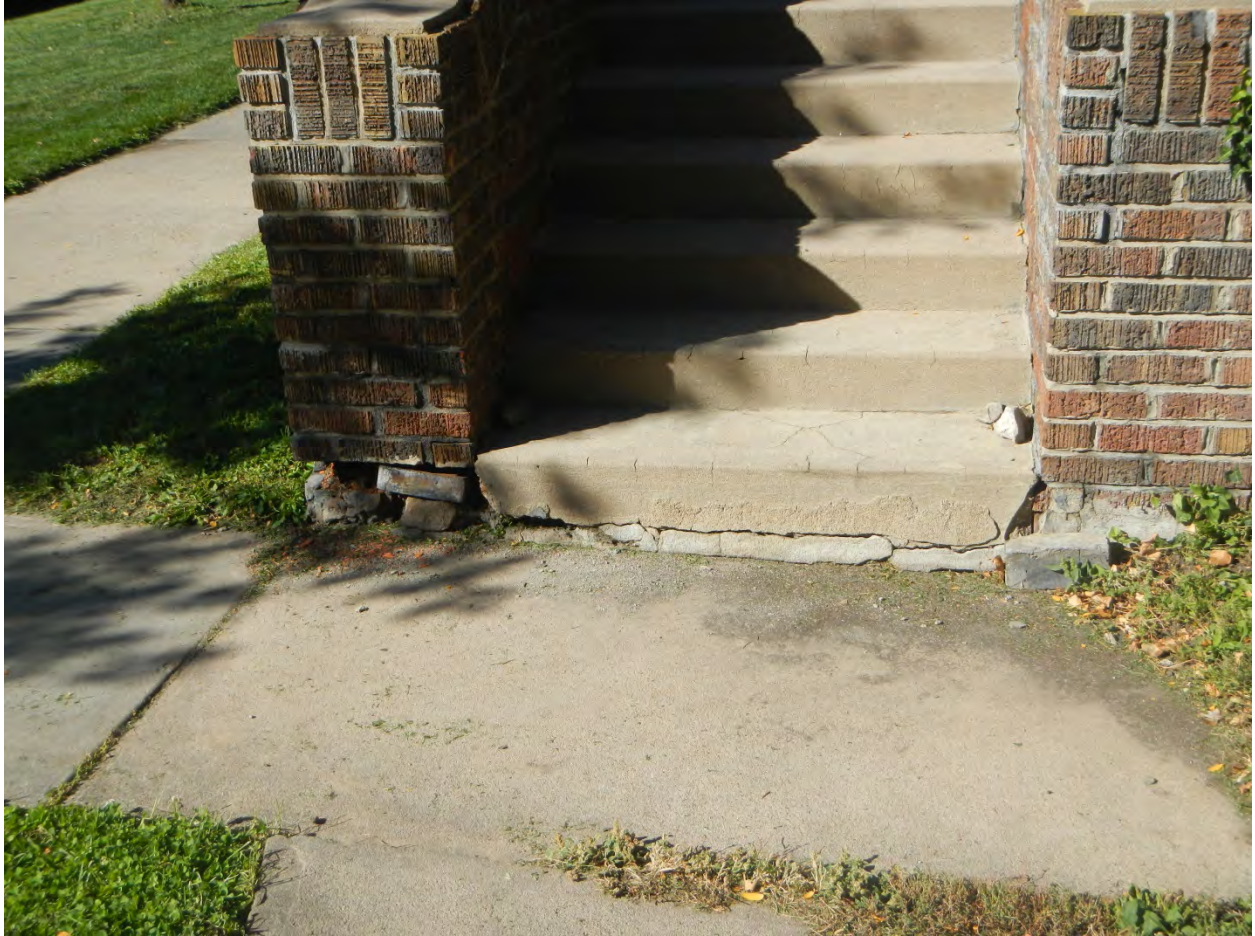
Figure 9: Front Stairwell showing stair and brick wall deterioration.

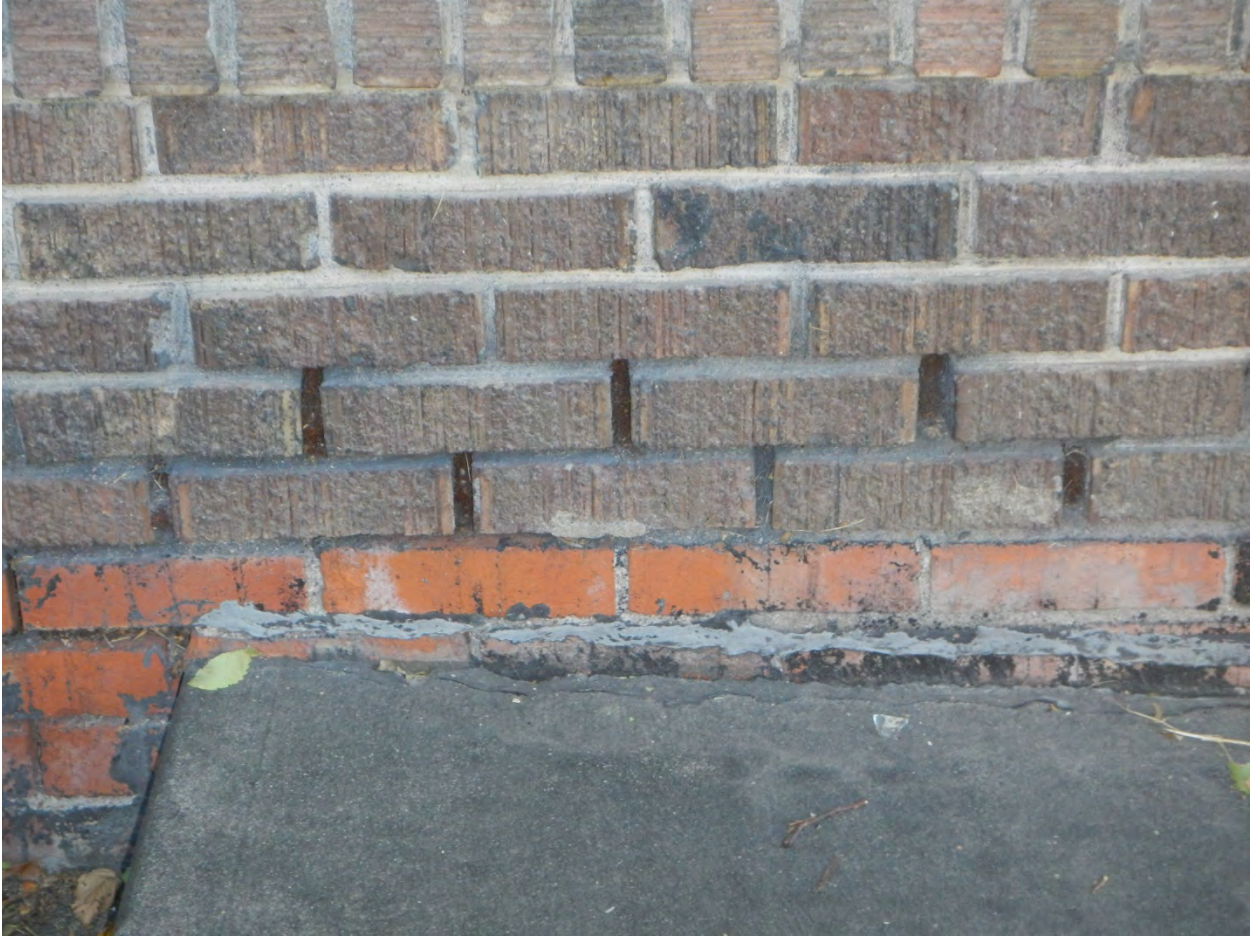
Figure 10: Wrong colored replacement brick and failing mortar found on main building.
