CERTIFICATE OF APPROPRIATENESS ISSUED: September 29, 2023 EXPIRATION: September 29, 2024

Rehabilitation of the historic stained-glass panels on the façade of the building – Removal, cleaning, repair, in-kind replacement as needed, reinforcement, and reinstallation as more particularly described in attached report by Scottish Stained Glass.

Stained Glass Report and Assessment for: Opera Galleria 123 N College Ave, Fort Collins, CO 80524

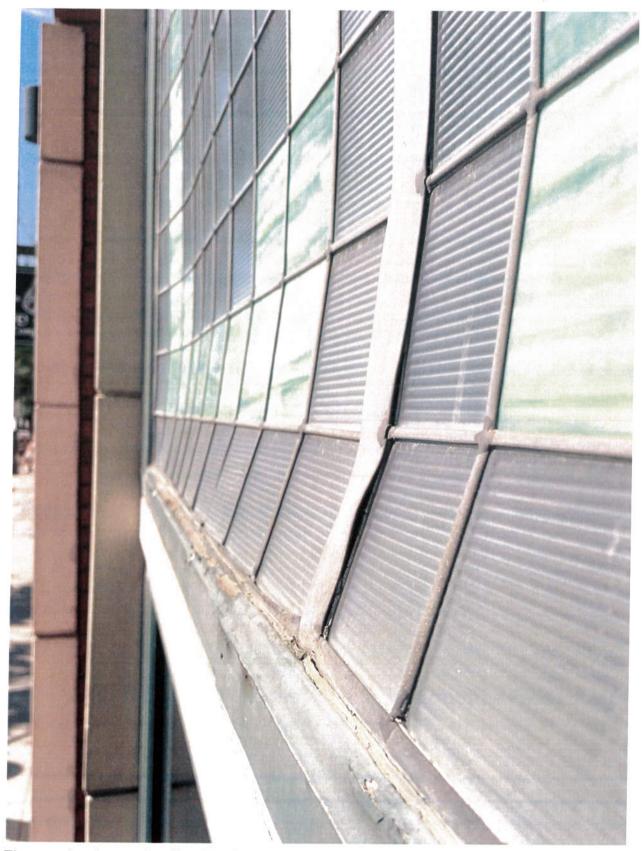
The zinc caming is warping, causing some of the panels to show a wavy appearance. This is also starting to cause stress fractures. Within the next few months-years, more glass will continue to break where the warping is most extreme. This occurs to a certain degree in most of the panels, but is most severe on the Crystal Joys, Mary's Mountain Cookies, Savory Spice Shop, Jax Fish House North Windows, Rocket Fizz and Hoggatt Law panels. The worst panels are showing category 5 warping and even the better ones are showing category 3+ (see appendix 2 for warping categories)

Zinc caming is warping (buckling), causing a wavy appearance.

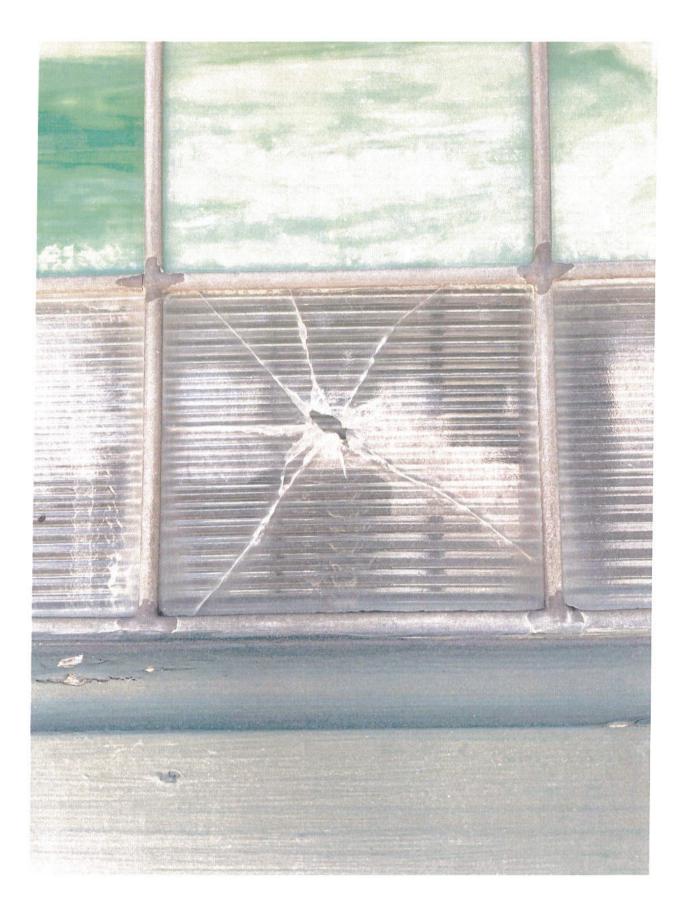
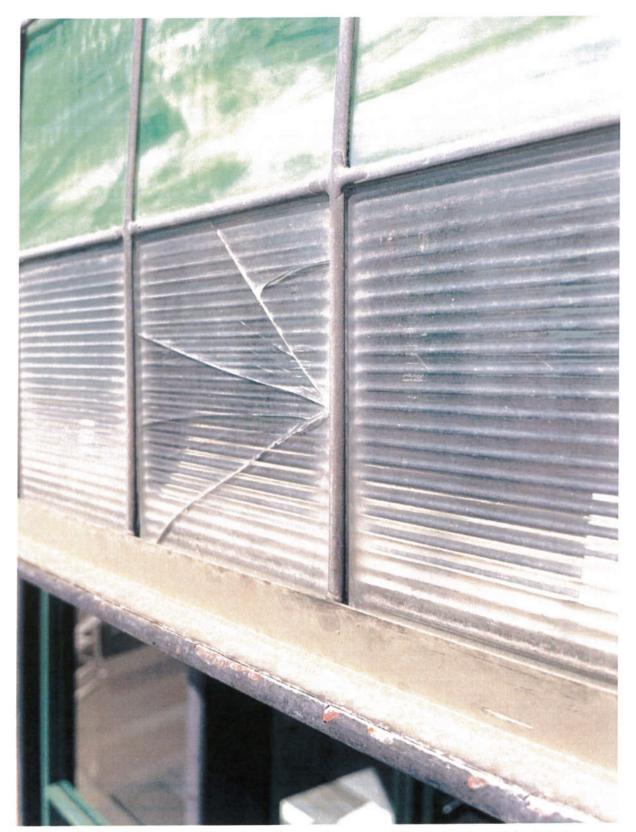
Broken glass due to warping, harsh weather, vandalism, and accidental damage.

- 2. Glass is mostly broken from the severe warping stress on the glass, however there are a few instances where an exterior impact (beebee or rock) has caused a break. Possibly some breaks are due to accidental damage or severe weather.

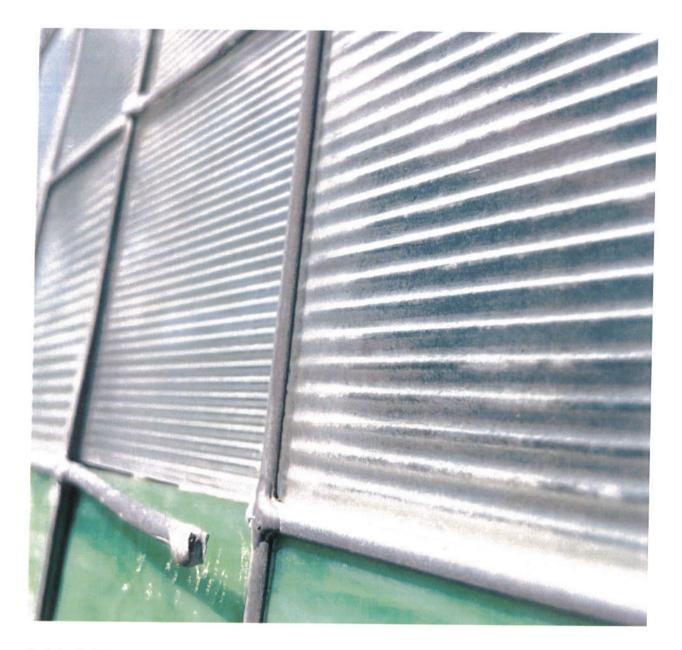
Solder joints are splitting under pressure from warping and age.

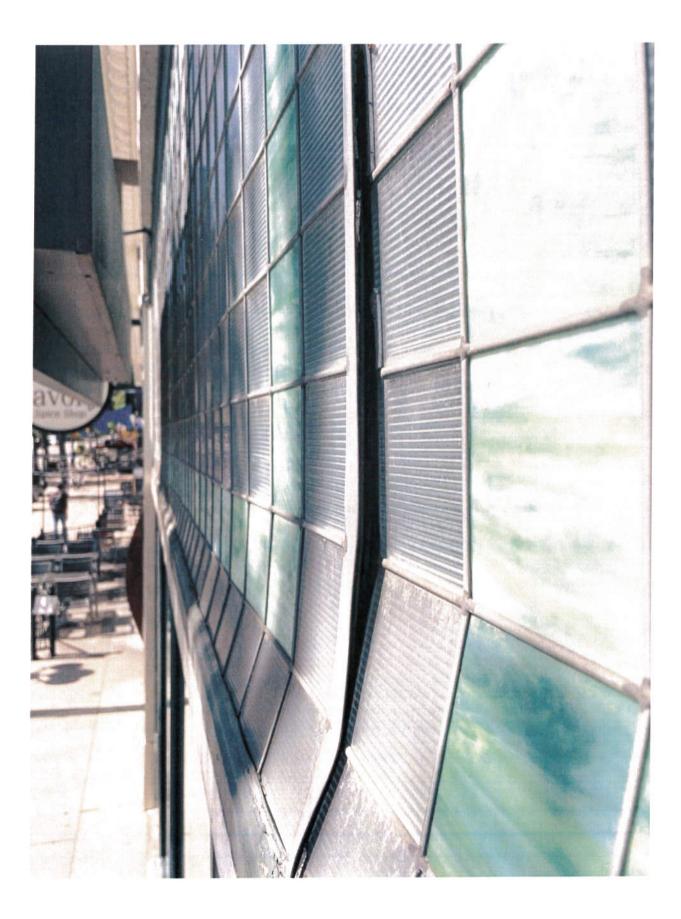
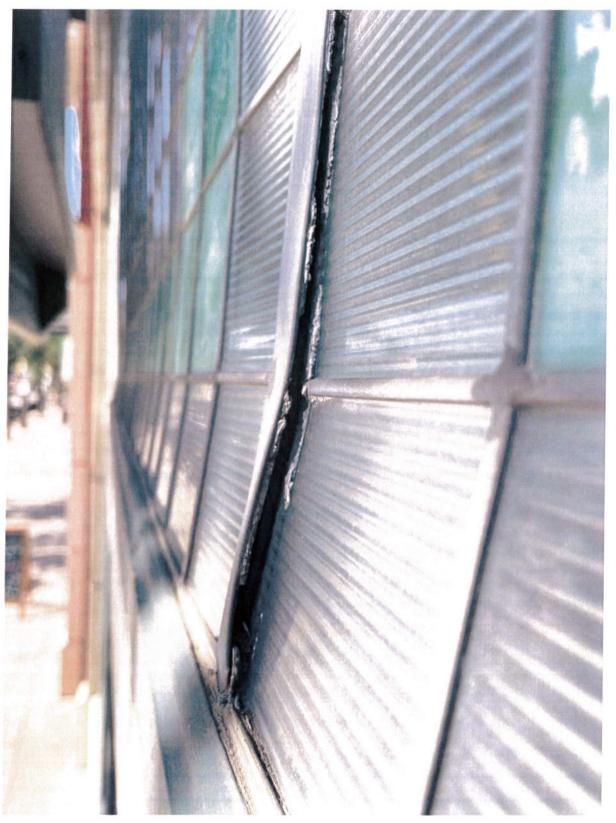
Zinc/ glass separating in places exposing the interior.

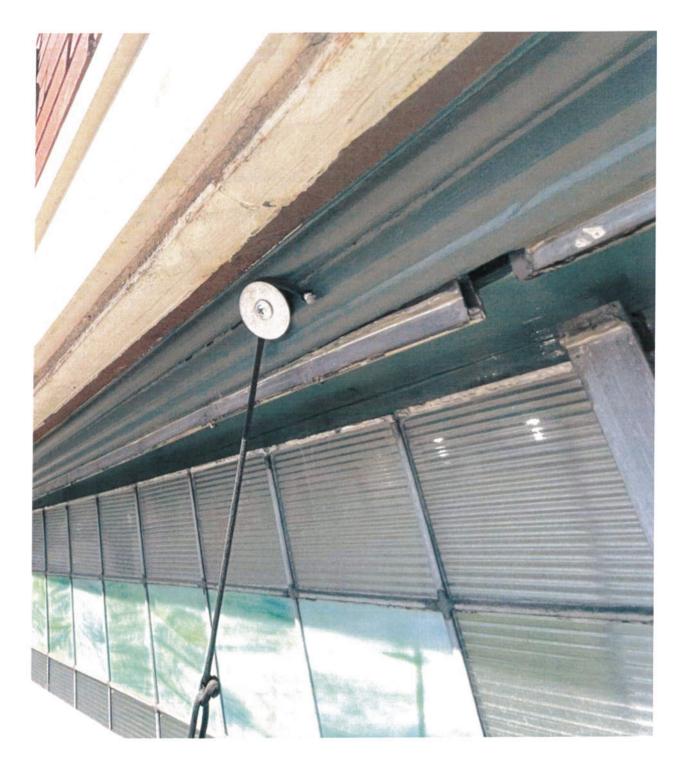
Rebar is separating from stained glass and dislodging from frame.

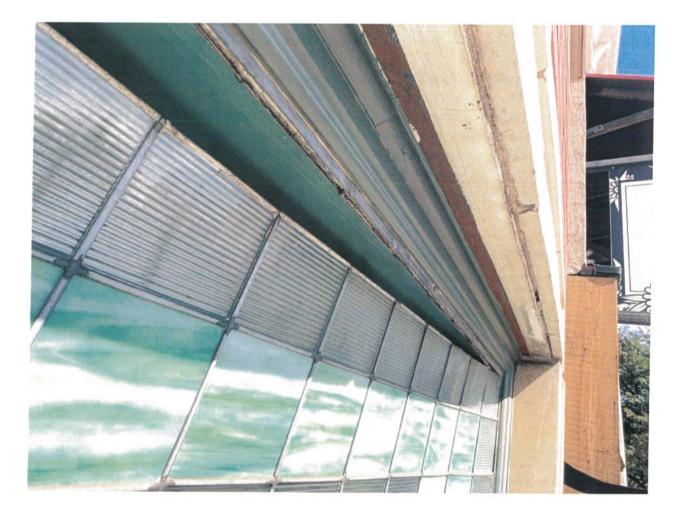
The glass has separated from the outer zinc edging at the top.
