CERTIFICATE OF APPROPRIATENESS ISSUED: June 11, 2024 EXPIRATION: June 11, 2025

This letter provides you with confirmation that the proposed changes to your designated Fort Collins landmark property, the Colorado and Southern Freight Depot and Docks at 250 N. Mason St., have been approved by the City's Historic Preservation Division because the proposed work meets the criteria and standards in Chapter 14, <u>Article IV</u> of the Fort Collins Municipal Code.

Downtown Transit Center

Date Thu 11/16/2023 Job # 51431 Weather 6:00 AM 12:00 PM 4:00 PM Clear Overcast Wind: 7 MPH | Precipitation: .0" | Humidity: 57% Wind: 10 MPH | Precipitation: .0" | Humidity: 37% Wind: 15 MPH | Precipitation: .0" | Humidity: 28% Work Logs Name Description Quantity **Total Hours** Asssessment of main Roofing assembly is composed of three distinct areas. 0 n roof. Larry Tate RRO Section A (south section) Fully adhered Carlisle 60 mil EPDM membrane over wood fiber coverboard over polyisocyanurate over a wood deck.

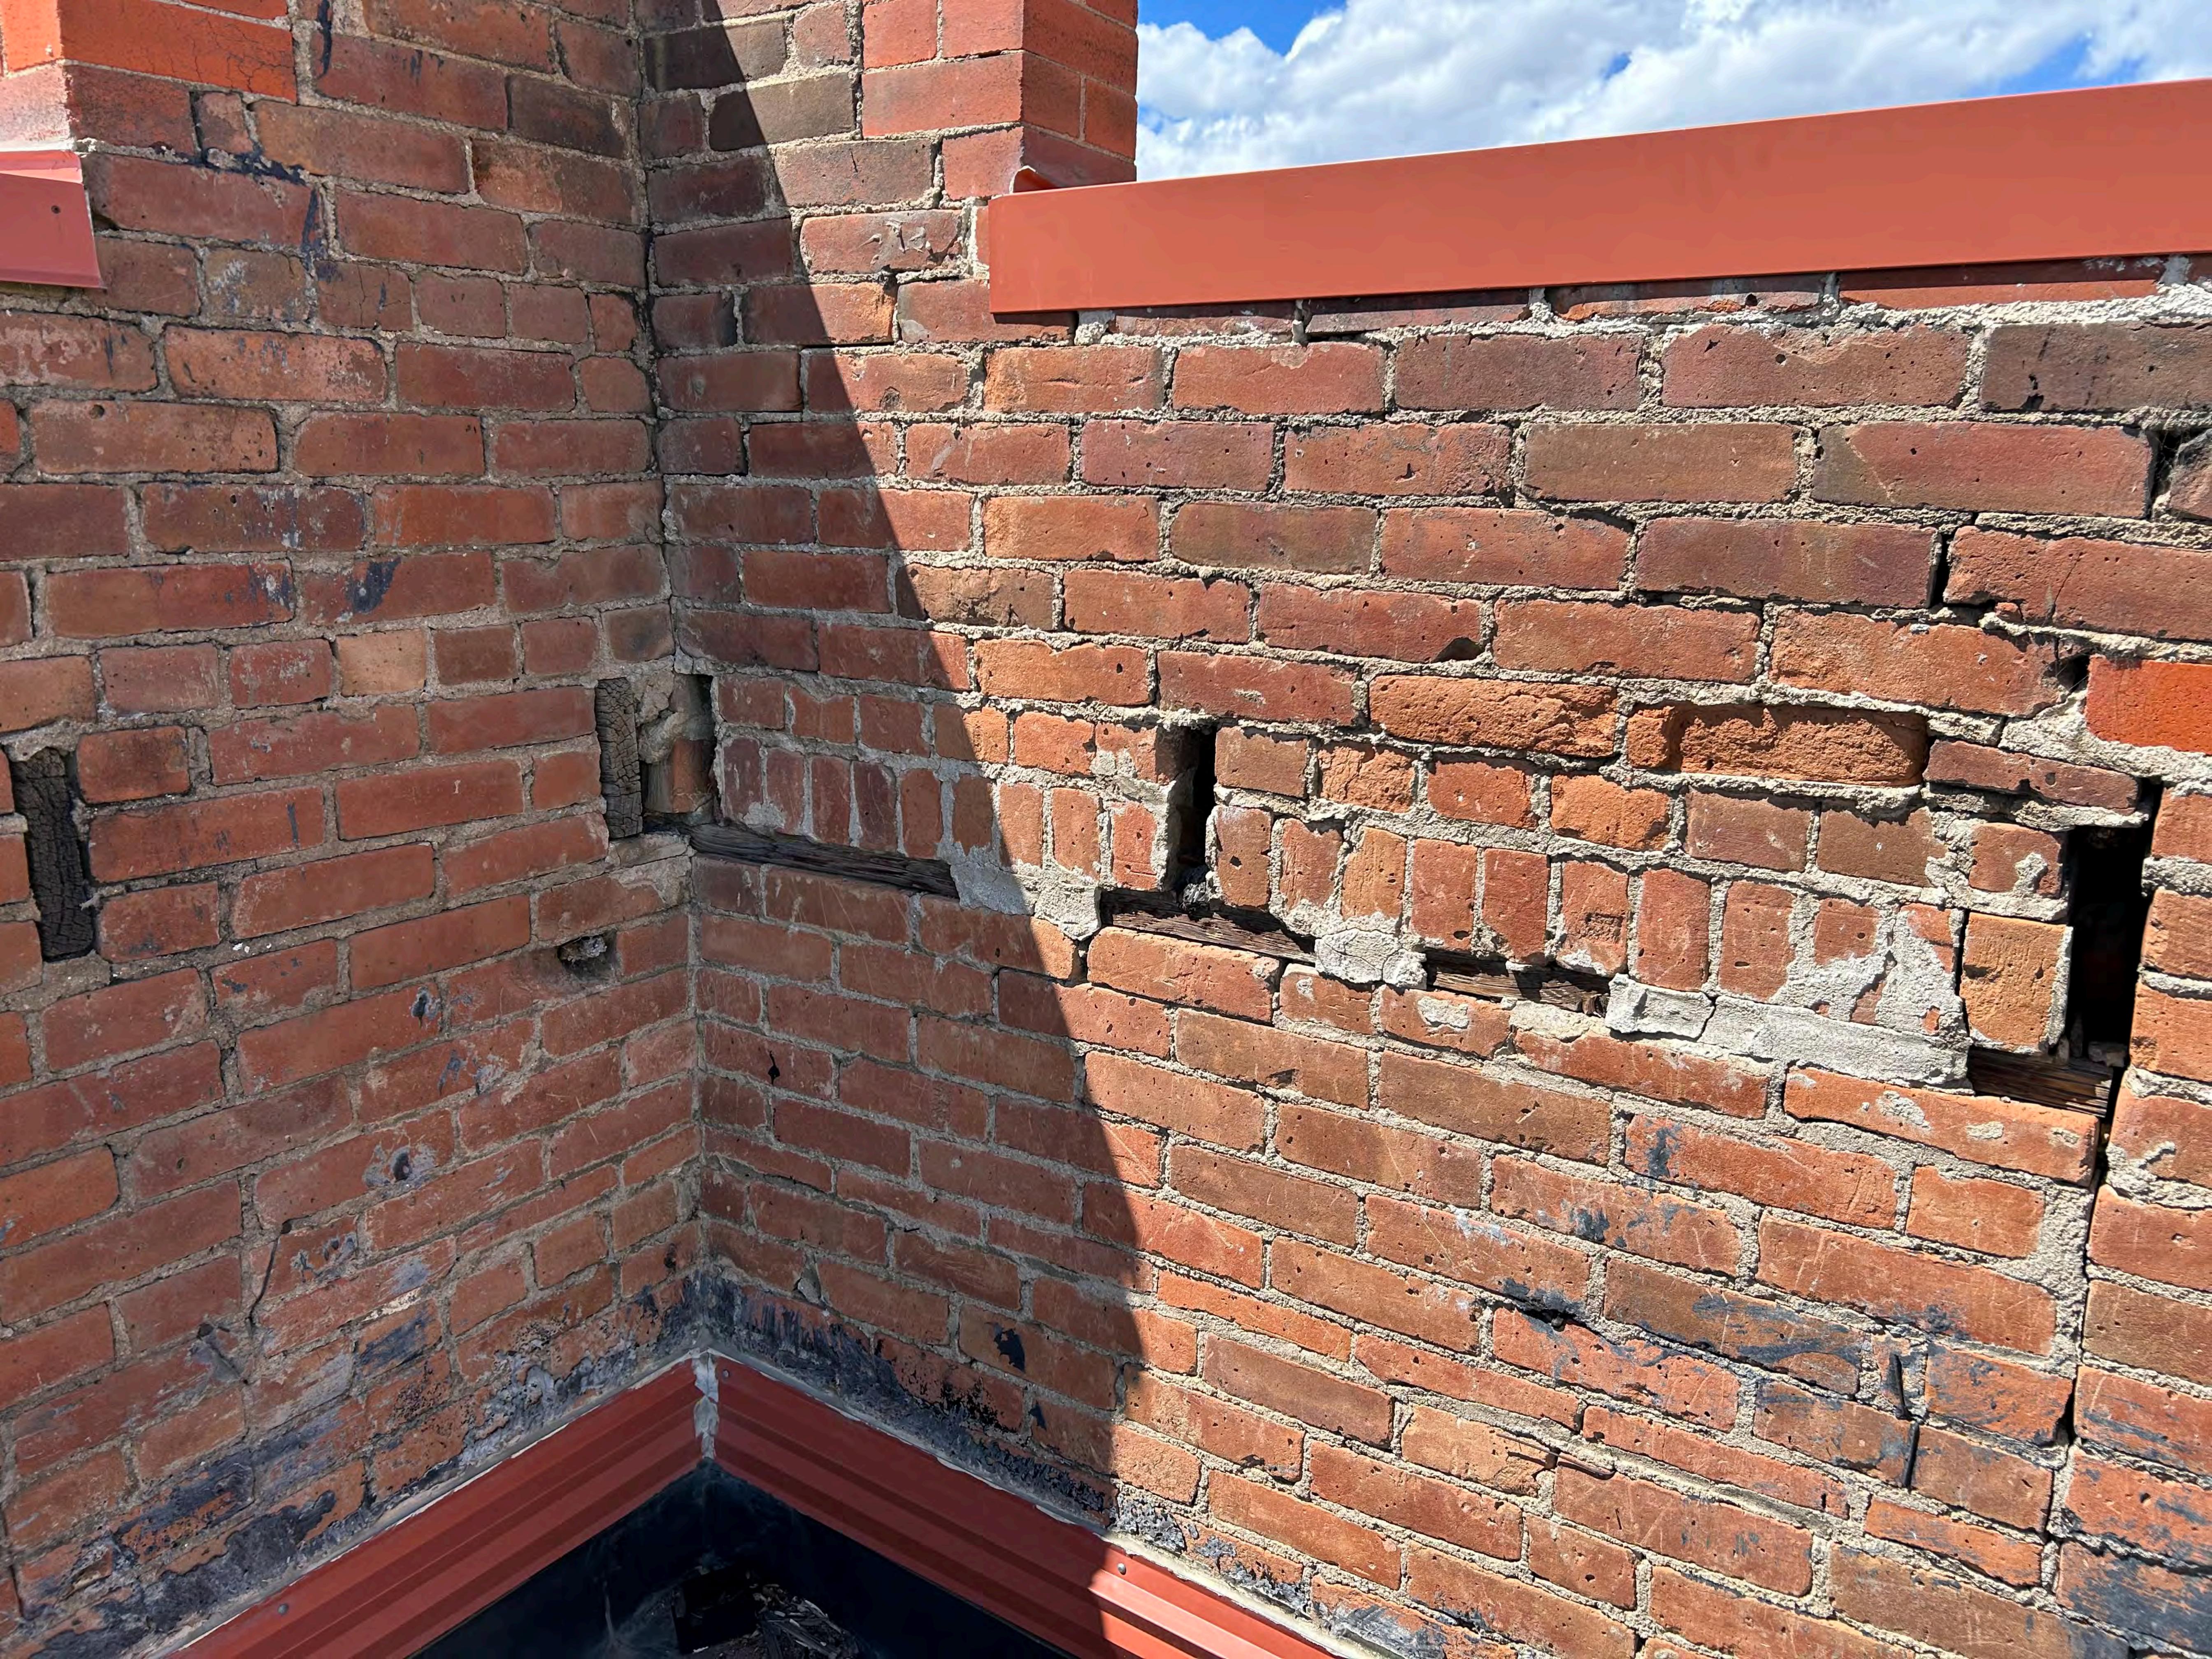
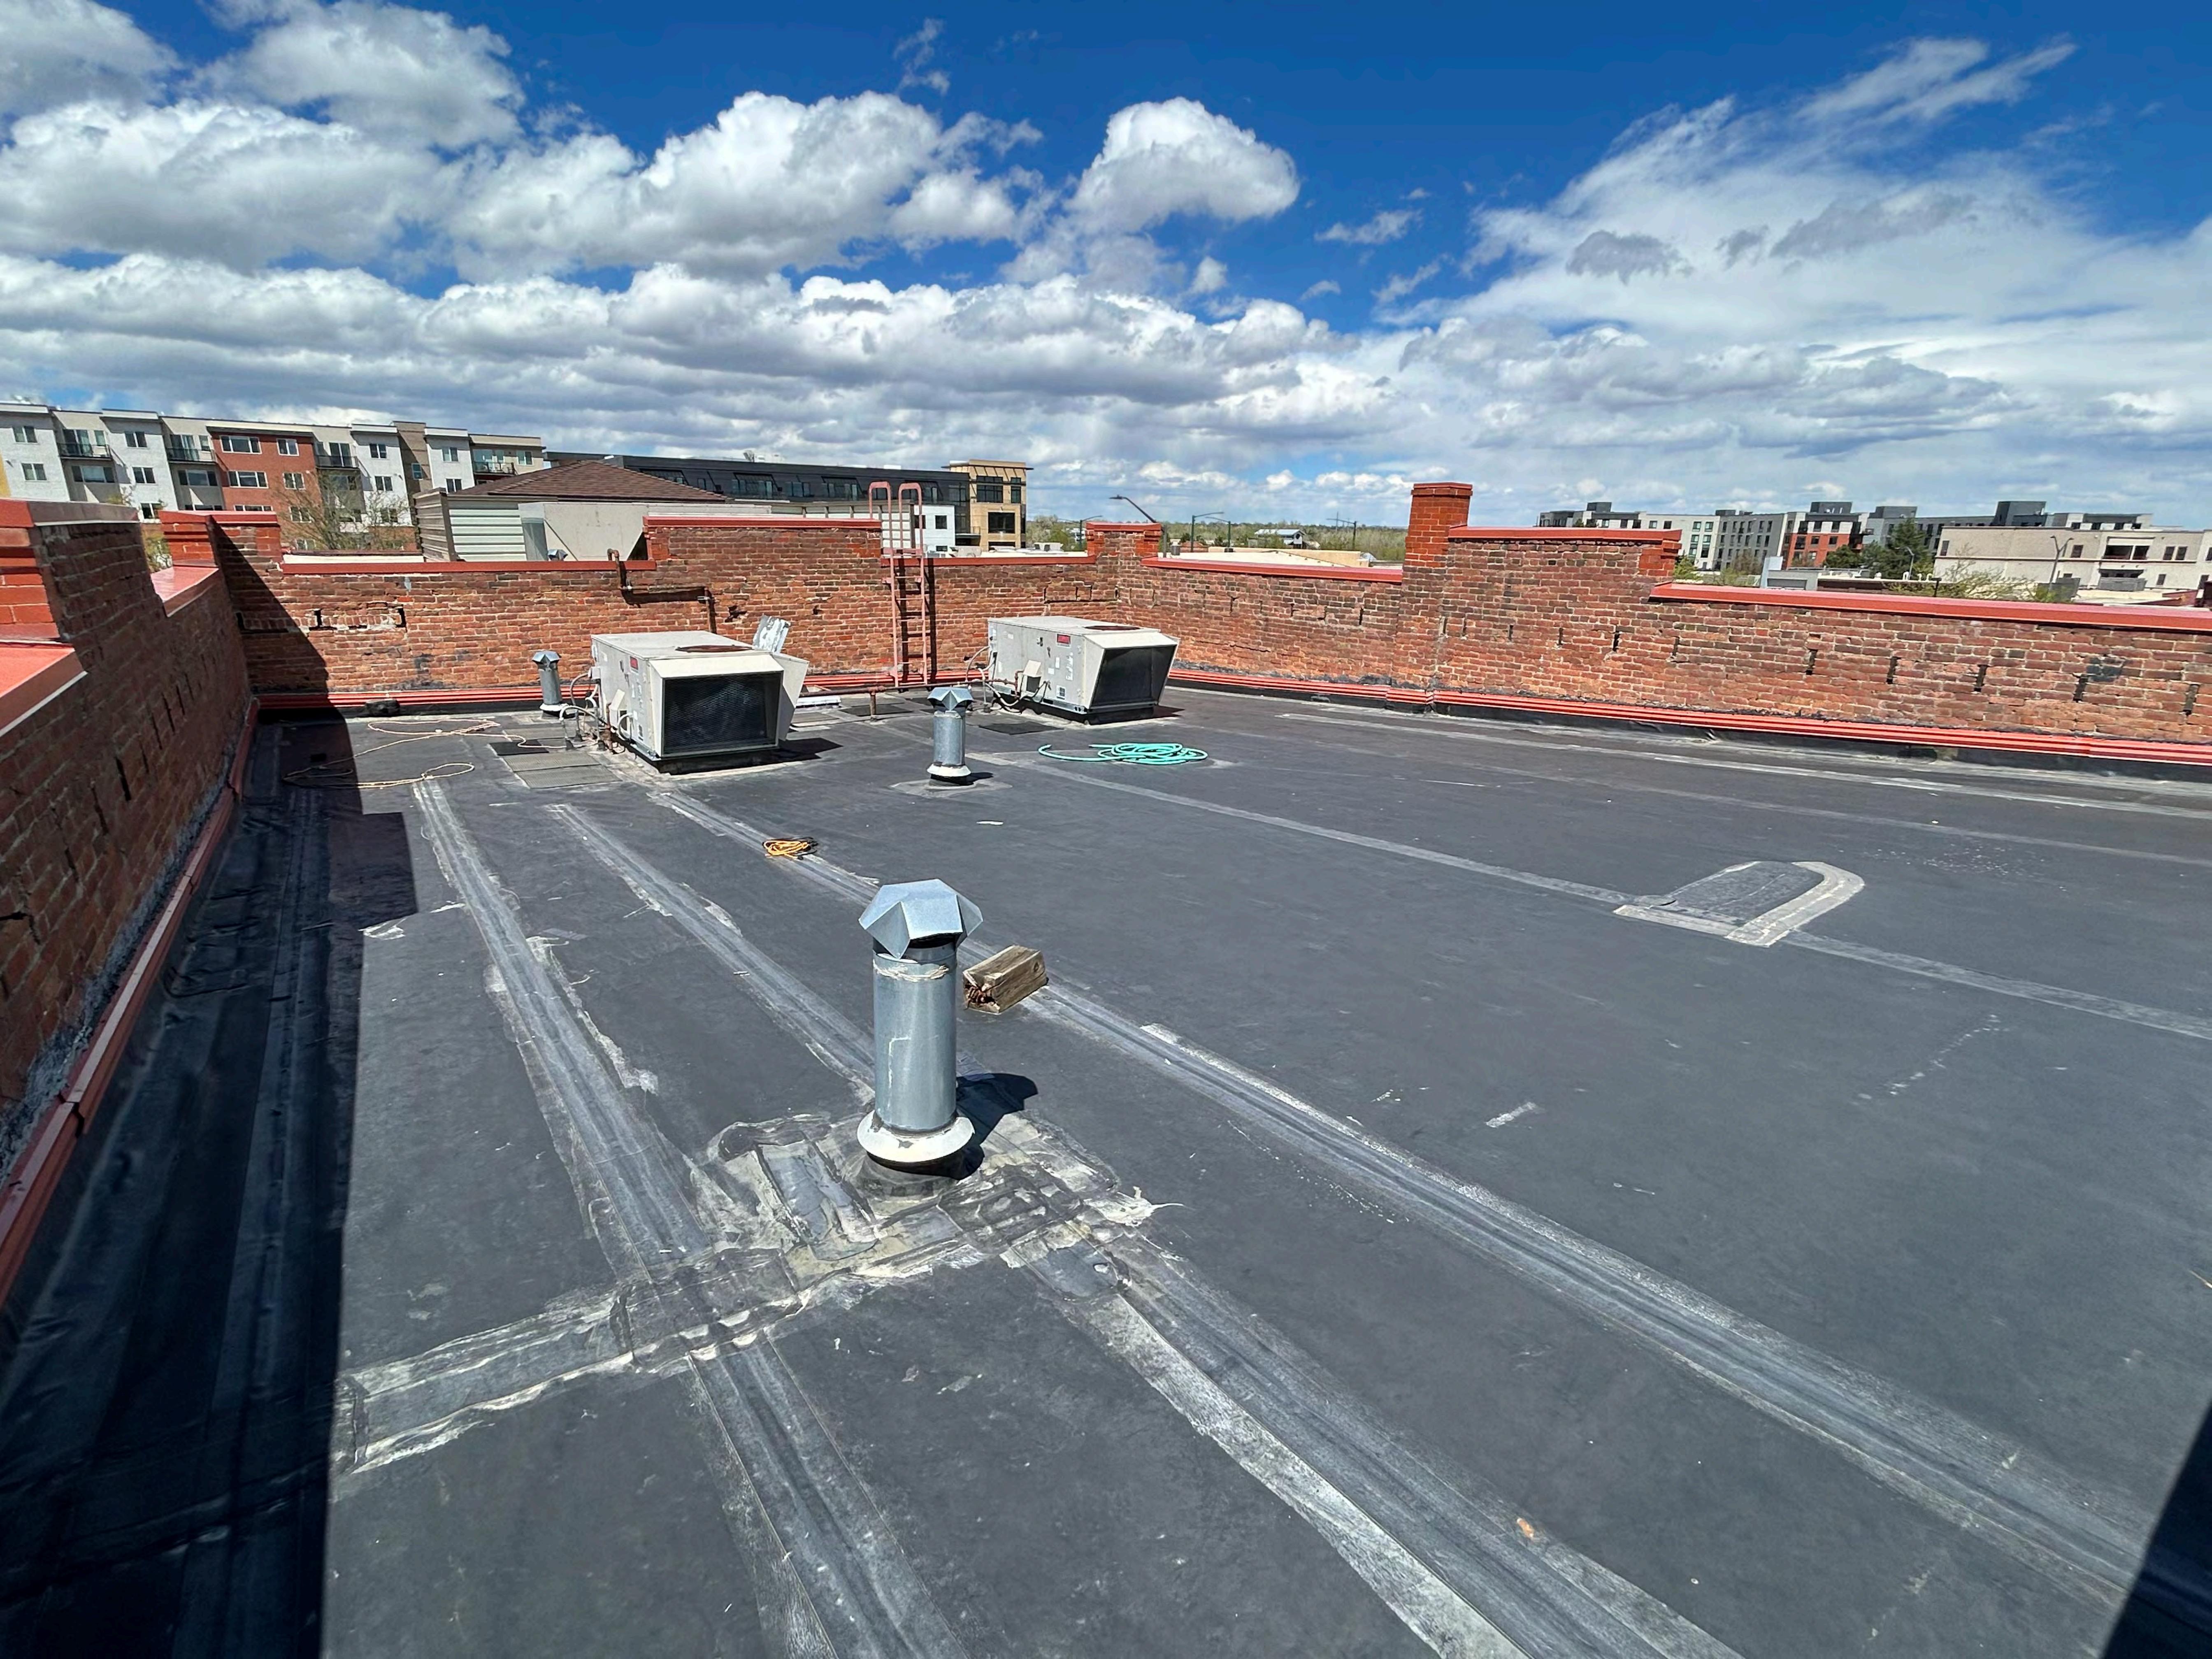
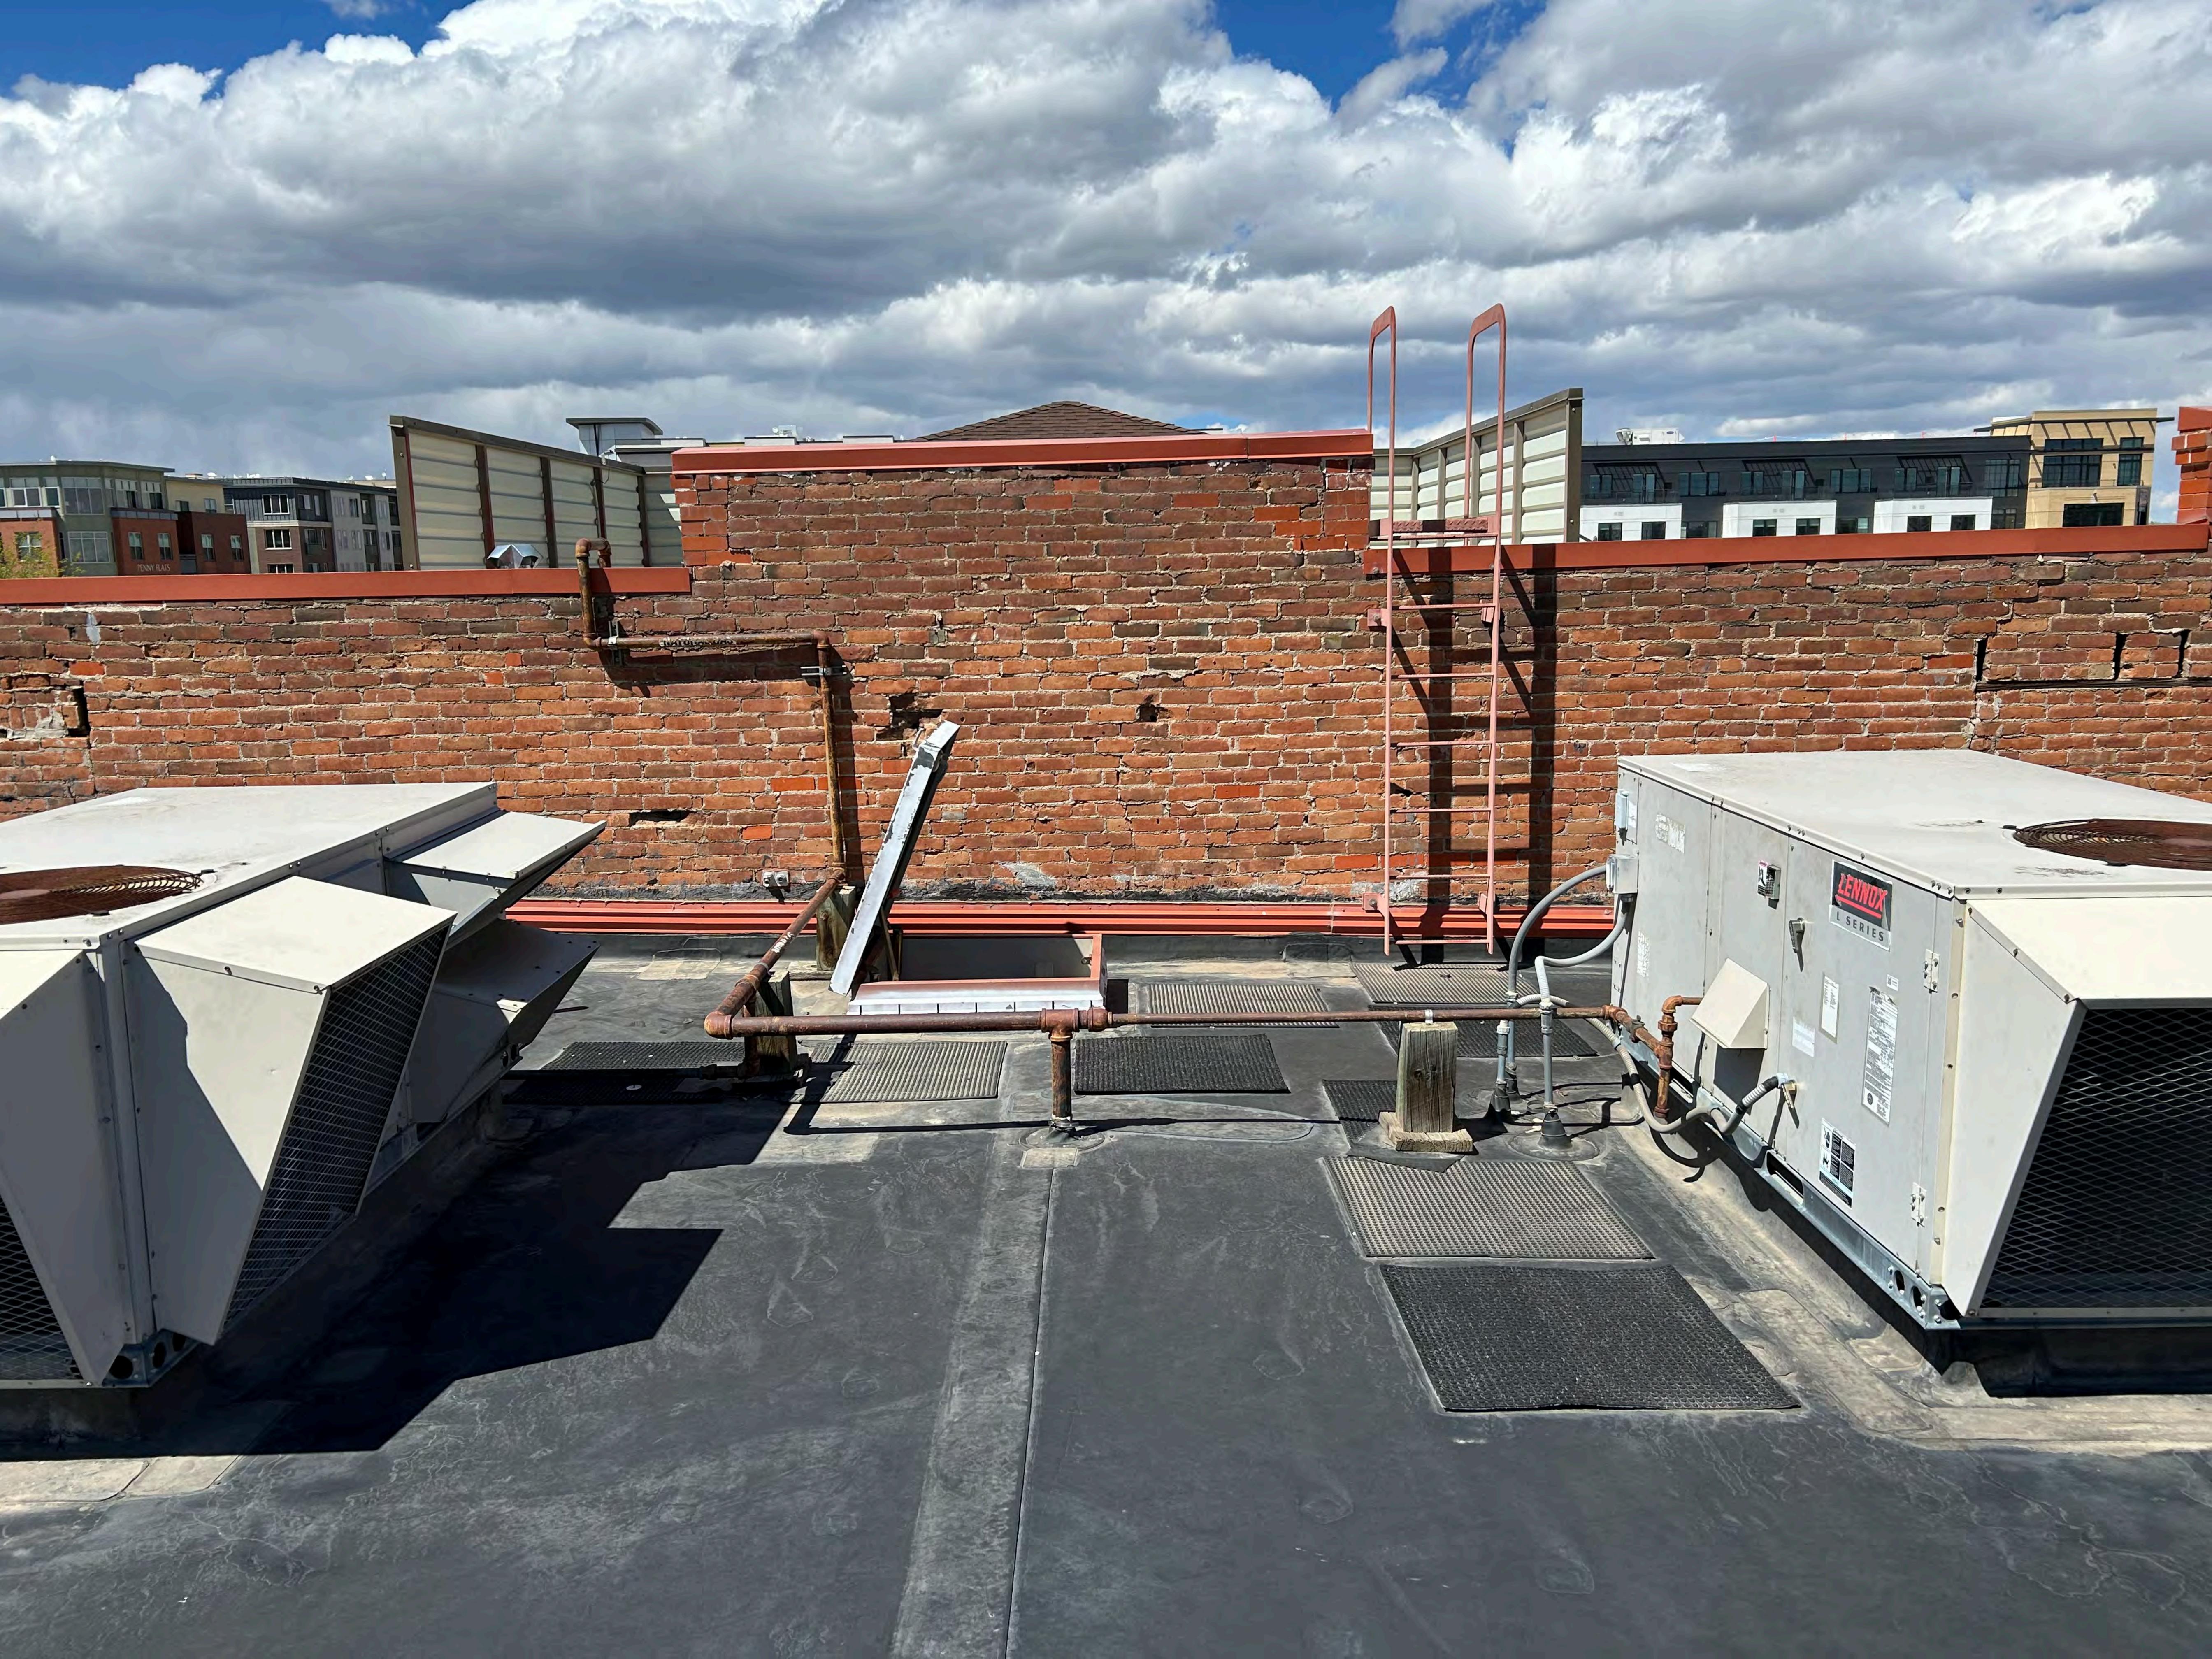
Attached is a picture of what the existing scupper looks like with a rough sketch of what would be added. I've also attached some additional photos of the roof and the inside face of the parapet wall – this is where all the deteriorated brick is located. When repairing the existing masonry we would use a standard N type mortar mix and try to match the look of the existing mortar as closely as possible. I also don't foresee us parging the interior face of the parapet wall as the roof assessment proposes.

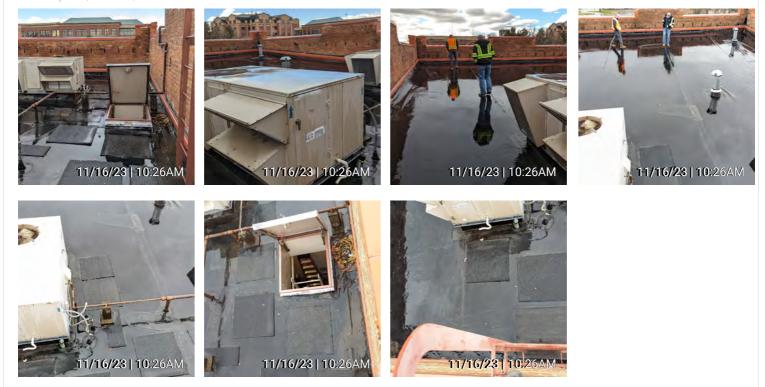
Roofing assembly is failing. Membrane shrinkage is pronounced along west side extending down to south end in a triangular pattern. Membrane is delaminated from wall, and insulation substrate in this area. Area is actively leaking.

Roof Section A Photo's depict failing roof due to shrinkage and delamination from substrate. This is common with older single ply roof membranes.

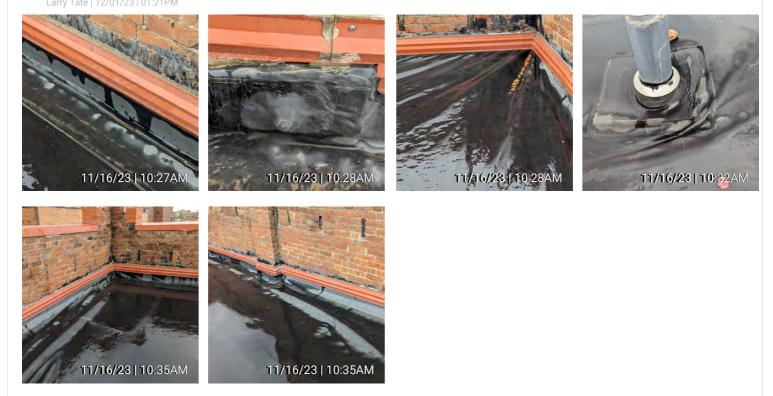
Roof Section A Masonry wall deterioration is advanced. Tuck point combined with Parge coat is some areas is highly recommended. Larry Tate | 12/01/23 | 01:22PM

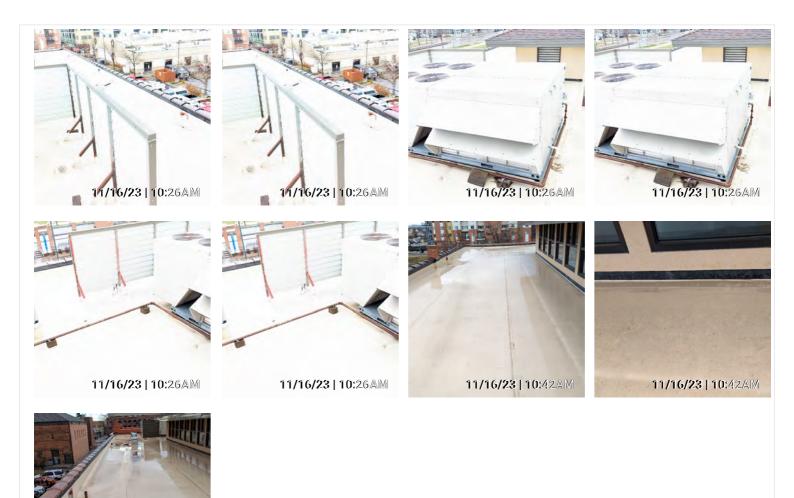
5. Roof section B

Photos depict typical details associated with roof. No issues noted.
