Evaluation of New Home Energy Efficiency

An assessment of the 1996 Fort Collins residential energy code and benchmark study of design, construction and performance for homes built between 1994 and 1999.

Summary Report

June 2002

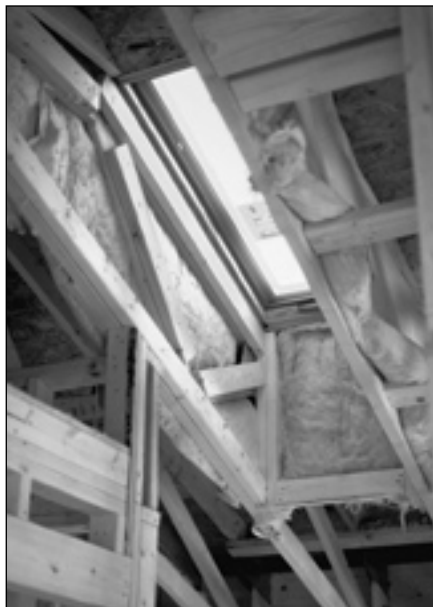
The code requires insulation to be in substantial contact with the wallboard and a vapor barrier to be installed on the warm side of the insulation. At this skylight well, insulation was held several inches back from the wallboard by framing. The vapor barrier was on the cold side of the insulation, a potential moisture trap.

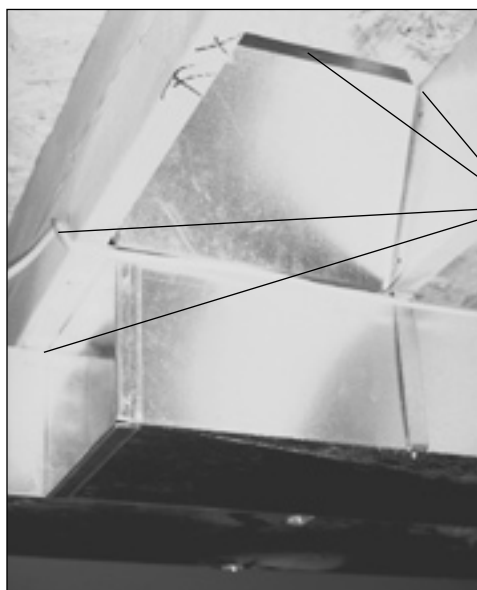
Typical leakage locations in return ductwork

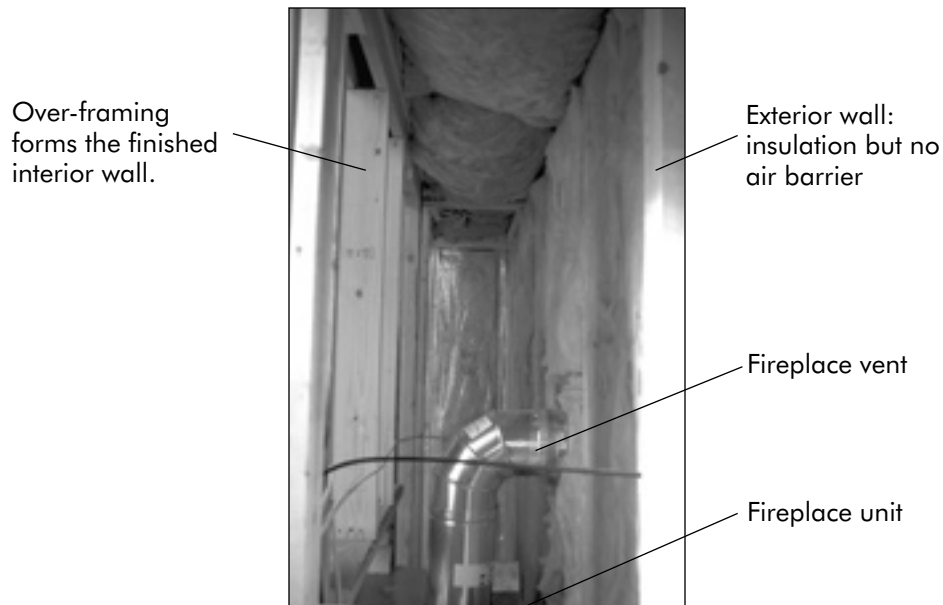
In this example, there was no air barrier at the exterior wall. This will allow outdoor air to move from the wall into the cavity around the fireplace unit and then, through cracks and holes, into the living space.

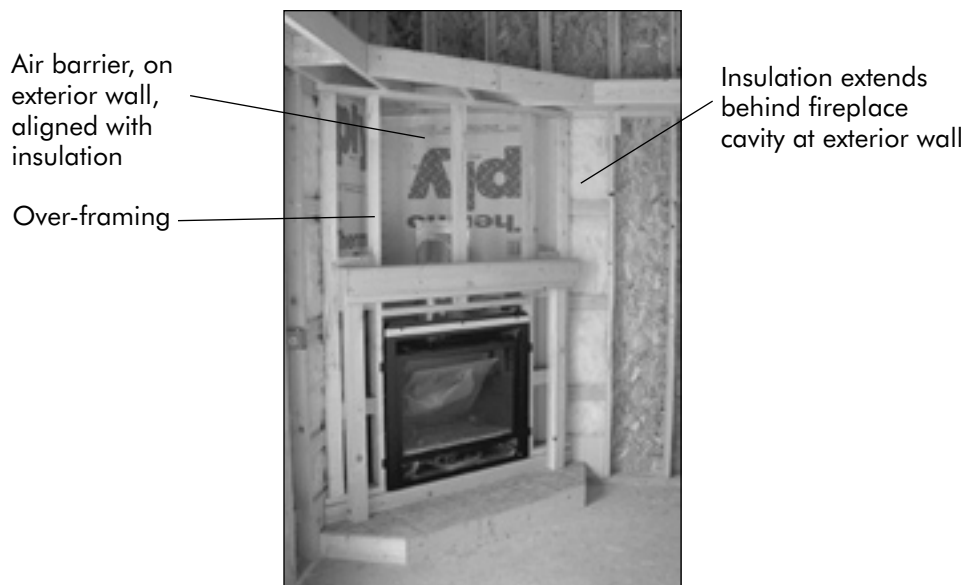
In this example, the insulation and air barrier, aligned at the exterior wall, were installed before over-framing was built and before the fireplace unit was installed. This approach will stop drafts and help the insulation perform effectively.

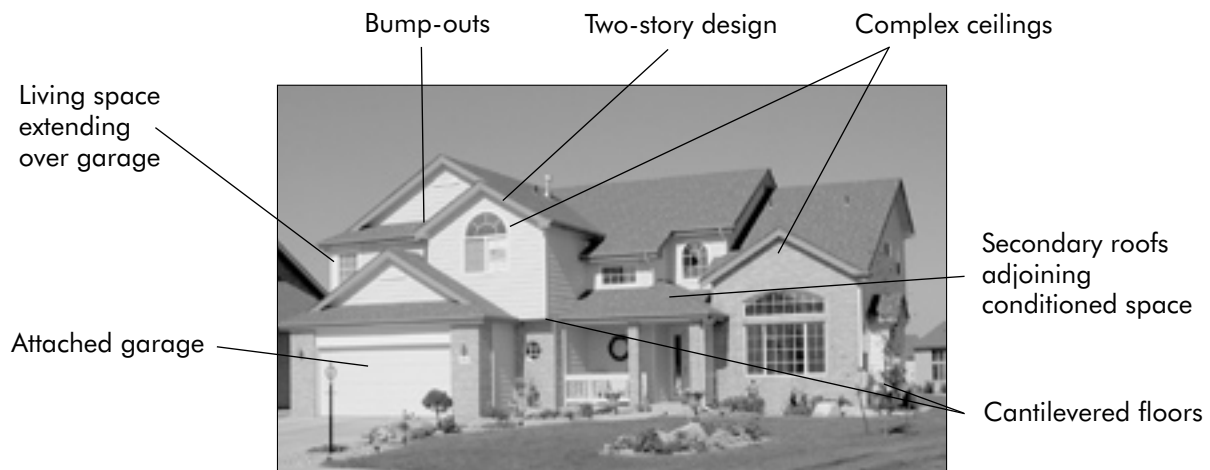
This house provides examples of many common architectural features that were associated with problems in the study homes.

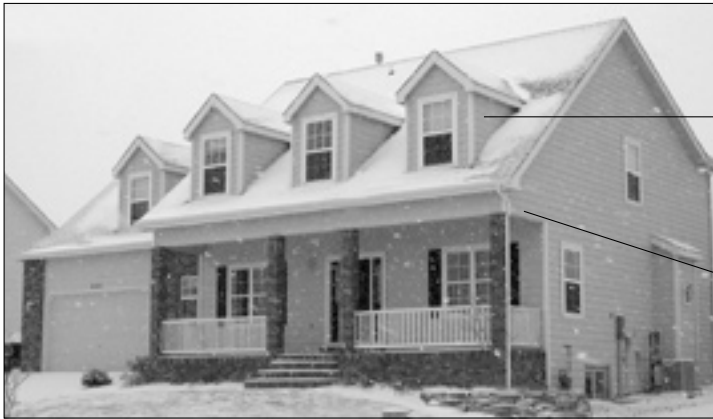
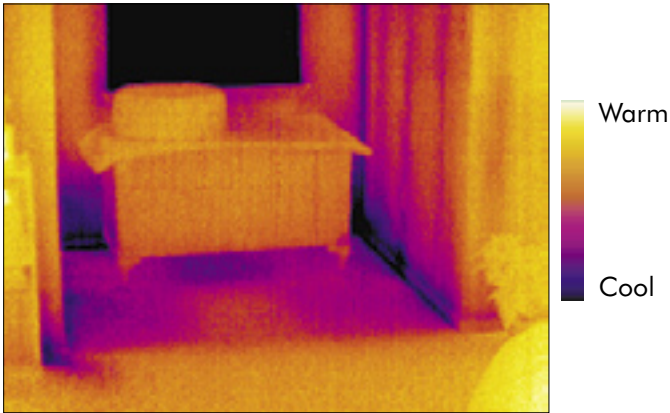
The upper level dormers and cantilever floor in the house shown above posed air sealing and insulation challenges. From the interior (conventional photo lower left, infrared photo lower right), thermal flaws showed up as cold spots (dark). These can cause discomfort and provide opportunities for moisture condensation, mildew and mold growth. The owners of this house complained that the dormers were so cold that they could not use these areas during the winter.

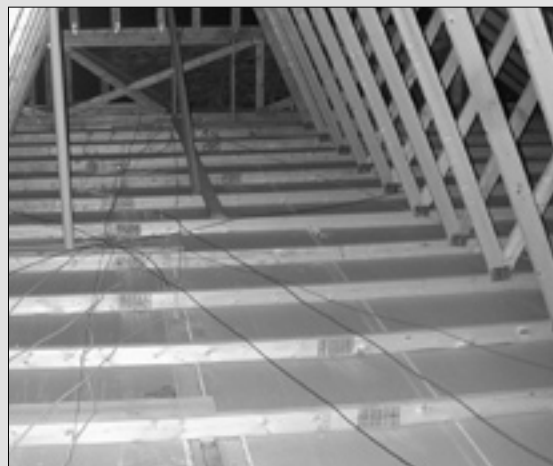
Several months after occupancy: no insulation in the attic.

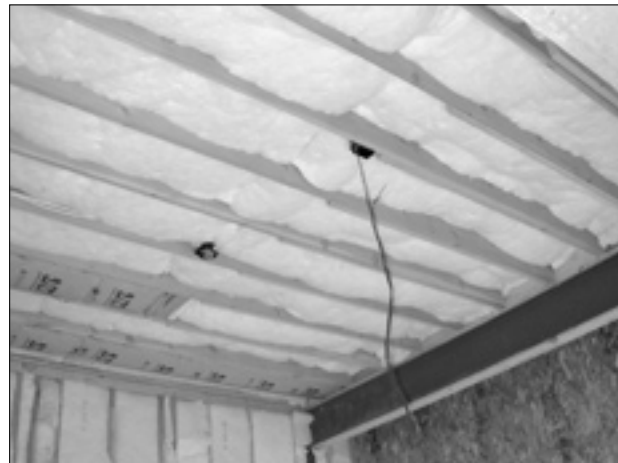
Code requires minimum R-19 insulation in floors above garages. The insulation must be in substantial contact with the subfloor above, permanently supported using one of several approved means. In this example, 6-inch thick R-19 fiberglass batts, installed in 9.25-inch joist cavities, were held in place only with staples—not an approved method. Some of the staples had failed prior to wallboard installation.

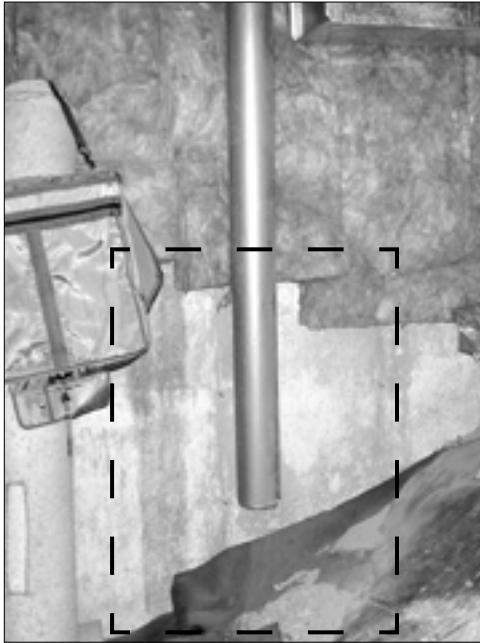
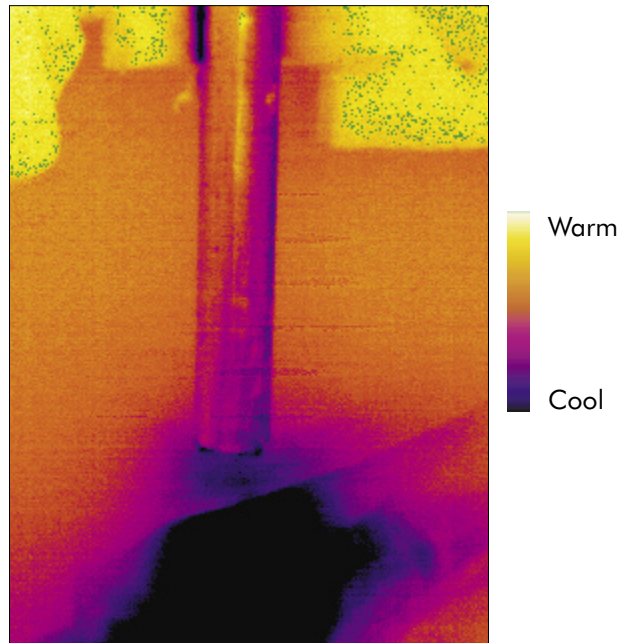
Code-required combustion air ducts, such as the one shown above, are direct openings to outside. An infrared photo of the same area (above right) demonstrates a typical winter problem: cold air is continually drawn in to replace air lost through other cracks and holes high in the house. This phenomenon contributed to cold basements and crawl spaces. In response, it was not unusual to see combustion air ducts plugged by homeowners—despite prominent labels warning against tampering with these safety devices.

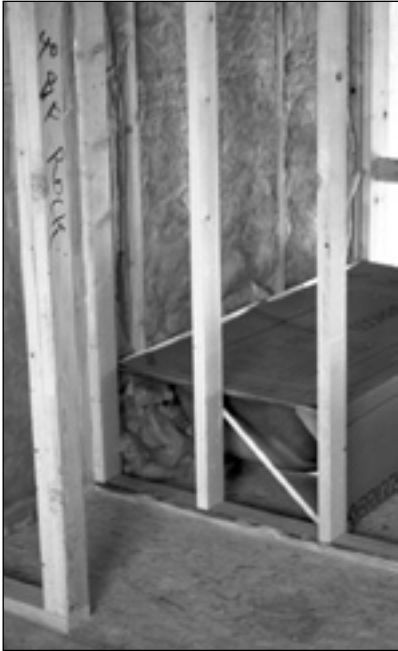
This bathtub had more than enough insulation at the exterior wall. But there was no air barrier to stop air from the outside wall from flowing through the insulation and circulating beneath the tub. From there, connections through partition walls and holes around the plumbing connected this leak to the rest of the house.

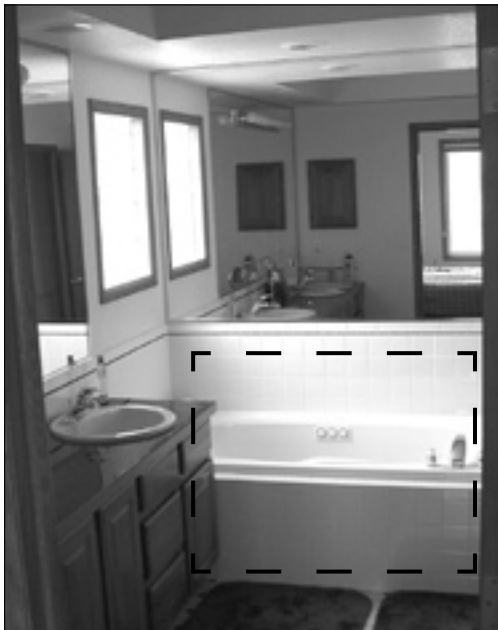
The infrared photo above shows the symptom of a missing air barrier: a cold tub. This bathtub sat against two exterior walls and over a garage. Cold outdoor air moved through or around the insulation to cool the tub. (Infrared photo taken with blower door operating.)

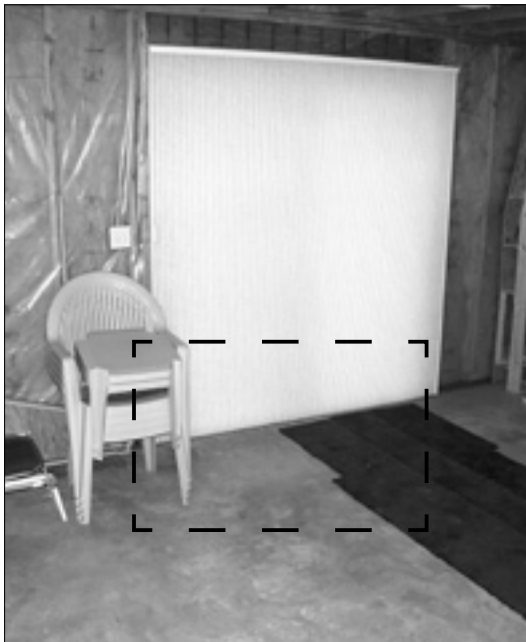
The on-grade slab edge of this walkout basement had no perimeter insulation. As can be seen in the infrared photo (right), the temperature of the slab dropped toward the edge. This translated into heat loss, cold floors and the potential for condensation.

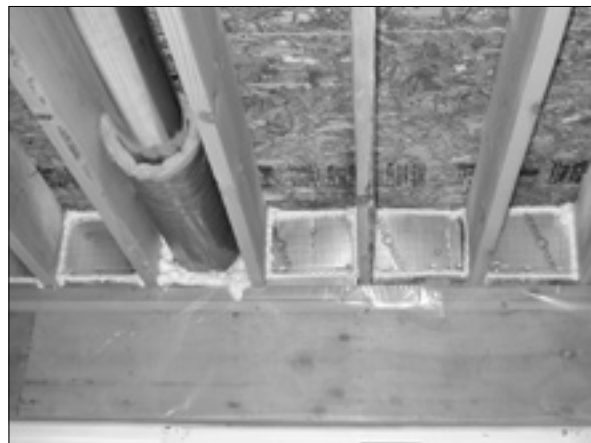
This photo illustrates an effective sealing job. Easily cut material, sealed at the edges, blocks air movement through the cantilever.

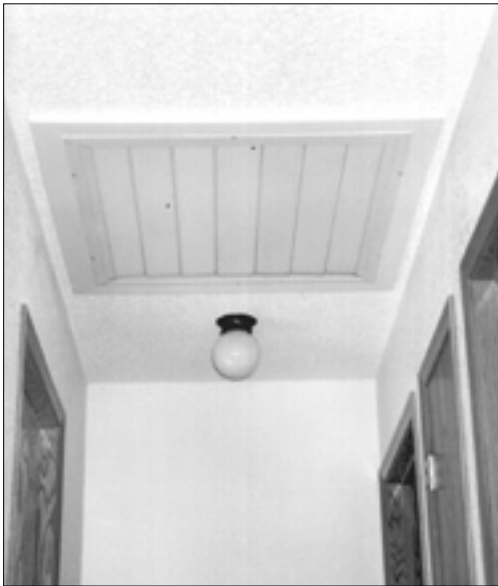
Whole house fan louvers were quite leaky even when closed. Code-required winter covers were provided to owners of two of the five post-group homes with whole house fans.

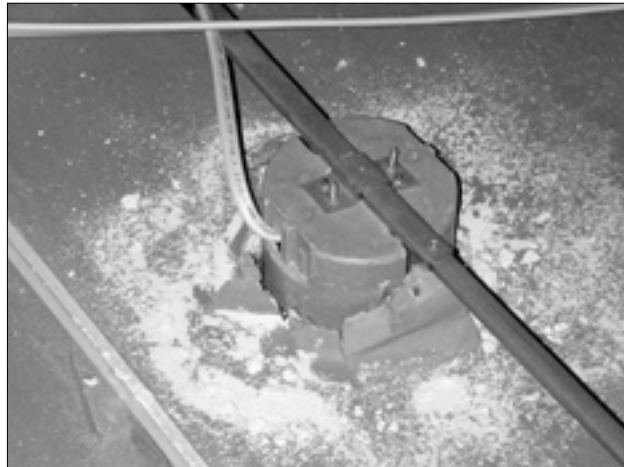
Air leaked around electrical boxes and through wiring penetrations.

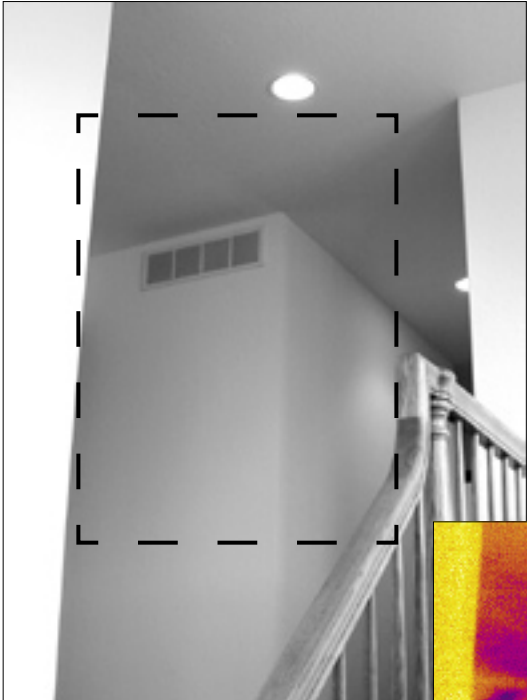
Air leaks through gaps between wallboard and framing. These gaps are skinny (1/16" to 1/8" typical) but extend many lineal feet.

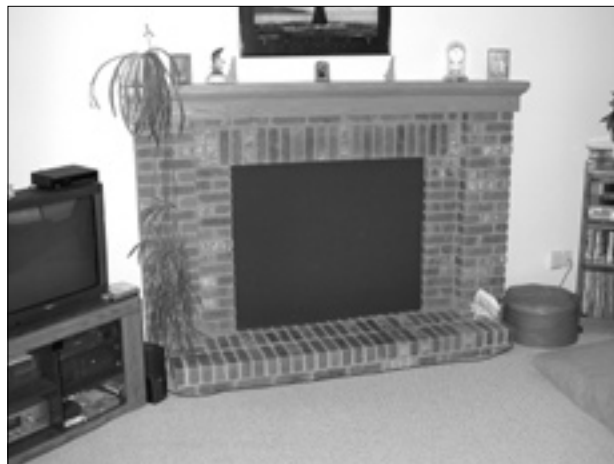
The owners of this house made a removable, fabric-coated foam insert to block drafts through the fireplace and make their living room more comfortable.

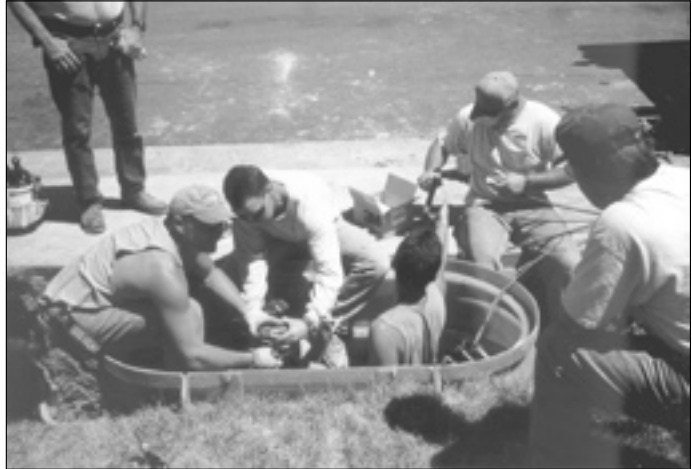
Fort Collins Utilities crew members change out a transformer that was overloaded under peak summer demand conditions.
