CERTIFICATE OF APPROPRIATENESS

As you are aware, at is March 17, 2021 meeting, the Historic Preservation Commission (then named the Landmark Preservation Commission) provided after-the-fact Final Design Review for several work items at the Long Apartments at 220 E. Laurel Street, a designated Fort Collins Landmark.

PROJECT DESCRIPTION:	This is a request for final design review of work to the Landmark-designated Long Apartments, 220 East Laurel Street, that was undertaken without approval and has already occurred.
APPLICANT/OWNER:	Jordan Obermann, Forge and Bow Dwellings, on behalf of Kent Obermann, Rarem LLC.
RECOMMENDATION:	Staff recommends approval in part, and denial in part, of a Certificate of Appropriateness.

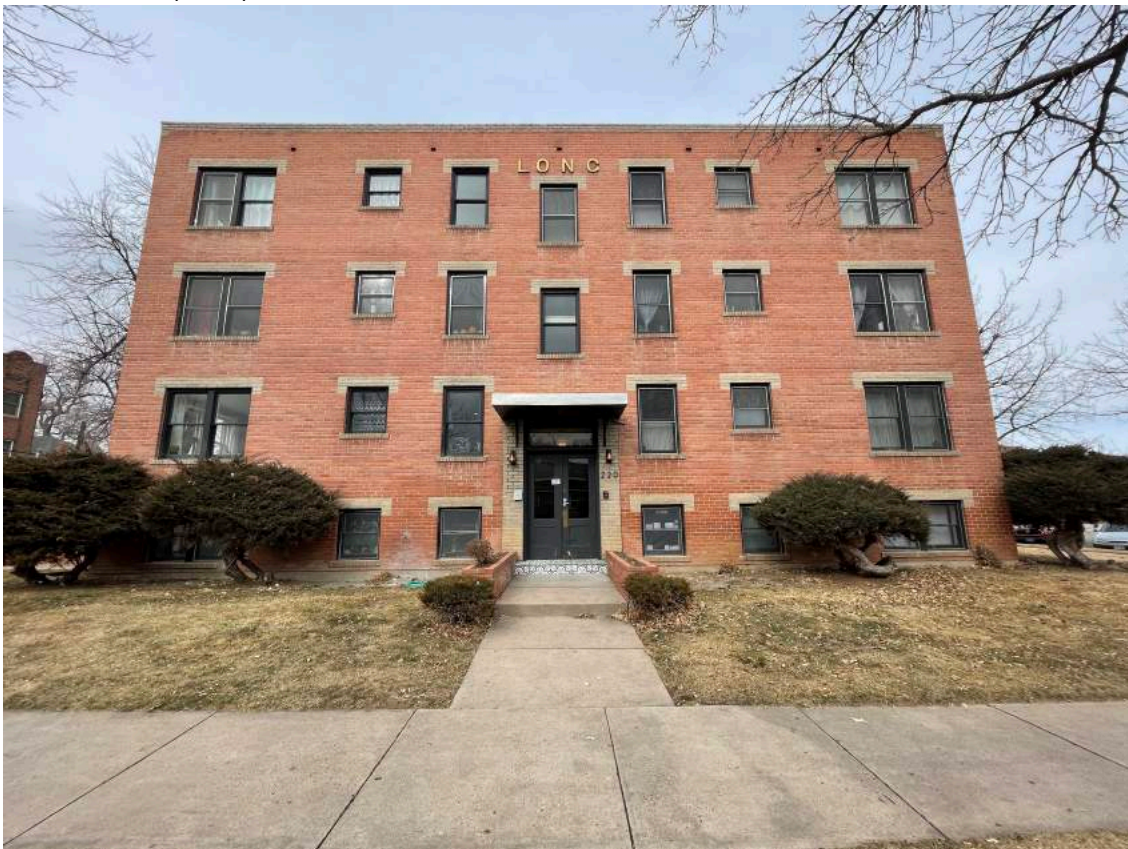
South Elevation (2021)

Feature F: Change from white to black accent paint color.

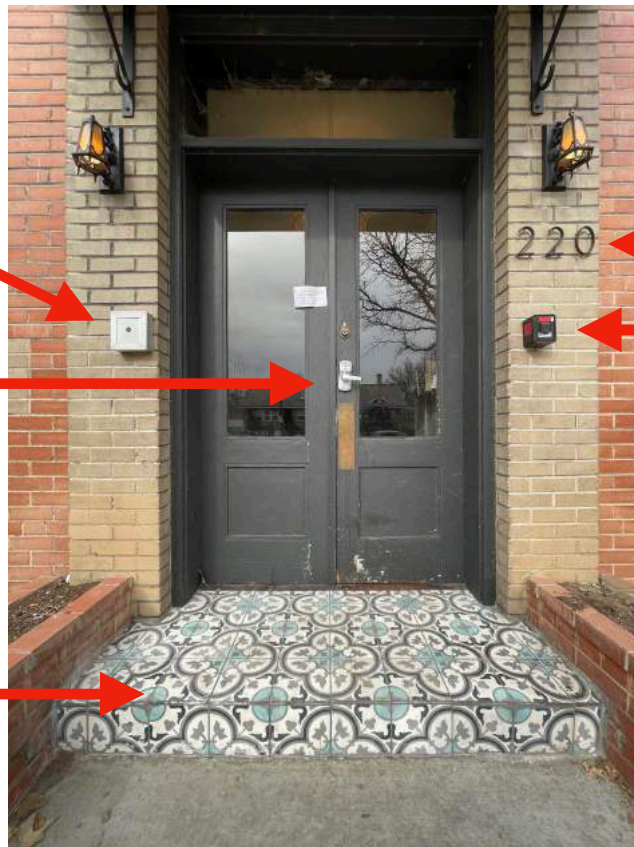
South Entrance (2021)

Feature J:
Hardware

Feature B:
Front Stoop Tile

Feature J: Hardware

1. Removing a historic access door and filling in the opening on the north (rear) elevation of the c.1951 addition.
 - a. Action required: Reversal to re-establish opening and historic door.
2. Alteration of front stoop tile.
 - a. Action required: New dimensions based on IEBC code requirements may stand but tile cladding must be reversed based on historic photographs.

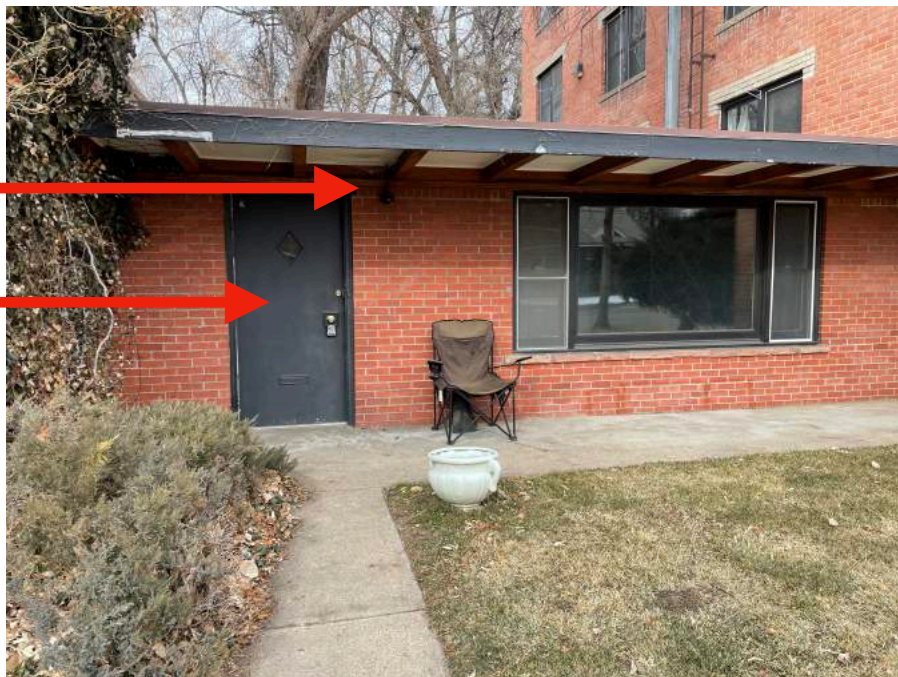
South Elevation on 70's Addition (2021)

Feature I:
Light

Feature H:
Removal of
Storm Door

Feature F: Change from white to black accent paint color.

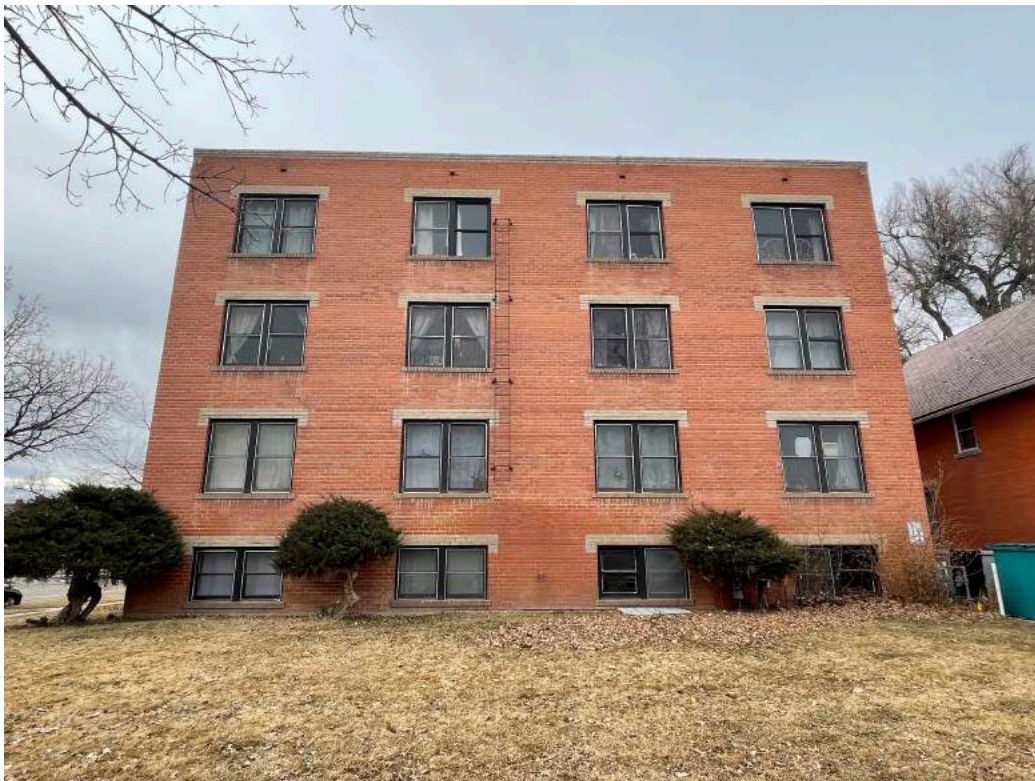
East Elevation (2021)

Feature F: Change from white to black accent paint color.

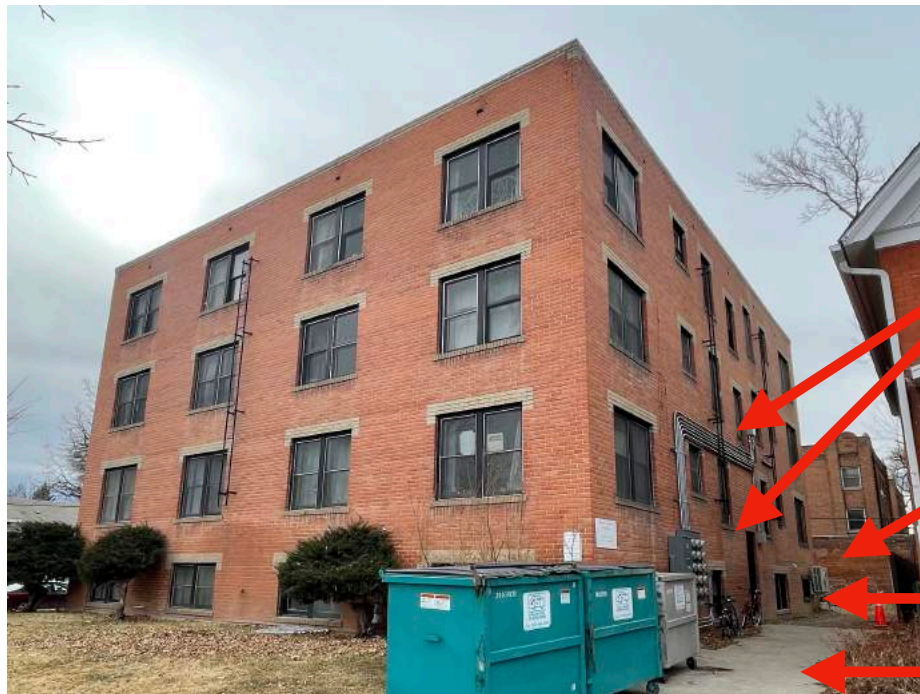
North Elevation (2021)

Feature C:
Electric
Meters

Feature D:
Condenser #1

Feature F: Change from white to black accent paint colors.

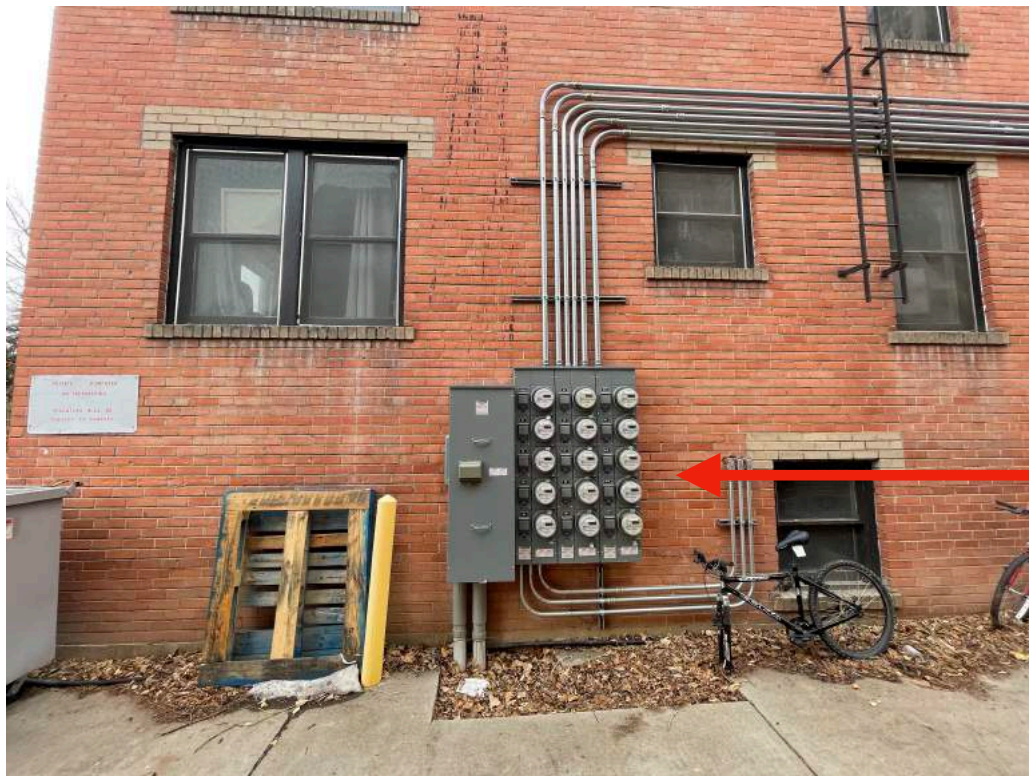
North Elevation - Electric Meters (2021)

Feature C:
Electric
Meters

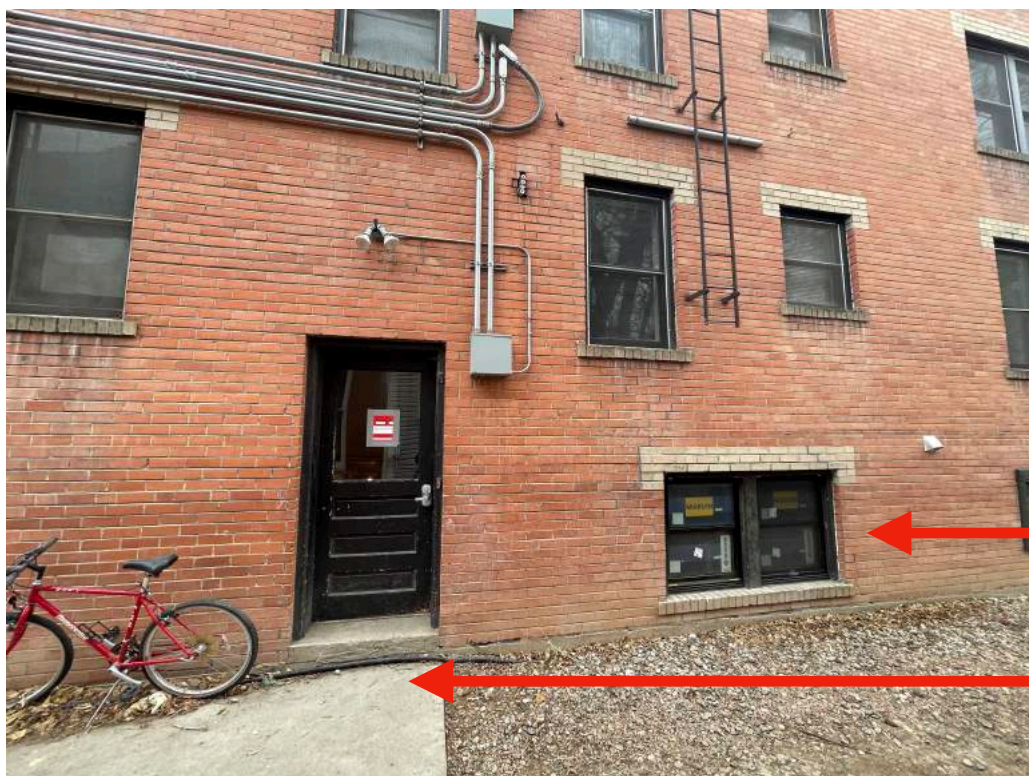
North Elevation - Entrance (2021)

Feature A:
Windows

Feature G:
Driveway
(step removed)

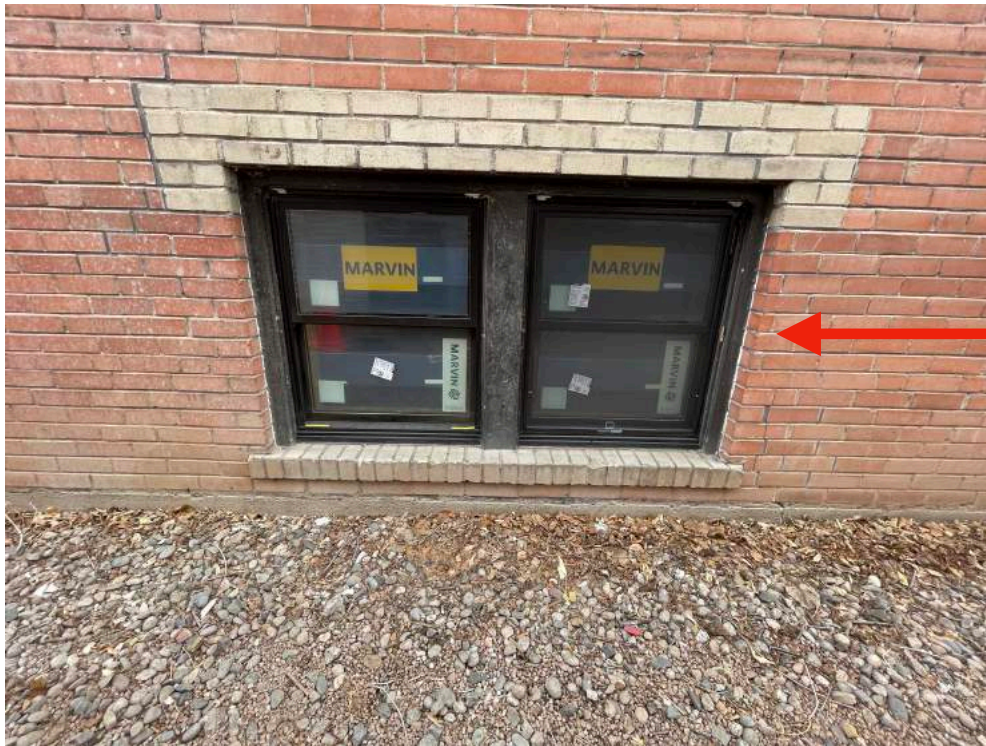
North Elevation - Unit A Windows, East (2021)

Feature A:
Windows
(closer photo)

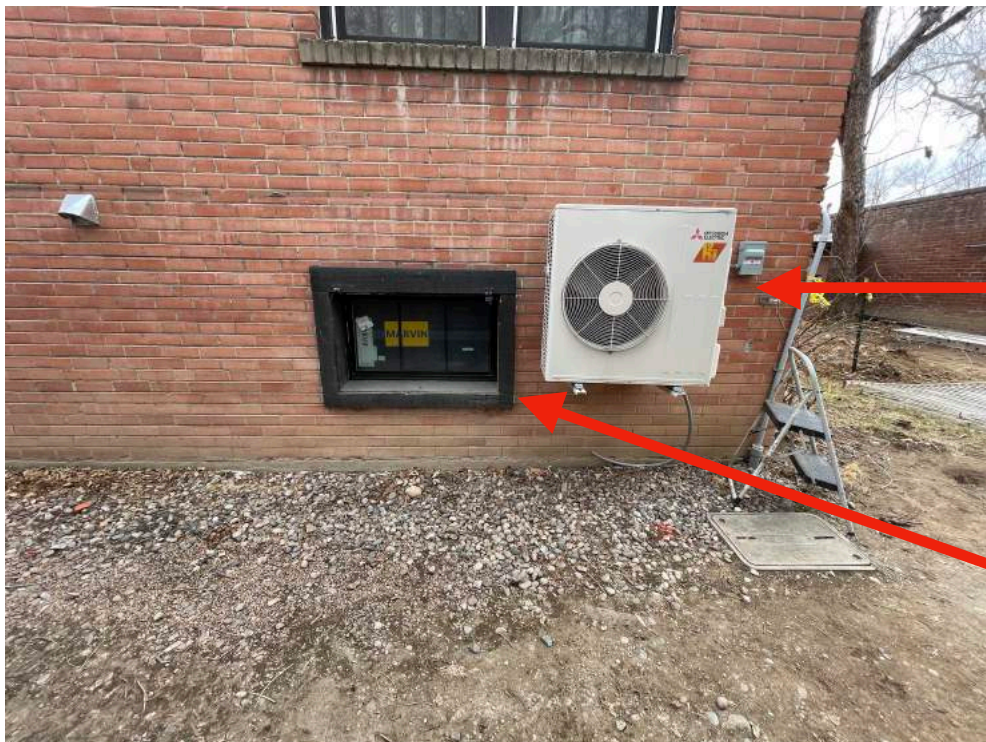
North Elevation - Unit A Window (West) and HVAC (2021)

Feature D:
Condenser #1

Feature A:
Windows
(Converted coal
shoot)

- Replacing three wood windows with fiberglass replacements in Unit A (basement); according to the applicant, the wood window surrounds were retained. On a field visit, staff noted that the bottom sill of the converted coal chute window has either been replaced or covered with the fiberglass material, while the rest of the surround appears to be wood. (A fourth window was approved by staff in 2019 to be converted to an egress window.)

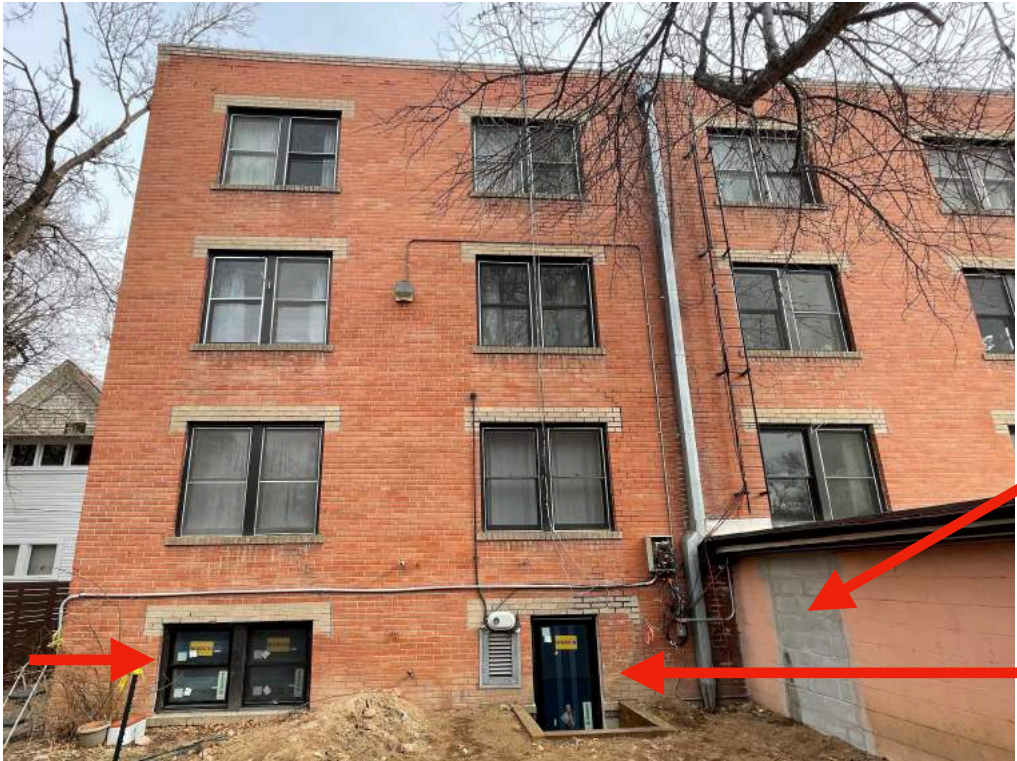
West Elevation (2021)

Feature A:
Windows

Feature E:
Door

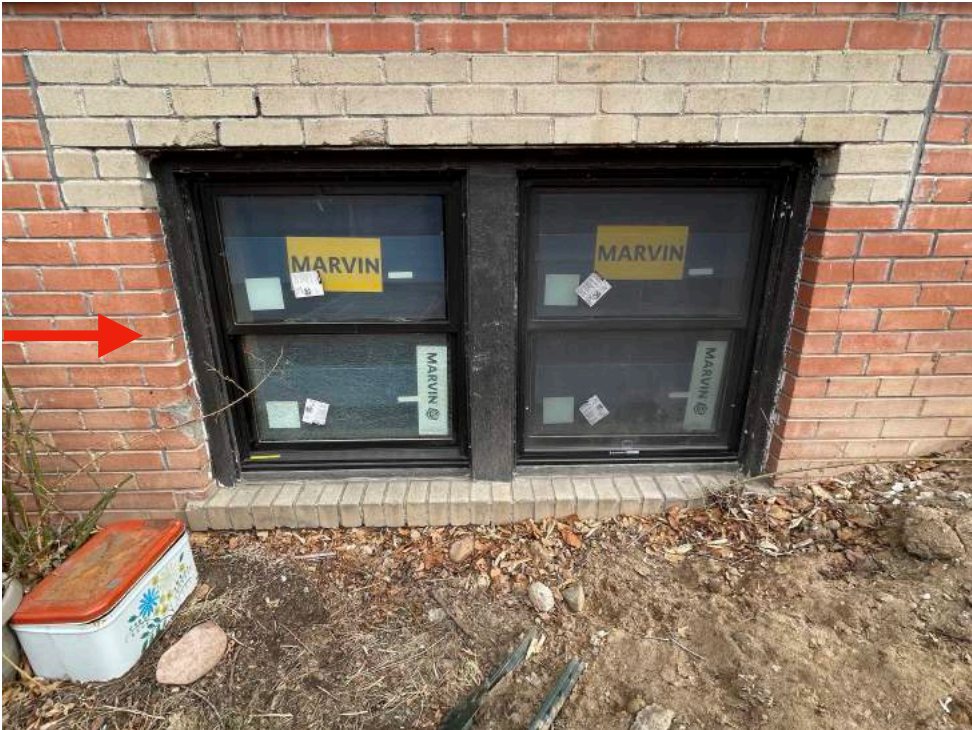
West Elevation - Unit A Windows, North (2021)

Feature A:
Windows
(Closer Photo)

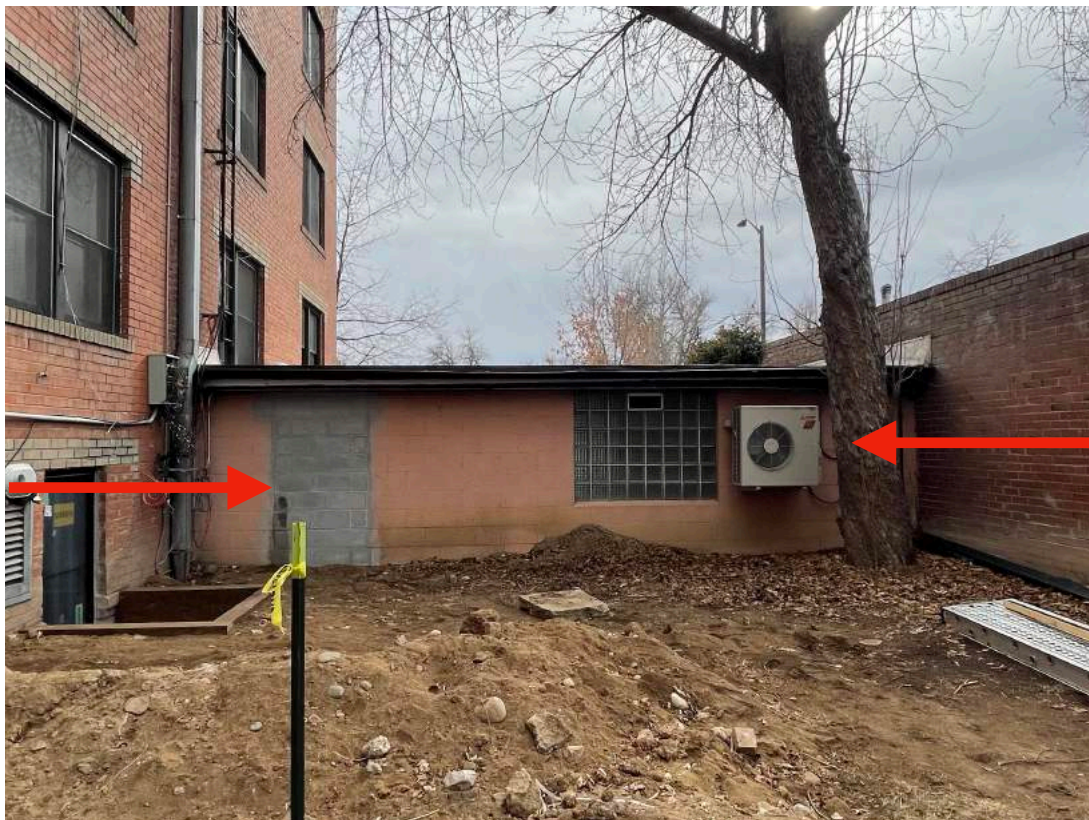
North Elevation of 70's Addition (2021)

Feature E:
Door

Feature D:
Condenser

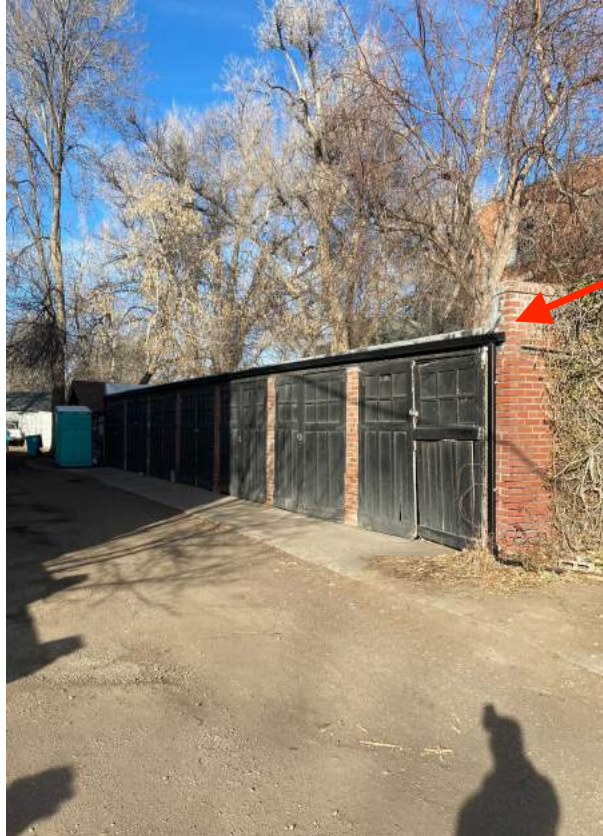
West Elevation,
Garages (2021)

The gutter on the garage was replaced. The old gutter from 1996 appears to be a K-Style gutter. The new gutter is also a K-Style gutter with a black finish.

Feature K: New Gutter

Feature F: Change from white to black accent paint color.
