CERTIFICATE OF APPROPRIATENESS

As you are aware, the Historic Preservation Commission gave Final Design Review approval at their November 18, 2021 meeting for the work you are proposing for the City Landmark property, the Old Post Office at 201 S. College Avenue.

Tile and Flat Roof Replacement

201 S College Ave, Fort Collins, CO 80524-3182

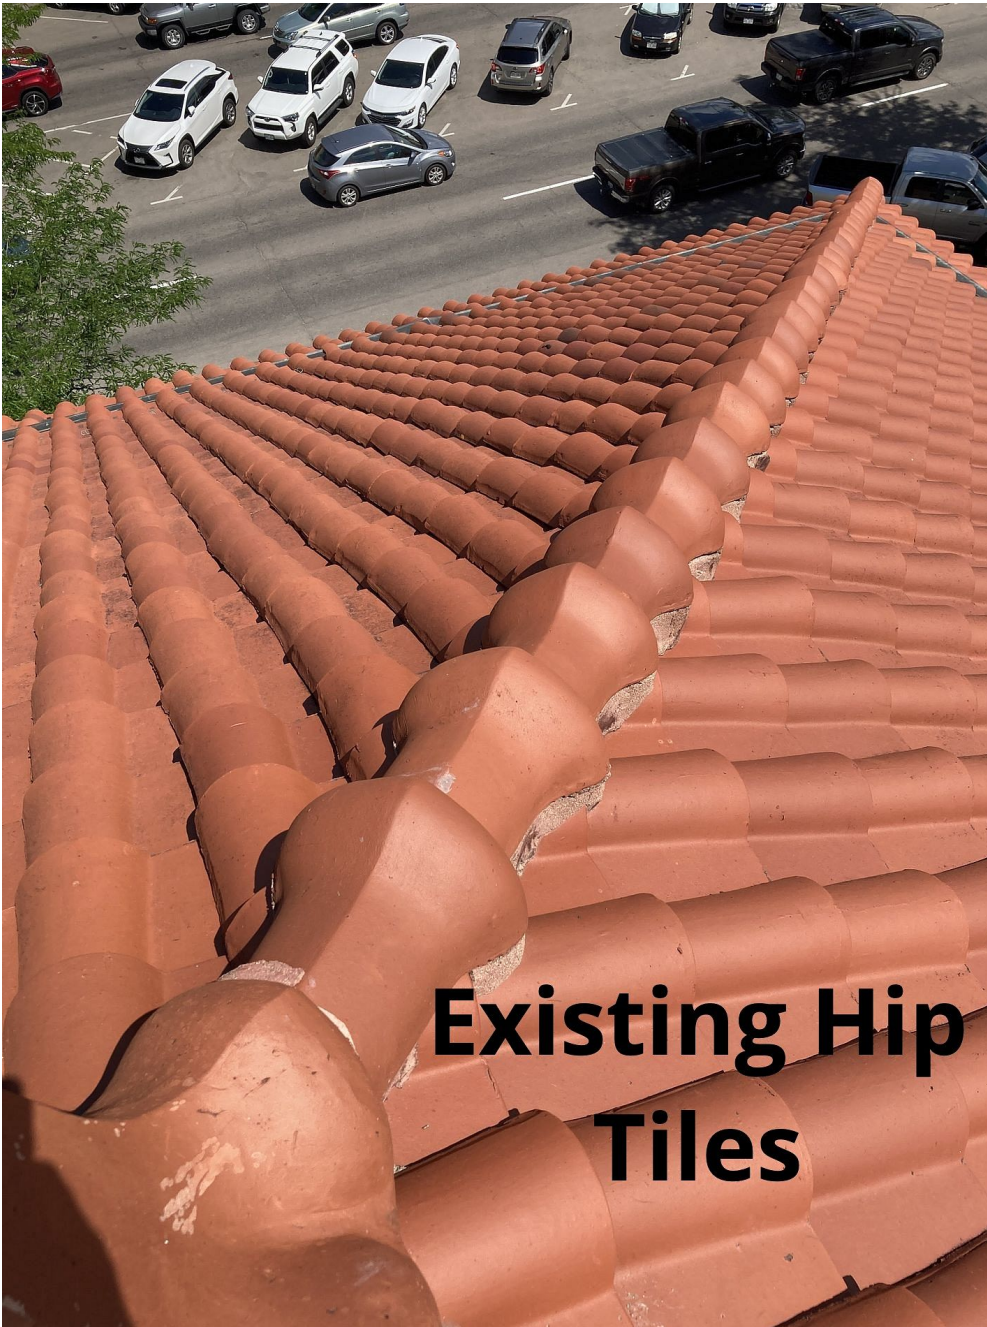
img_4983.jpg

Existing Hip Tiles

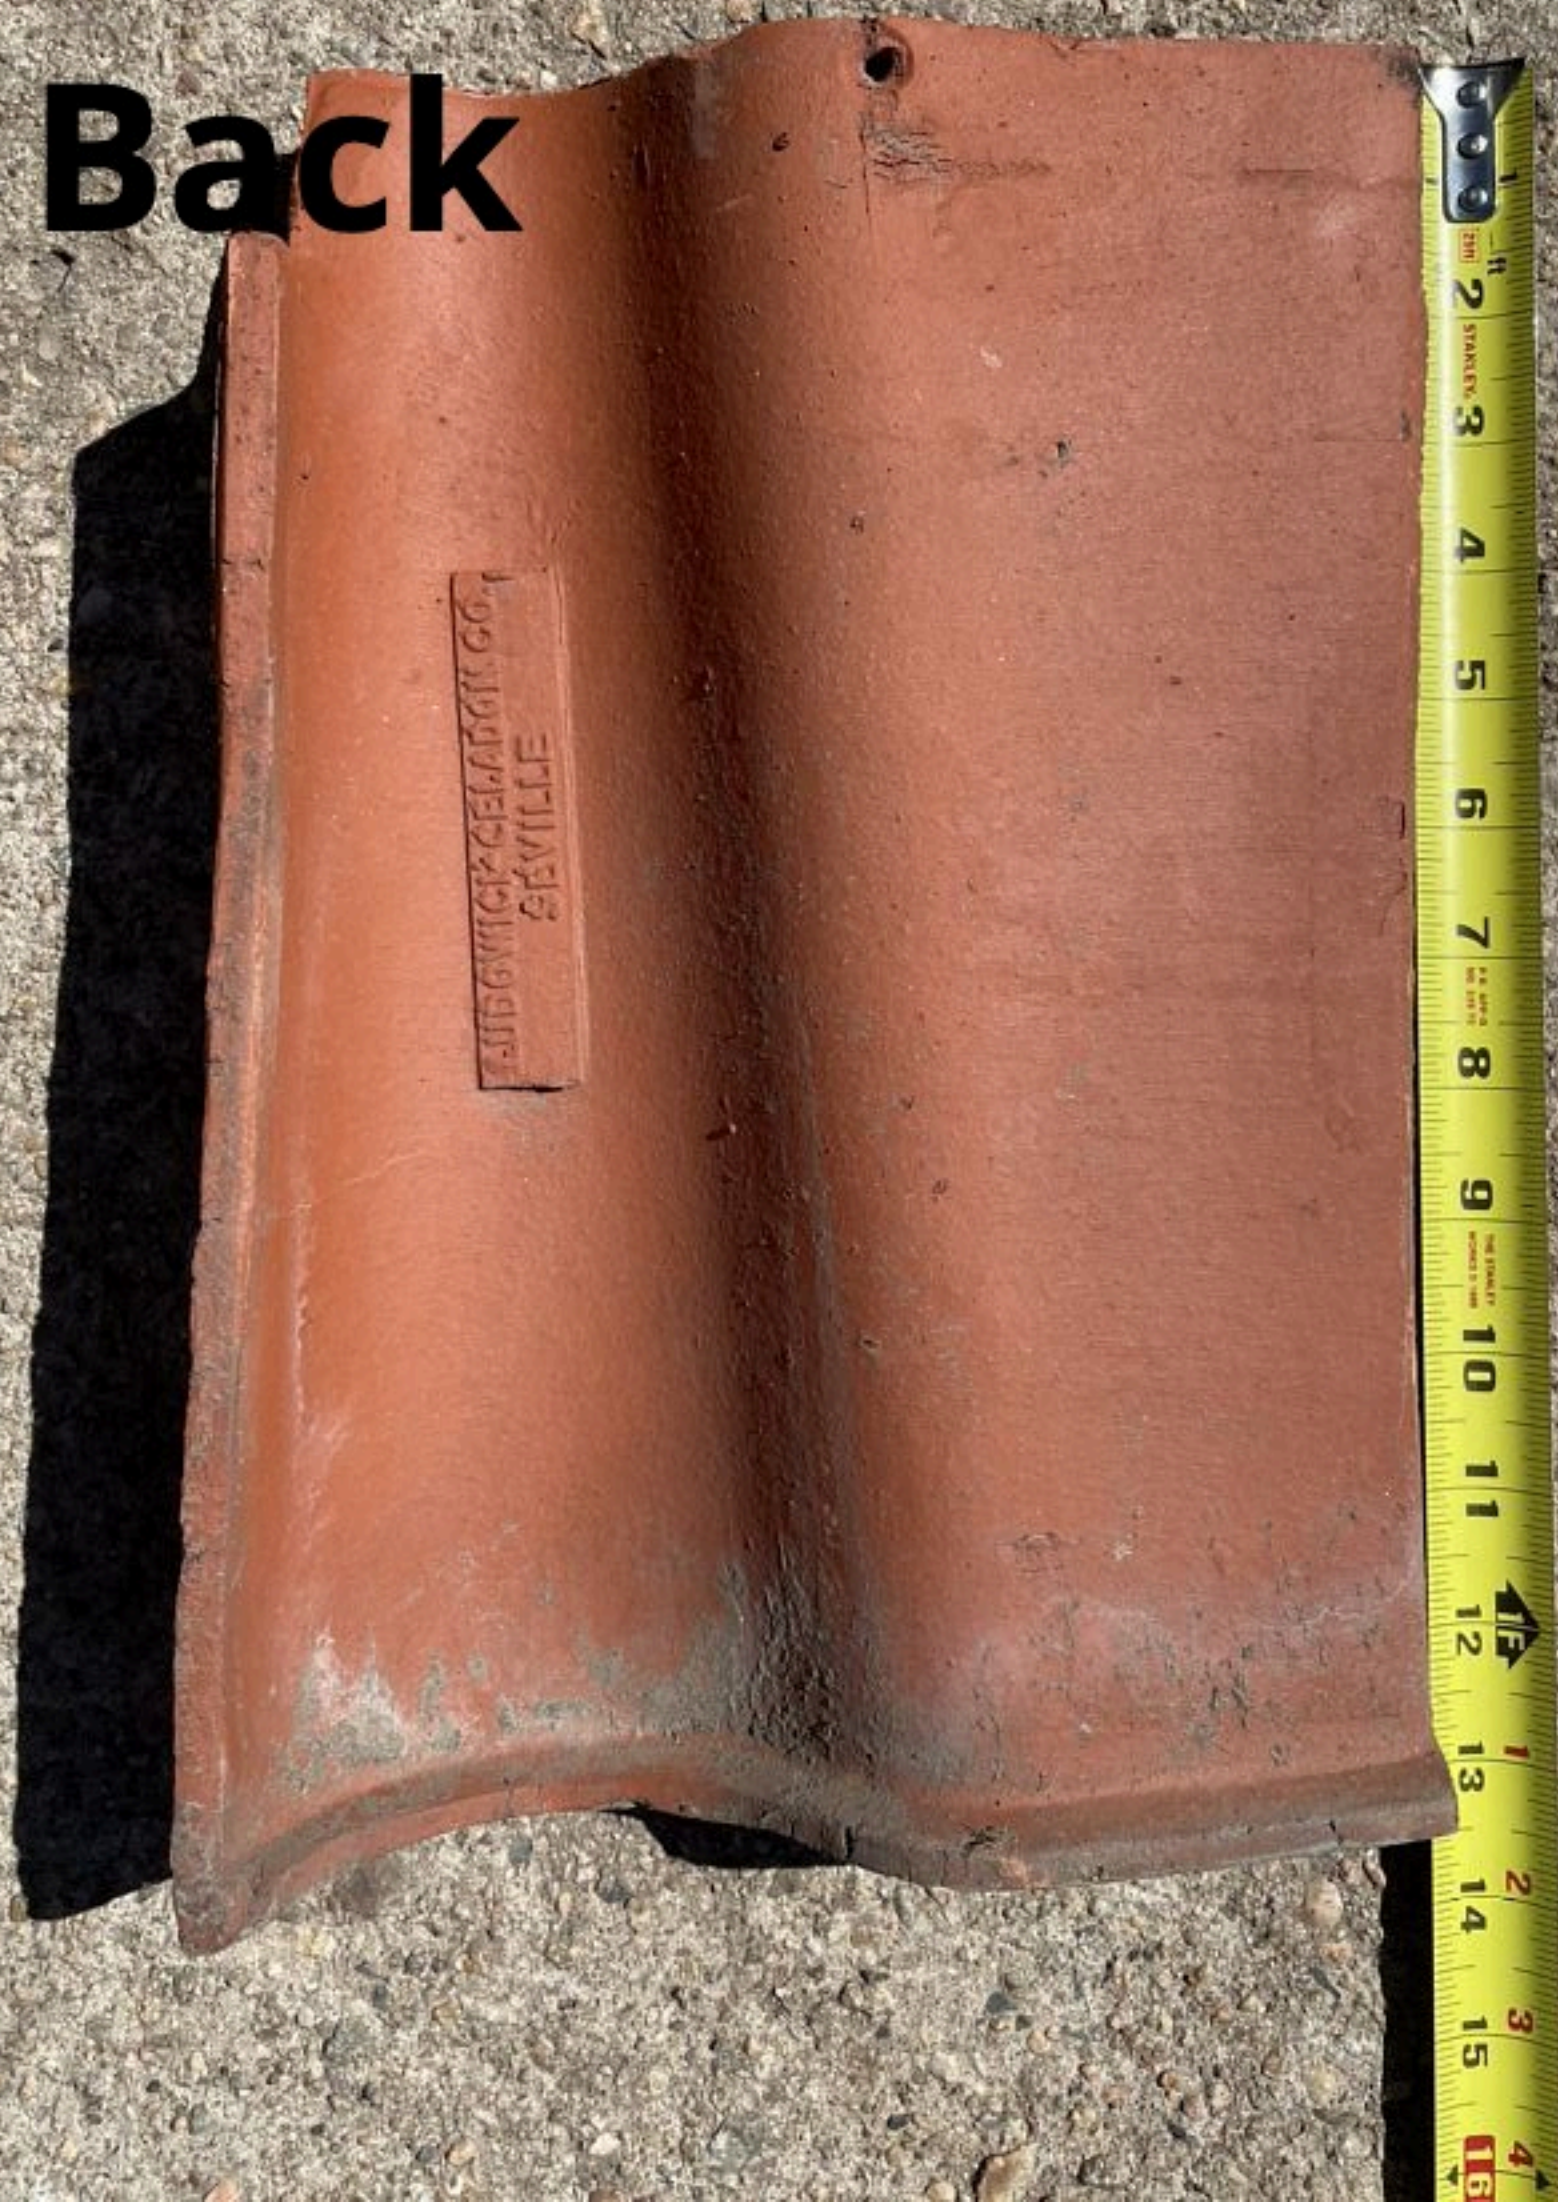
**Mound City H-3 vs.
Ludowici H-11**

- Mound City vs. Ludowici hip tile backup replacements: Concern that the sizing may not line up – if replacement hip tiles are used on the same hip as salvaged originals, will they lay appropriately? Should the full set of hip tiles be replaced instead to avoid slippages or other maintenance issues?

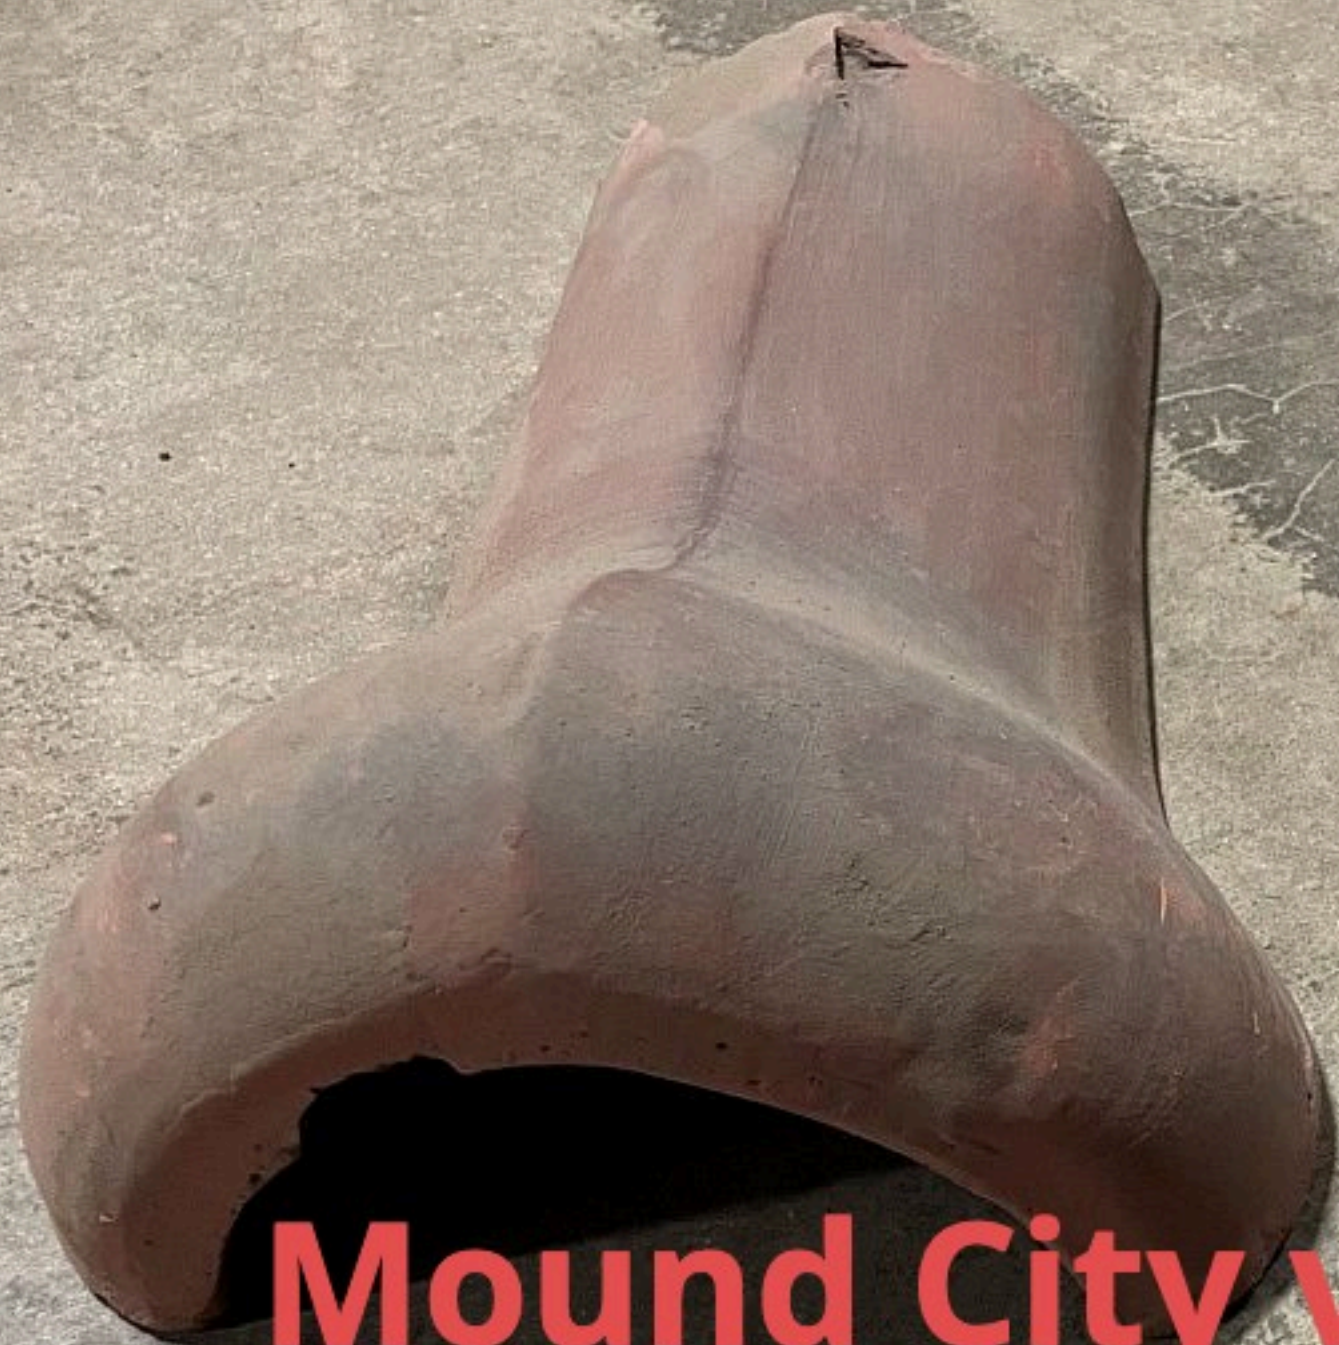
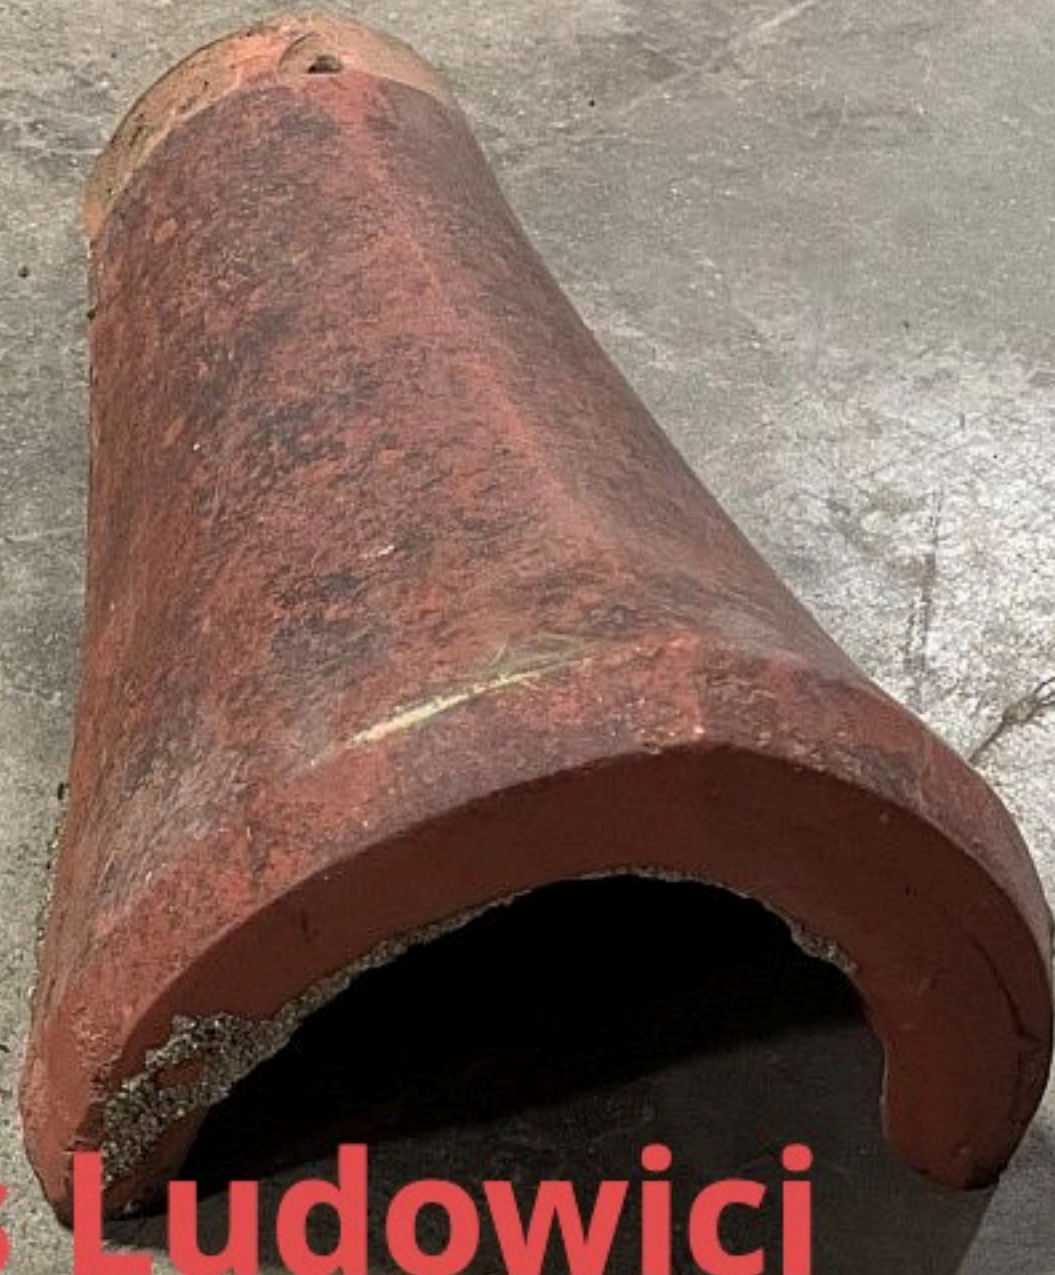
Mound City vs Ludowici

Ludowici #206 vs Mound City R-1
