CERTIFICATE OF APPROPRIATENESS

This letter provides you with confirmation that the proposed changes to your designated Fort Collins landmark property, The Juan and Mary Barraza Property at 412 Wood St., have been approved by the City's Historic Preservation Division because the proposed work meets the criteria and standards in Chapter 14, [Article IV](#) of the Fort Collins Municipal Code.

Repair of 5 windows that cannot open correctly

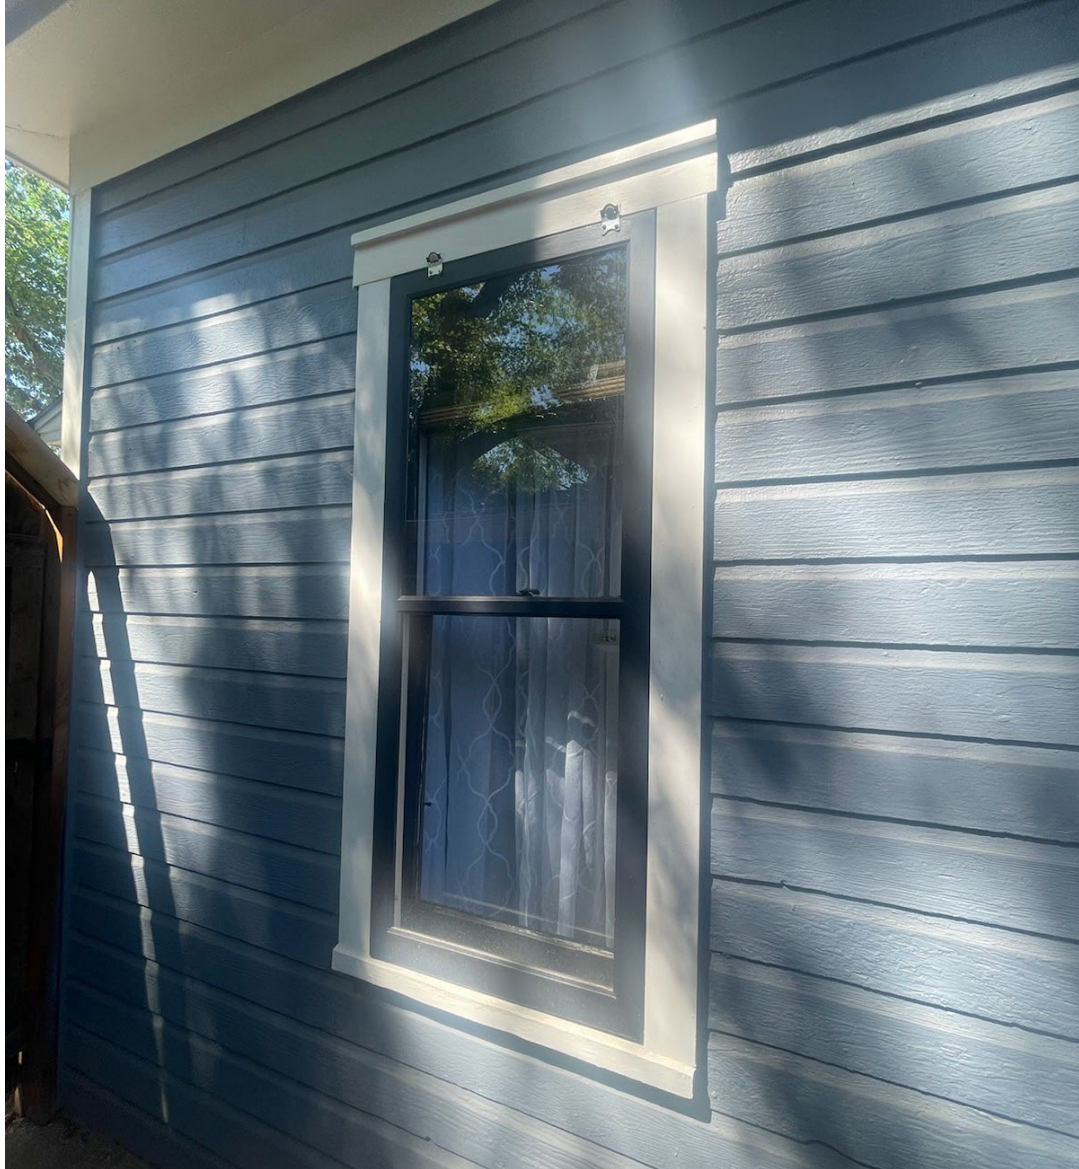
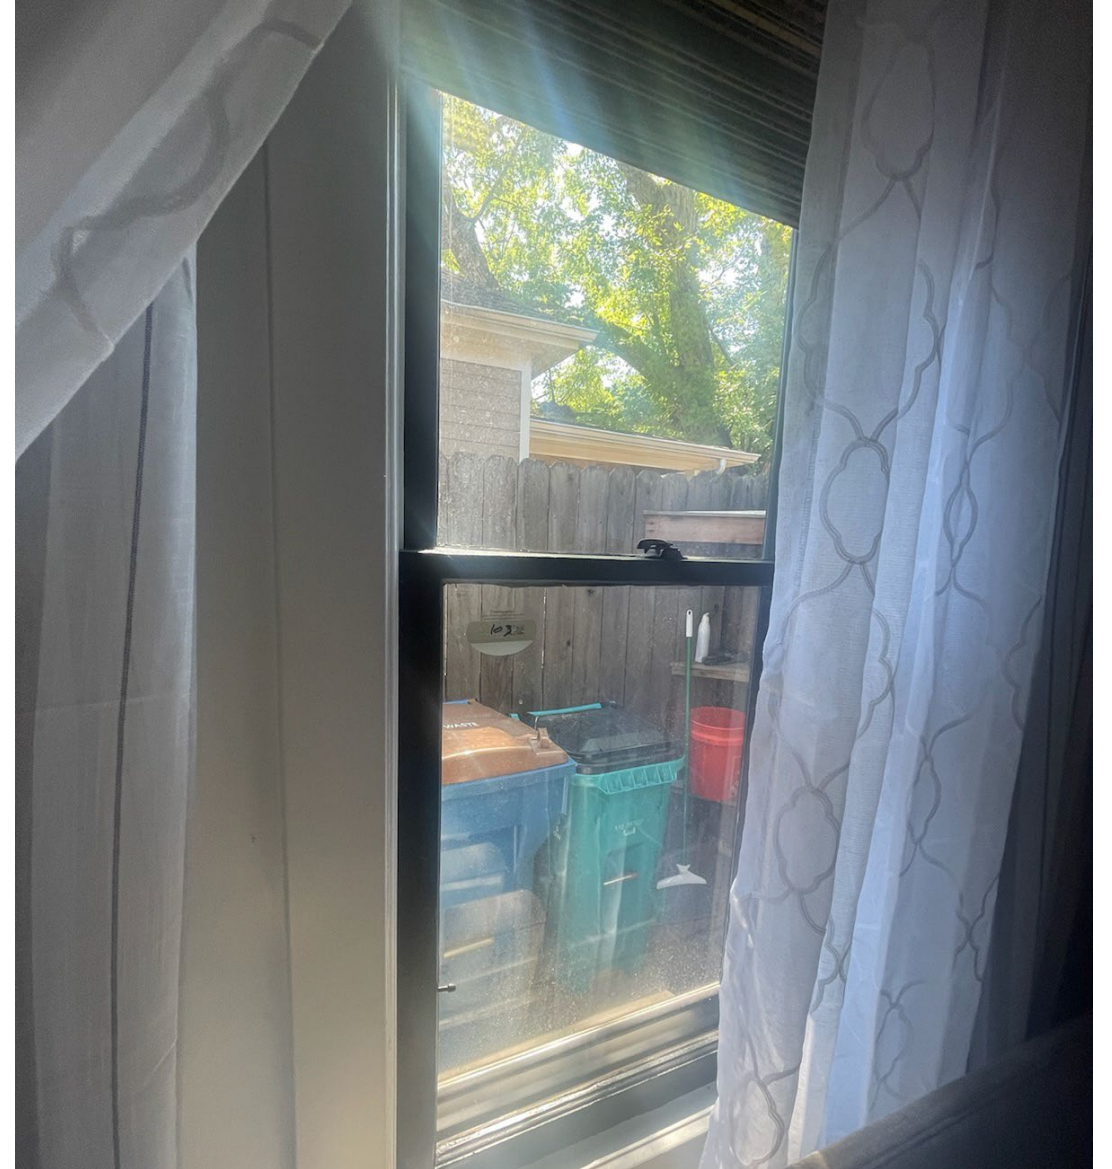
South side of the house = 1 out of 2 windows

Assessment

Lower sash is stuck in place
Glazing compound needs additional compound
Lower sash glass is loose

Repairs Suggested

Remove interior stops and take out sash
 review degree of warping of sash
 repair if needed or replace
lightly sand interior stop and edge of sash for smooth operation
inspect glazing compound
 if needed add compound to prevent water penetration
tighten loose glass with glazing compound
touch up paint over new compound
scrape excess paint from glass

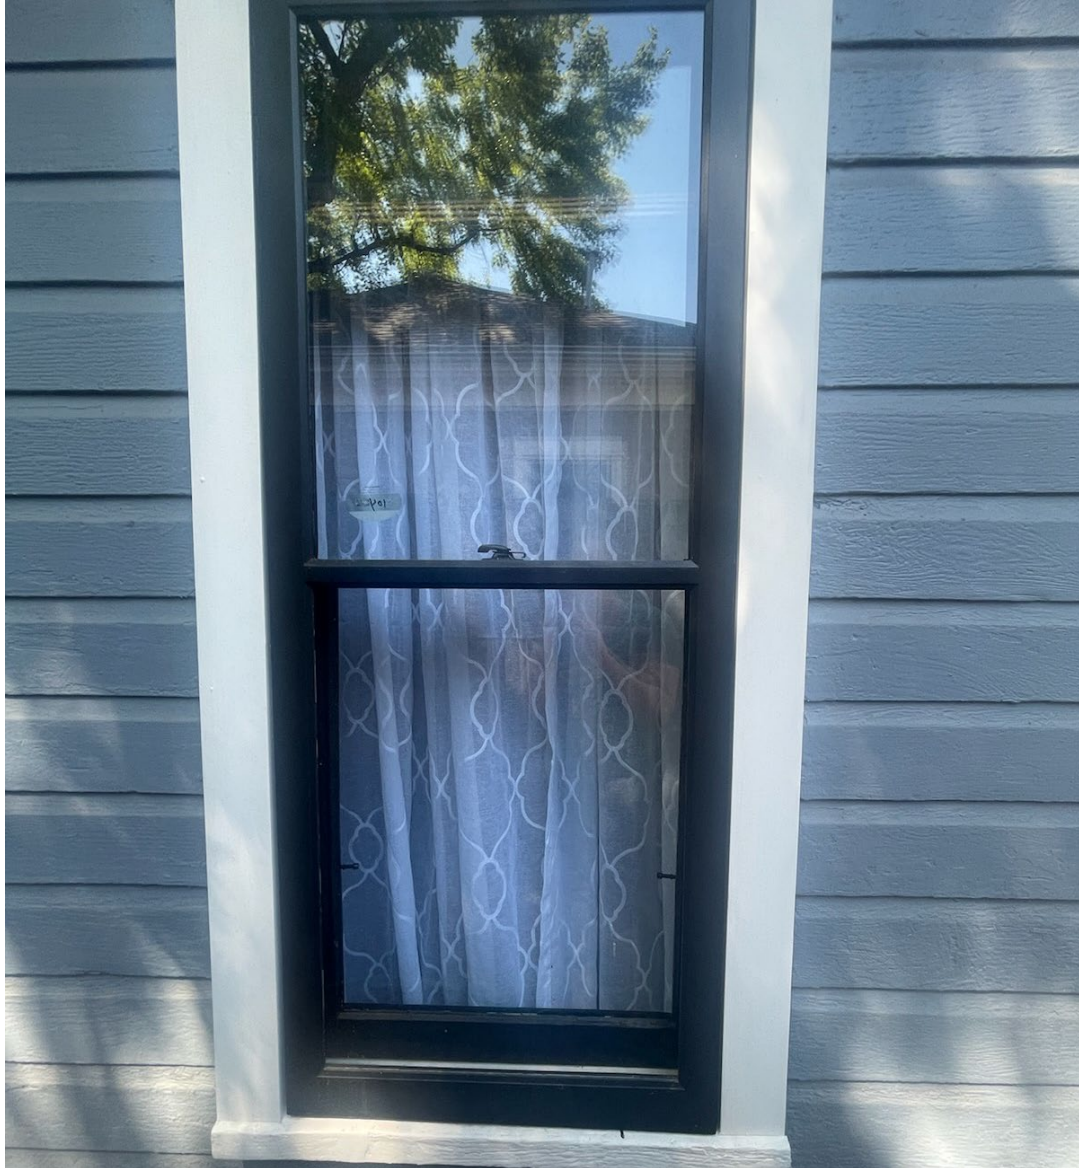
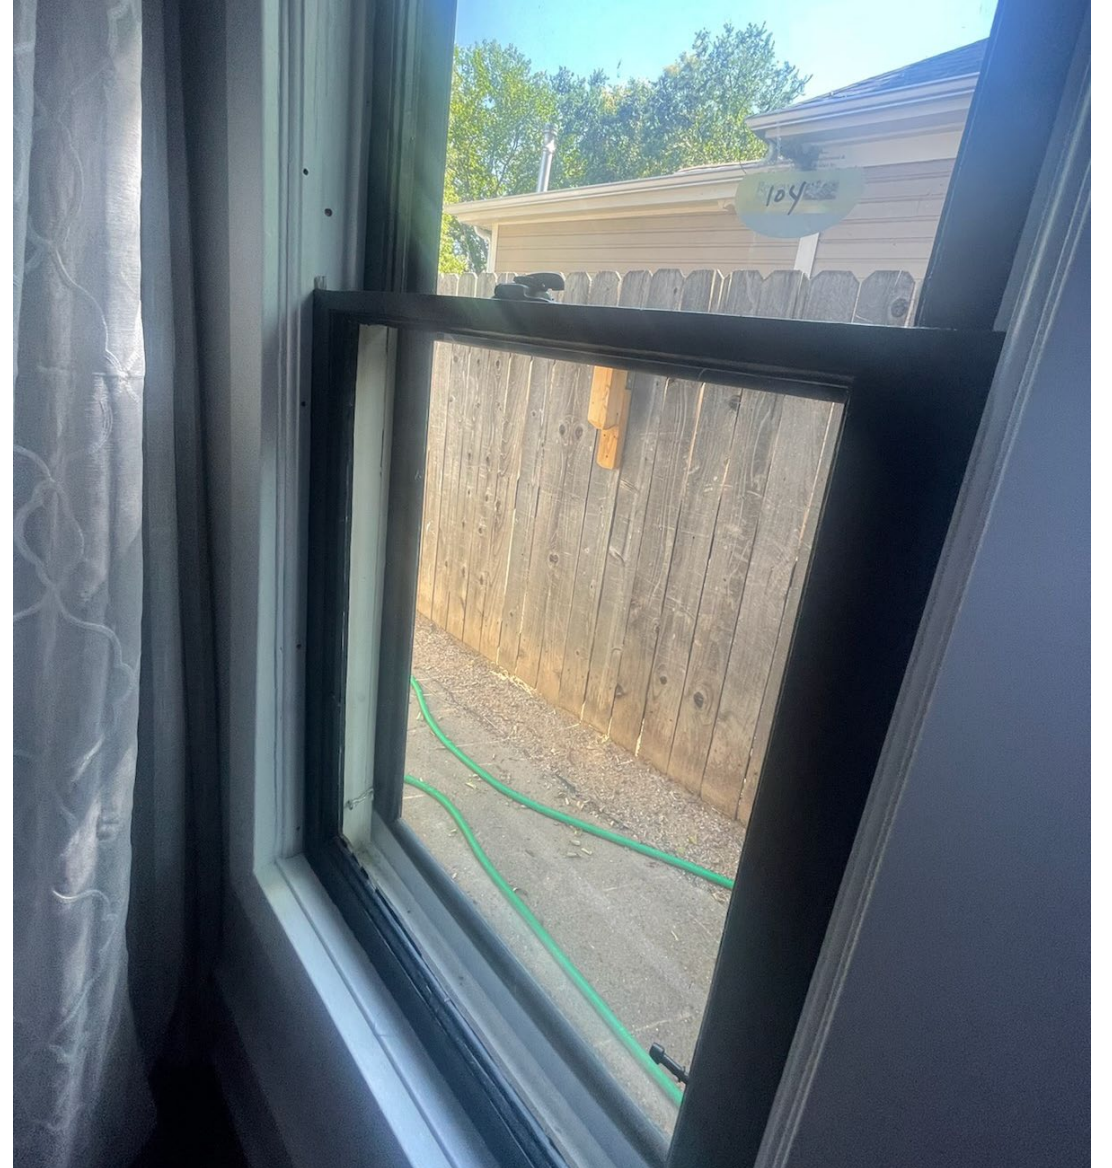
South side of the house = 1 out of 2 windows

Assessment

Lower sash is stuck in place
Glazing compound needs additional compound
Parting stop on left stile is too wide, window slides out of channel

Repairs Suggested

Remove interior stops and take out sash
 review degree of warping of sash
 repair if needed or replace
lightly sand interior stop and edge of sash for smooth operation
remove left parting stop and narrow the stop, reinstall
inspect glazing compound
 if needed add compound to prevent water penetration
touch up paint over new compound
scrape excess paint from glass
