**CERTIFICATE OF APPROPRIATENESS – Minor Alteration**

**Grace Church  
300 Whedbee St  
Fort Collins, Colorado**

**Presented through City of Fort Collins Design Assistance Program  
Historic Preservation**

**GOAL: The goal of this Narrative is to suggest a best practice in flashing roofing to the stone walls of the Church. This will give a system sympathetic to the masonry and moisture protection.**

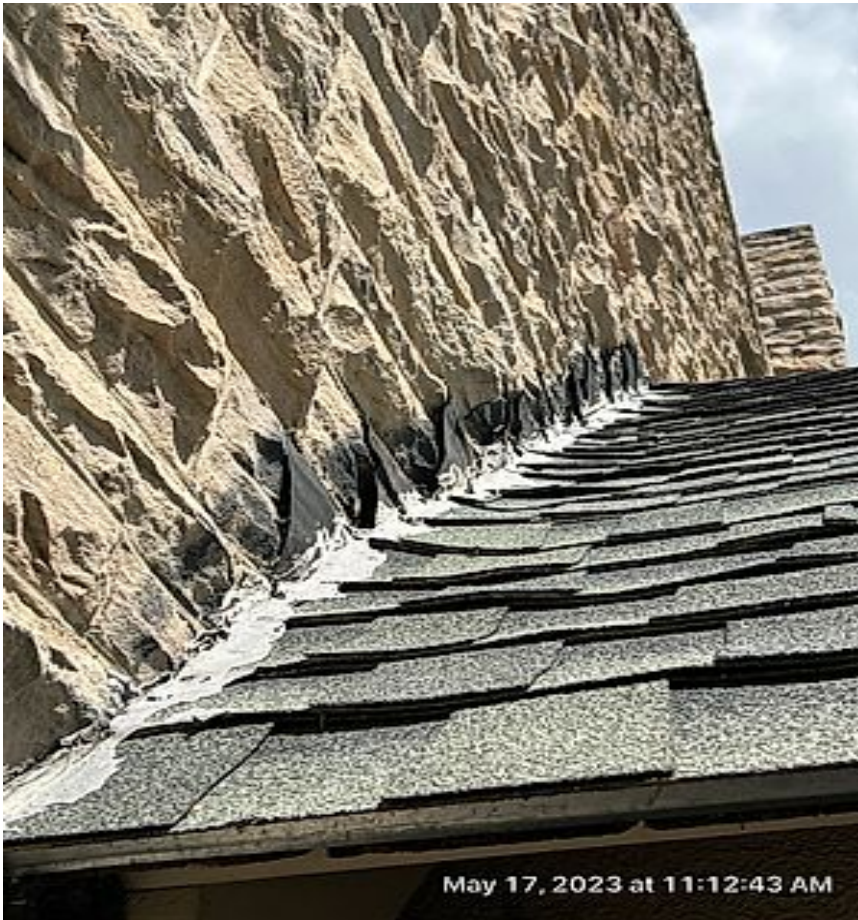
The high pitch roofs occasionally run next to high stone wall; especially by the belltower. On the sides there is flat roof shingles sealed to the stone wall. Some existing Reglet counter flash can be seen from a possible earlier installation (Figure 1).

Figure 1: Existing conditions - Tall wall to roofing. Note some reglet flashing installed.

- When roof is removed, existing counterflashing should be bent up and left in place. Flashing should be checked for deterioration and replaced if deteriorated.
- New step flashing should be installed with the roofing.
- The reglet counterflashing should be bent down over the step flash. New counterflashing should be installed where missing.
- Reglet Counterflashing need not be a hard metal flashing. A softer aluminum flash may fit into mortar space between stone and shape better to the uneven stone wall.
- A full length counterflash could be placed over the head wall flashing where the top of the roof meets the stone wall.

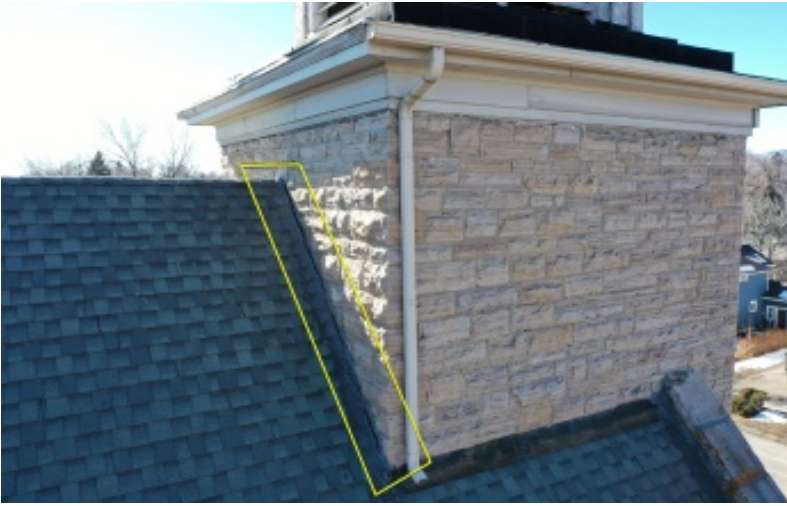
The connection of the top of the roof and a vertical wall has an existing flexible flashing that looks good. There is no counterflash on this area (Figure 2).

Figure 2: Yellow box showing roof - wall flashing failure. Flashing at top of roof and wall meeting looks to be holding but missing counterflashing.

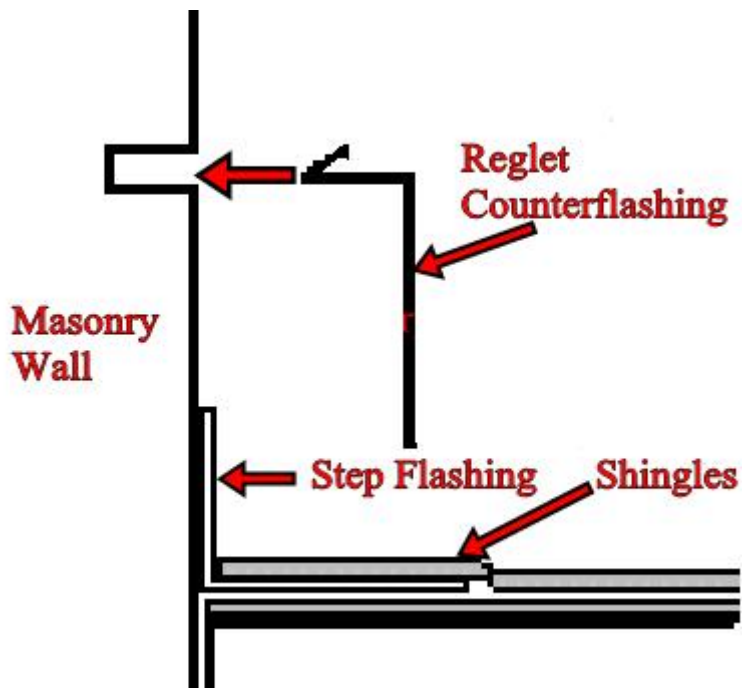
Below is an example of a reglet flash system.

Figure 3: Example of Reglet Flashing (courtesy of Old House Web).

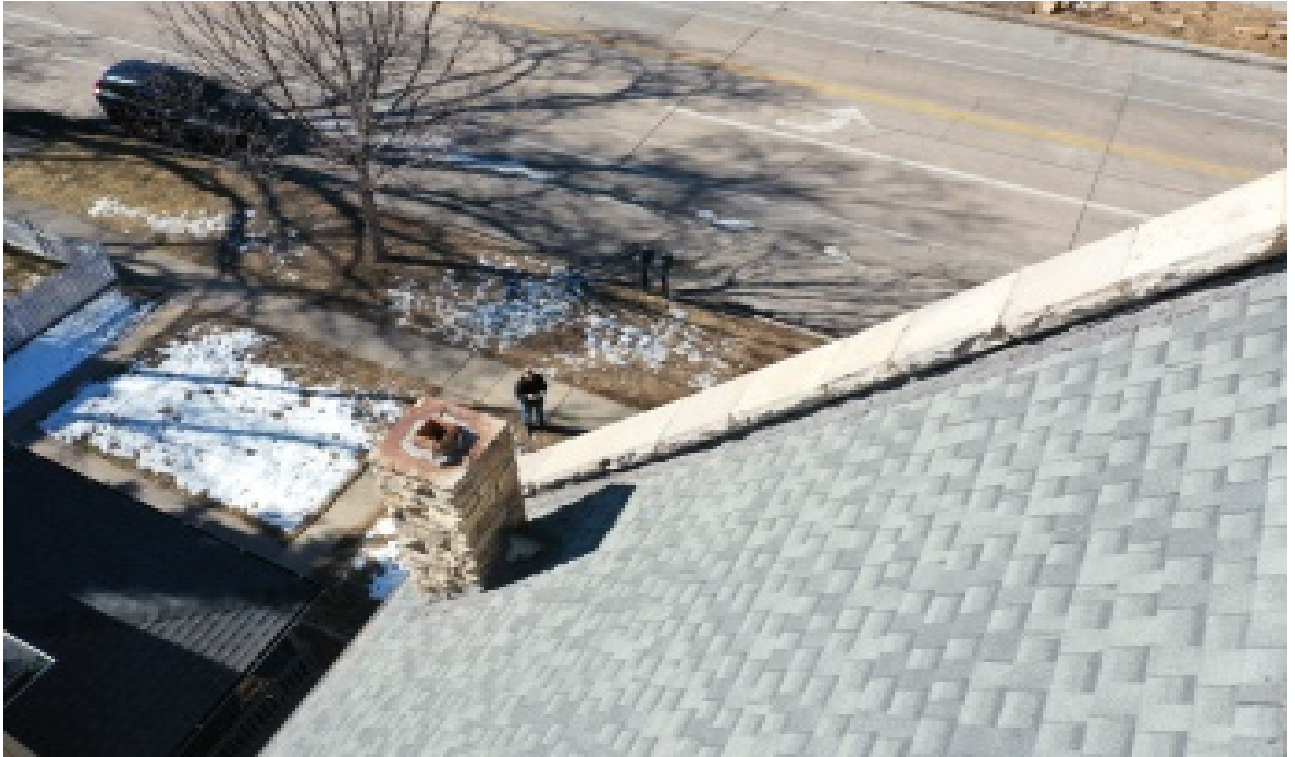
The largest area of roof and wall contact is where the sides of the shingles meet the parapet caps. This area is basically protected by the overlay of the stone parapet cap (Figure 3).

Figure 4: Roof showing existing tar flash of roof to parapet. Note chimney flash.

A cut step flash is suggested along the wall below the parapet stone. Each installed piece could include a flexible caulk on the rear top of the flashing before installation. That would seal well against the wall. None of this would be visible. This could be a rigid metal step flashing.

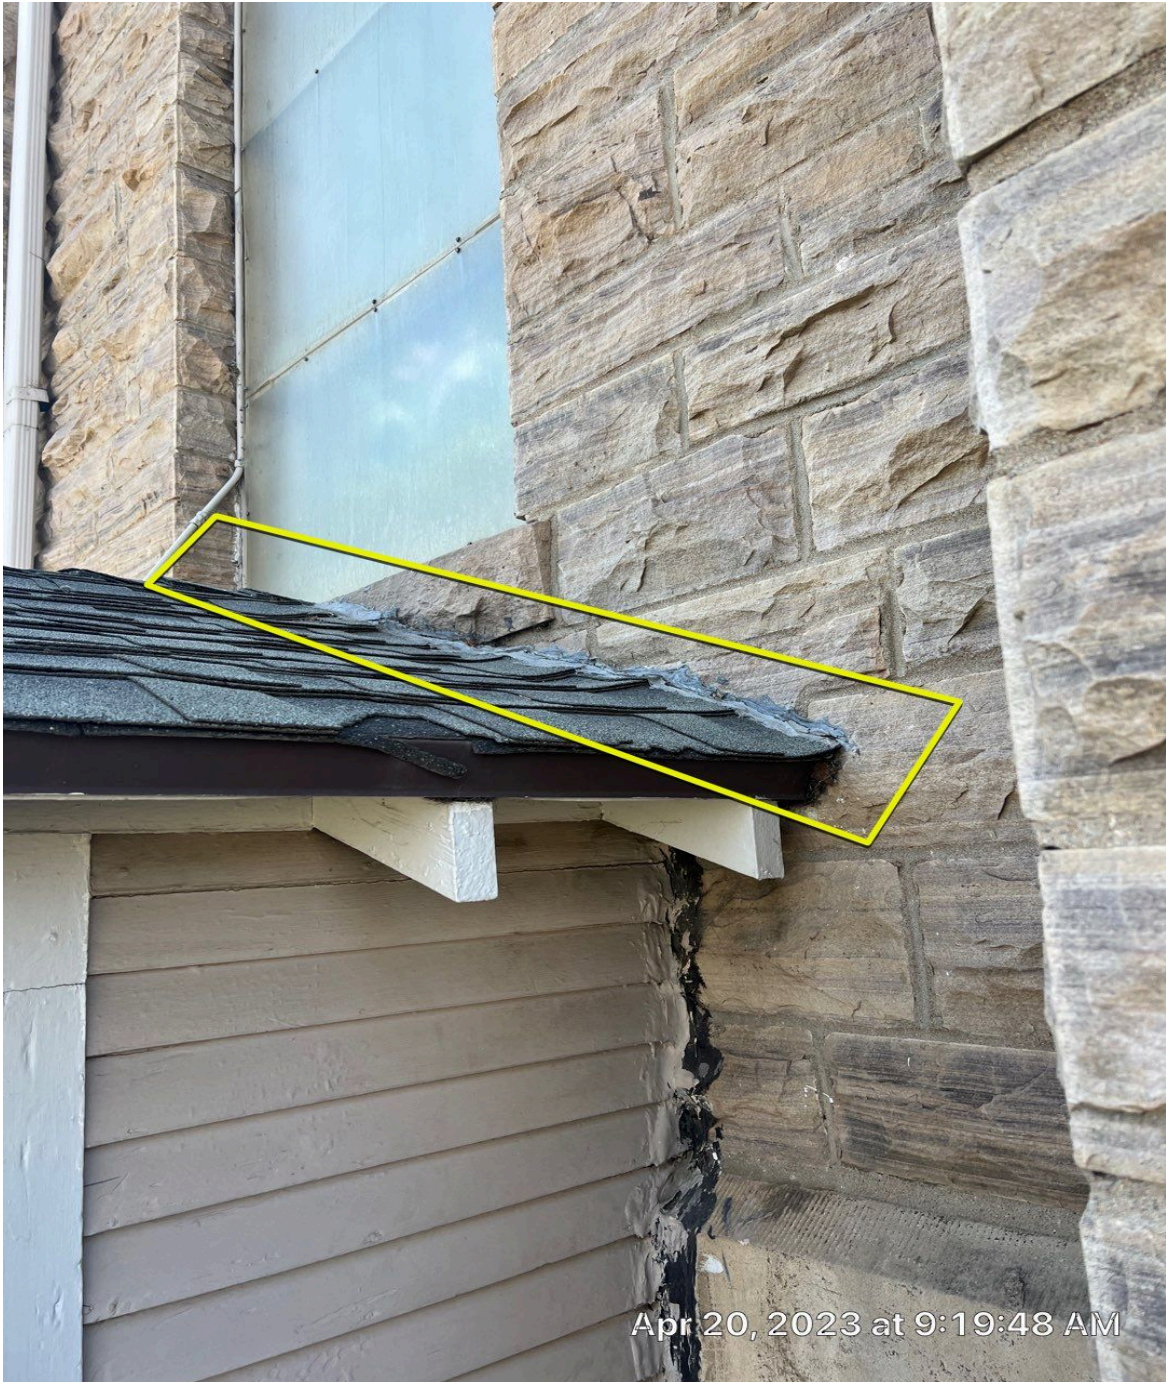
Figure 5: Low pitched roof invades wind sill and makes flashing hard.

An addition on the north side, most likely covering a stair, has a low pitch roof because of a window sill above. A traditional counterflash would not work well here. A possibility maybe to place a flexible adhesive flash against the wall with a flexible metal bar attached to stone for a tight seal. Otherwise a slathered caulk or tar can be used but is hard to remove and visually suffers.
