# **WETLAND DELINEATION TECHNICAL REPORT**

West Elizabeth Corridor Concept Design

FHU Reference No. 120305-01

January 2022

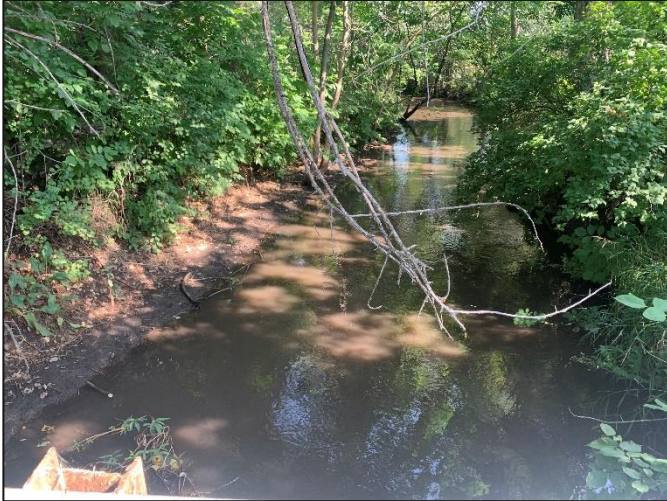
**Photo 1:**

Pleasant Valley and Lake Canal

(Located on the north side of West Elizabeth,  
north side of box culvert, facing north)

- Pleasant Valley and Lake Canal:** This canal crosses the study area under West Elizabeth approximately 0.25 miles east of Overland Trail (see **Figure 4**). There is a 14-ft span box culvert that allows the water to flow underneath West Elizabeth. There was a defined channel and the OHWM was delineated. The channel was approximately 10-feet wide and 1 to 2-feet deep of flowing or standing water present at the time of the survey.

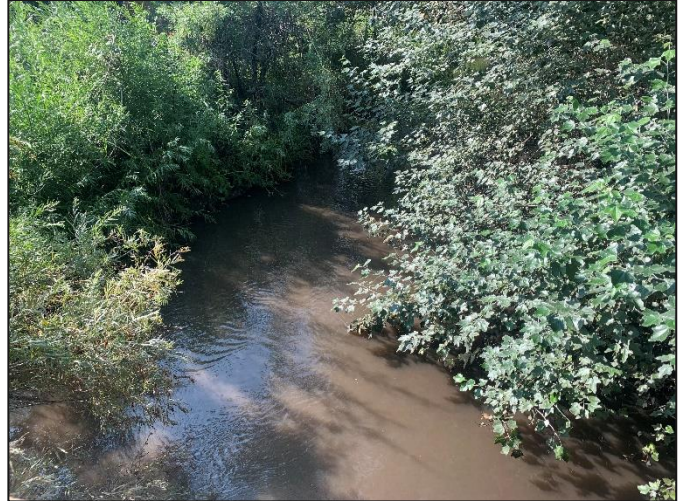
**Photo 2:**

Pleasant Valley and Lake Canal

(Located on the south side of West Elizabeth,  
south side of box culvert, facing south)

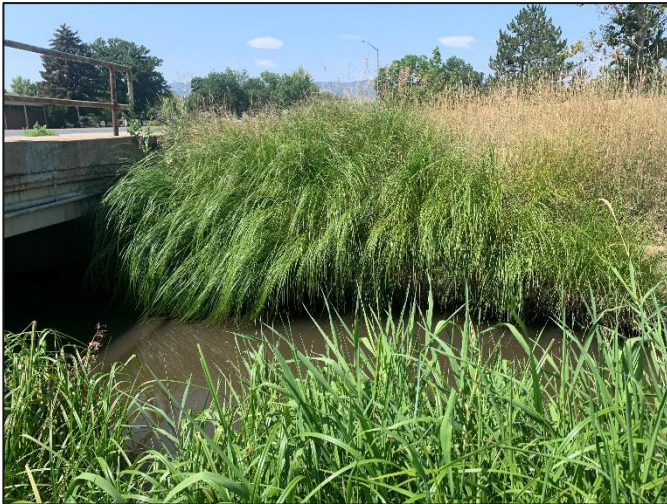
**Photo 3:**

Wetland I and New Mercer Canal

(Located along New Mercer Canal on the north  
side of West Elizabeth, facing west)

The primary source of hydrology for Wetland 1, which is located along the New Mercer Canal (see **Figure 4**), is likely provided by normal precipitation, stormwater run-off, and the intermittent flows of New Mercer Canal. At the time of the survey there was no surface water or water table present within the wetland, however the soils were saturated within 4-inches of the surface.

- **New Mercer Canal:** The canal crosses the study area under West Elizabeth approximately 0.10 miles east of Skyline Drive (see **Figure 4**). There is a 16-ft span bridge that allows the water to flow underneath West Elizabeth. There was a defined channel and the OHWM was delineated. The channel was approximately 5 to 10-feet wide and 1 to 2-feet deep of flowing or standing water present at the time of the survey.

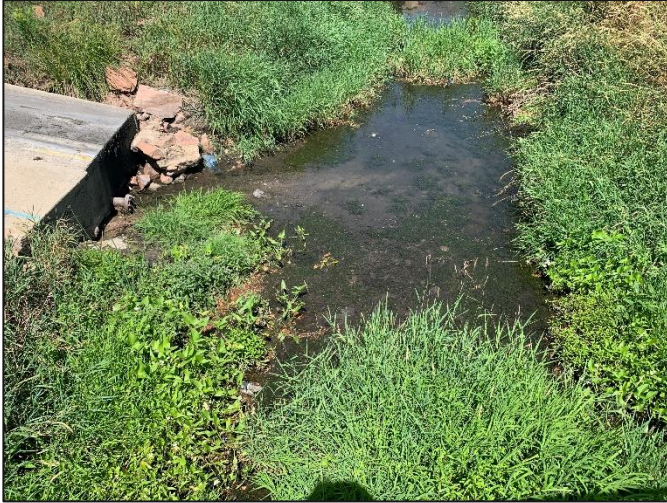
**Photo 5:**

Wetland 2 and Larimer County Canal No. 2  
(Located on the north side of West Elizabeth,  
facing north)

Wetland 2 is located along Larimer County Canal No. 2 (see **Figure 4**) and the primary source of hydrology is normal precipitation, stormwater run-off, and the intermittent flows of Larimer County Canal No. 2. At the time of the survey there was no surface water or water table present within the wetland and the soils were not saturated.

- **Larimer County Canal No. 2:** The canal crosses West Elizabeth at approximately 0.08 miles east of Constitution Avenue (see **Figure 4**). A single 20-ft span bridge allows the water to flow underneath West Elizabeth. The channel was approximately 12-feet wide and 0.5 to 1.5-feet deep with flowing or standing water present at the time of the survey.

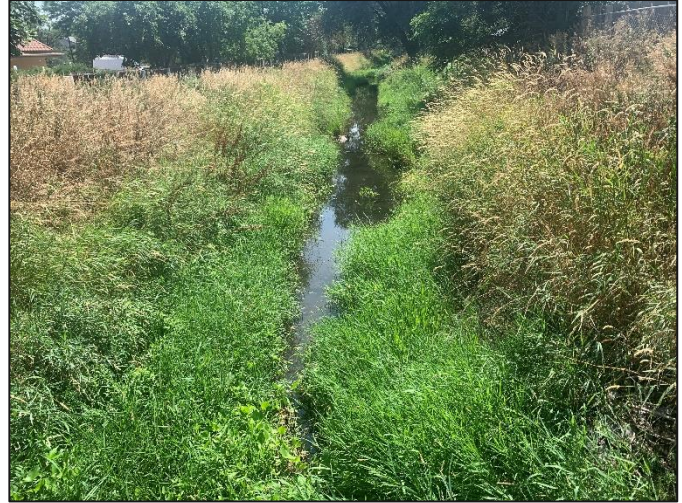
**Photo 6:**

Wetland 2 and Larimer County Canal No. 2  
(Located on the south side of West Elizabeth,  
facing south)

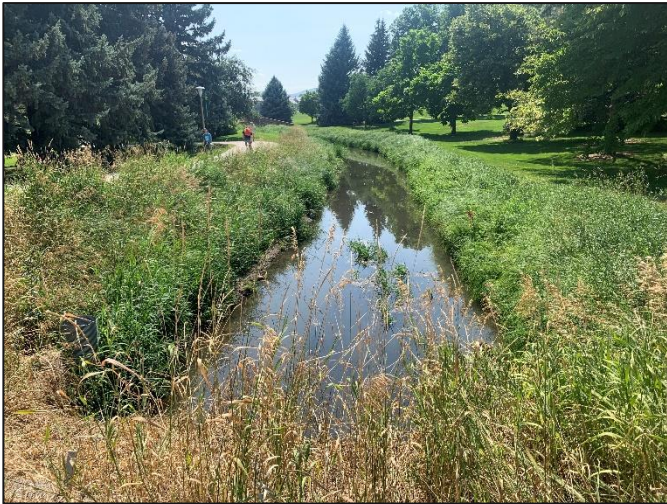
**Photo 7:**

Arthur Ditch

(Located just outside of the Study Area on the  
south side of Plum Street/CSU)

- **Arthur Ditch:** Arthur Ditch crosses the study area under Plum Street approximately 0.11 miles east of Meridian Avenue (see **Figure 4**). A box culvert allows the water to flow underneath Plum Street. Arthur Ditch does not daylight within the study area. Outside of the study area on the south side of Plum Street, the channel was approximately 10 to 15-feet wide and 1 to 2-feet deep with flowing water present at the time of the survey.
