REPORT OF ALTERATIONS TO DESIGNATED RESOURCE

Site Number/Address: 425 Mathews Street
Laurel School National Register Historic District
ISSUED: November 27, 2019

Re: **Mortar Analyses** for stone foundation and exterior brick wall; 425 Mathews Street, Ft. Collins, CO.

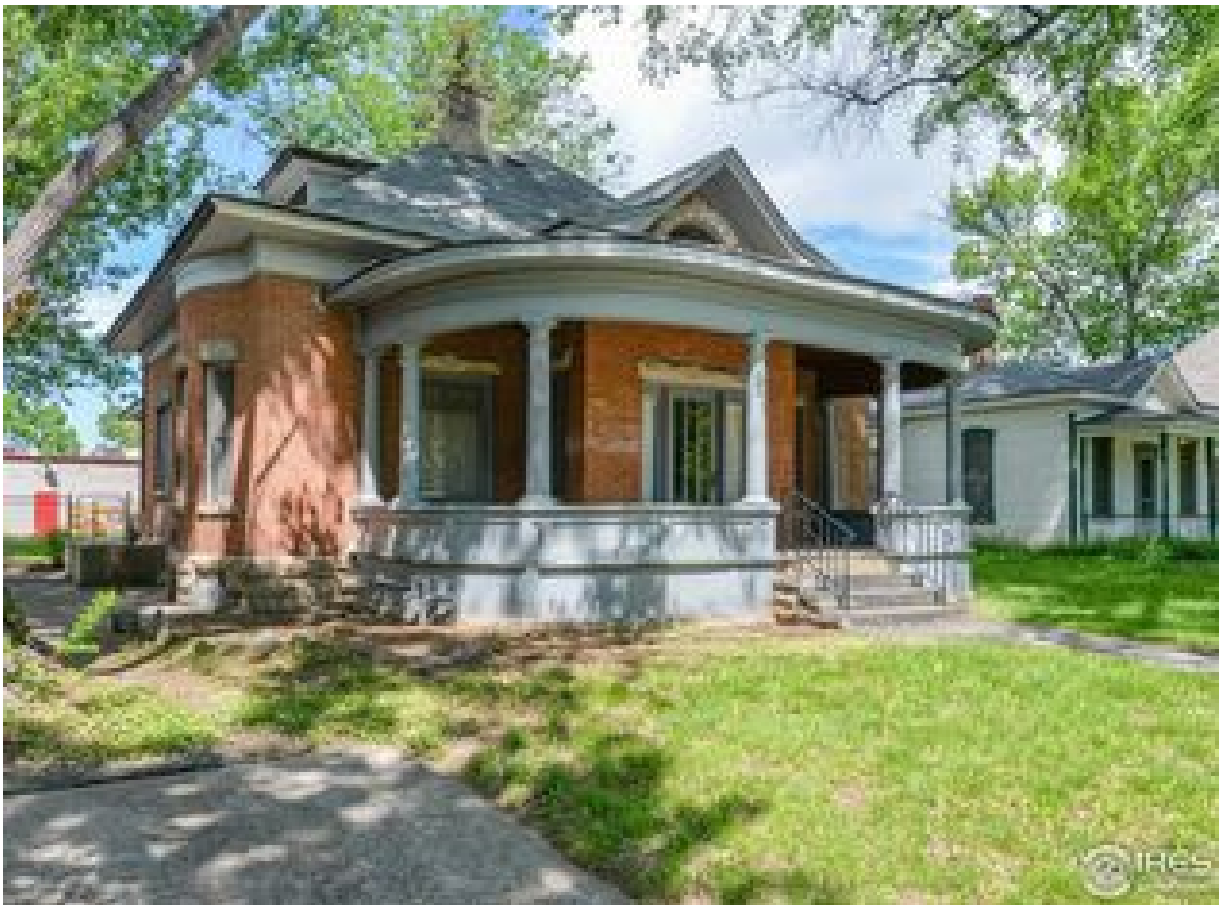
Figure 1: 425 Mathews

FOUNDATION: The Foundation is a rubble foundation with cut and fitted outer stone. The stone is a local buff color. The Mason bedded the stone in a straight lime and sand mix. On the outer edge of this soft bedding mortar, the Mason placed a Portland hardened 3/8" finish bead and cap, to seal the exterior of the joint. All this is typical for the age of the Residence.

Mortar: The mortar was observed to be as soft as the usual lime based mortar of the time. It had a coarse feel to it. The color was greyish-white. The sample could crumble, rolled in fingers.

Conclusion: Because of this thin joint, It's believed that a smaller aggregate was required. Also, the amount of lime was almost double that found in the stone mortar, possibly for better adhesion. **A Type K variant should be used for repointing, adding just a bit of cement for strength. Cement added should be Federal Cement (white) for color.** See Attachment B for Detail.
