## CERTIFICATE OF APPROPRIATENESS

As you are aware, the Historic Preservation Commission gave Final Design Review approval for the work you are proposing for the Scott Apartments and Garage at 900 S. College Avenue at its January 19, 2022 Regular Meeting.

## The Scott Apartments Before Photographs

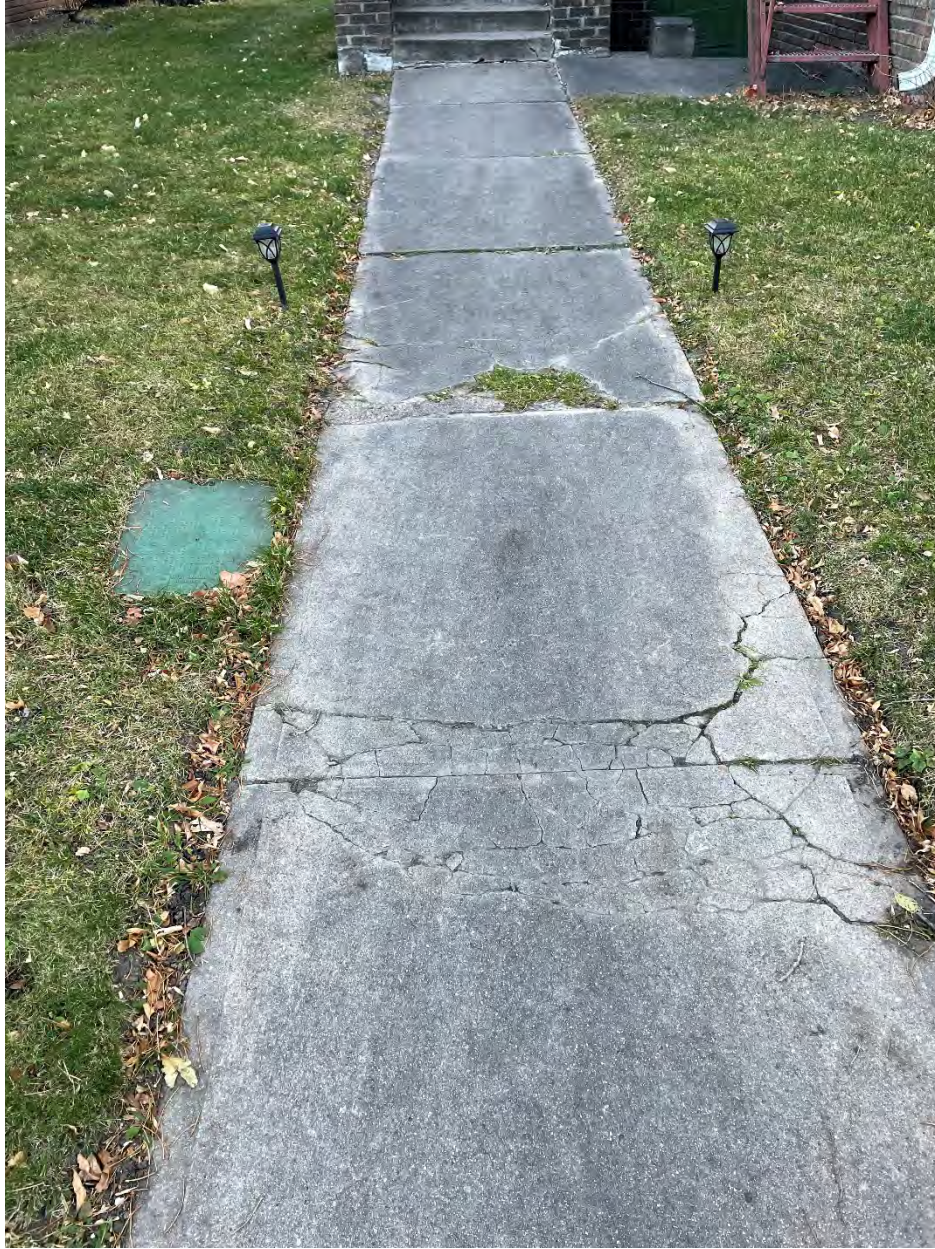
### Photo 50

Detail of deteriorated concrete sidewalk

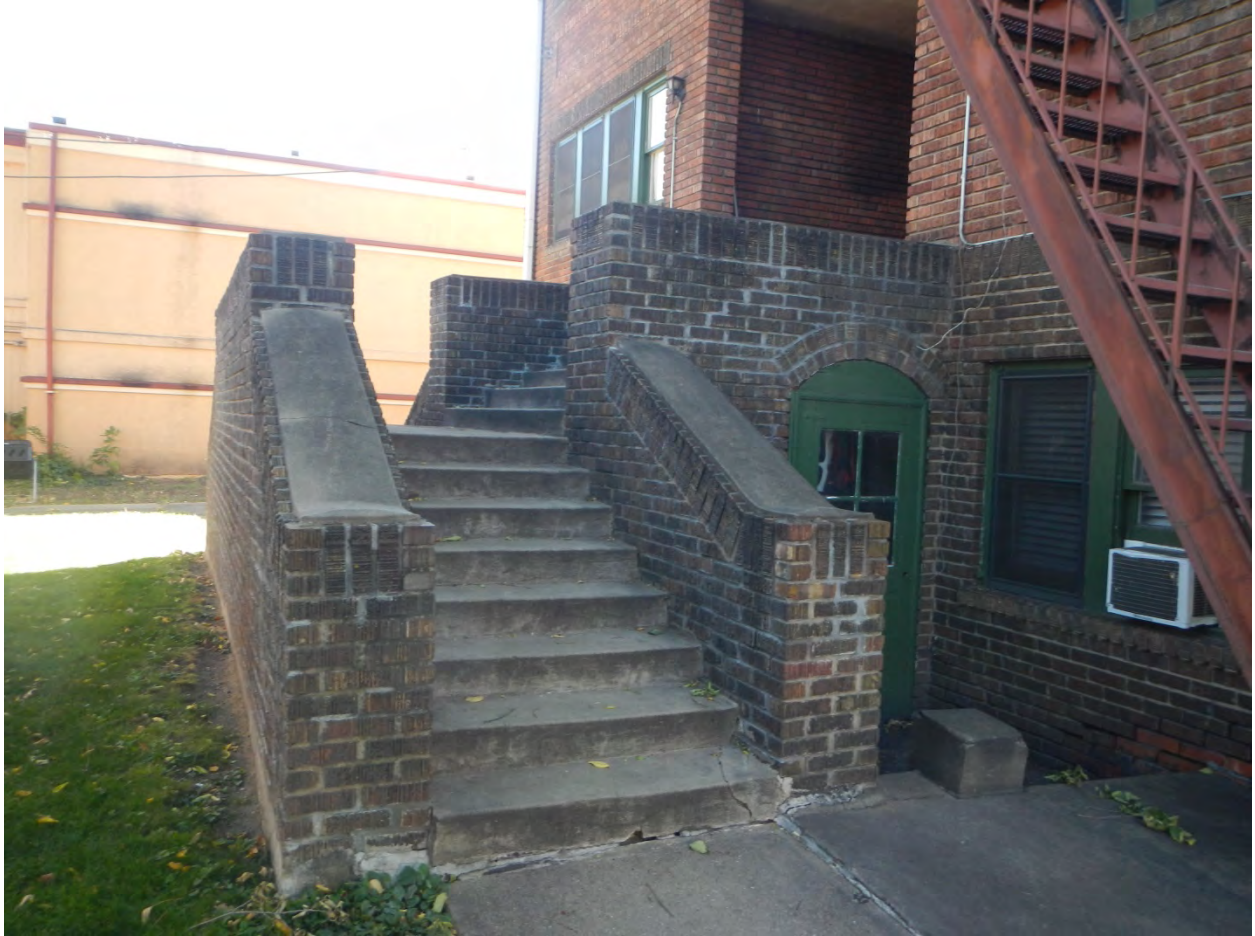
- **Back Entry:** The back entry is a copy of the front entry system. However, the location away from the persistent weather and foliage, has helped to minimize problems. The eastern (exterior) wall has not leaned out too bad, nor has the bulge found in the western wall of the front entry. Above, the upper landing has cracked where parts have moved away with the settling west wall and stairs. The crack, as well as others, allow moisture to enter the backfilled system. The tapered concrete caps (on the brick half walls) while in decent shape, have cracked in many places to allow moisture into the wall systems. It is assumed that these caps can be salvaged and rehabilitated.

Figure 11: Overall view of rear stairwell.

- Rebuild west wall and connect stair system for support
- **Back Entry:**
  - Install four helical (or push) piers under the east wall to stabilize.
  - Grind out concrete cap cracks to allow caulking with a one part urethane caulk.

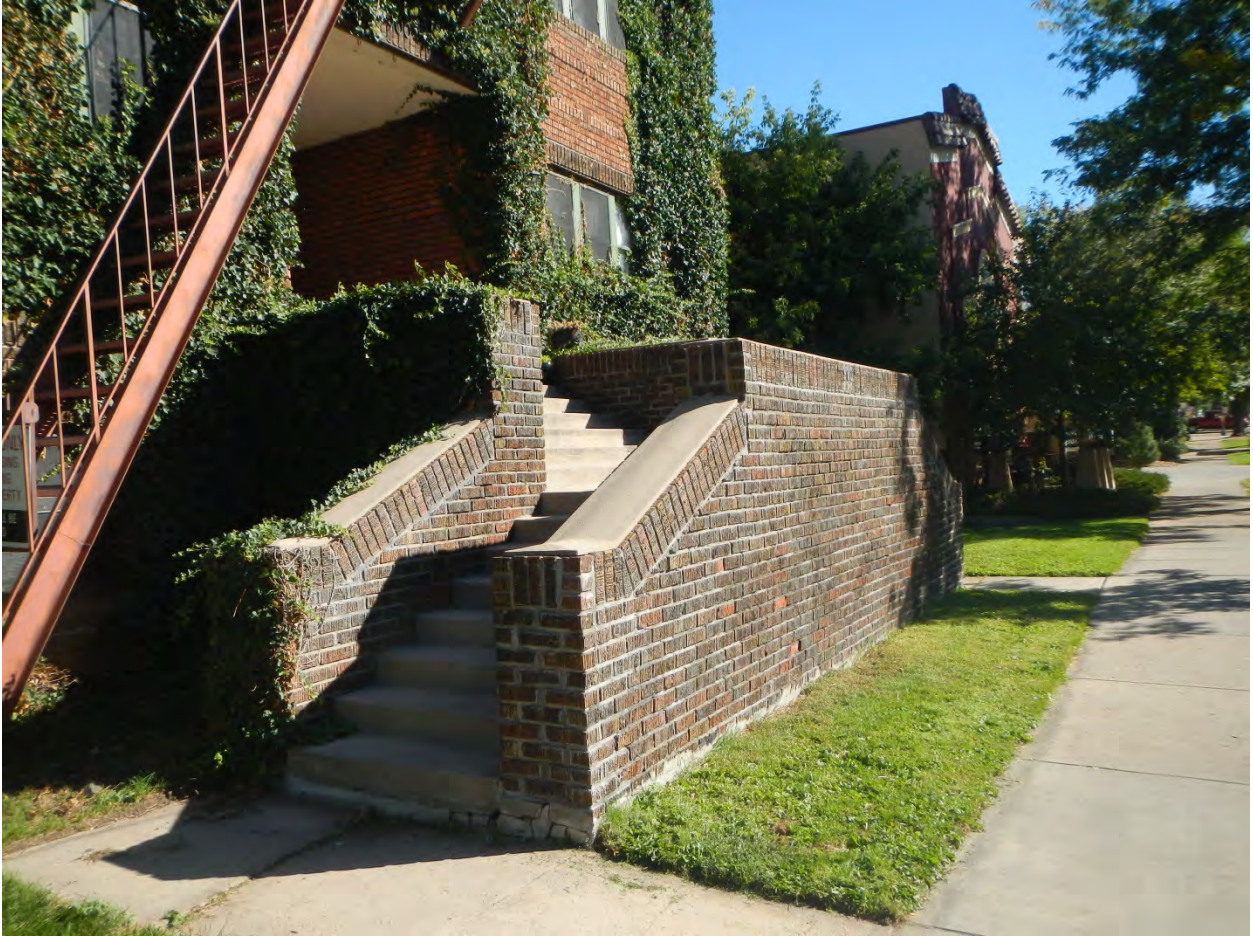
- **Front Entry:** The front entry shows the most deterioration. The exterior wall shows settling; causing the wall to lean towards the west. This wall shows bulging caused by fill and moisture pressure behind the brick. Above, the upper landing has cracked where parts have moved away with the settling west wall and stairs. The crack, as well as others, allow moisture to enter the backfilled system. The tapered concrete caps (on the brick half walls) while in decent shape, have cracked in many places to allow moisture into the wall systems. It is assumed that these caps can be salvaged and rehabilitated.

Figure 12: Overall view of front stairwell.

- **General:** Full mortar analysis be done on original mortar for color, hardness and mix.
- **Main Body:**
  - Treat deteriorated mortar to NPI Preservation Brief #2 Standards.
  - Crack between flatwork and the building will be rehabilitated to minimize moisture.
  - Sidewalk either side of Front entry stairs be replaced at correct height and angle. Broken section of sidewalk on SW side be replaced (5'x4').
- **Front Entry:**
  - Open west wall to allow support of stair landing. Support temporarily.
  - Tear down west wall and clean brick for re-installation.
  - Place concrete footer or piers to support rebuilt west wall.
