CERTIFICATE OF APPROPRIATENESS ISSUED: June 11, 2024 EXPIRATION: June 11, 2025

This letter provides you with confirmation that the proposed changes to your designated Fort Collins landmark property, the Colorado and Southern Freight Depot and Docks at 250 N. Mason St., have been approved by the City's Historic Preservation Division because the proposed work meets the criteria and standards in Chapter 14, <u>Article IV</u> of the Fort Collins Municipal Code.

Downtown Transit Center

Date Thu 11/16/2023 Job # 51431 Weather 6:00 AM 12:00 PM 4:00 PM Clear Overcast Wind: 7 MPH | Precipitation: .0" | Humidity: 57% Wind: 10 MPH | Precipitation: .0" | Humidity: 37% Wind: 15 MPH | Precipitation: .0" | Humidity: 28% Work Logs Name Description Quantity **Total Hours** Asssessment of main Roofing assembly is composed of three distinct areas. 0 n roof. Larry Tate RRO Section A (south section) Fully adhered Carlisle 60 mil EPDM membrane over wood fiber coverboard over polyisocyanurate over a wood deck.

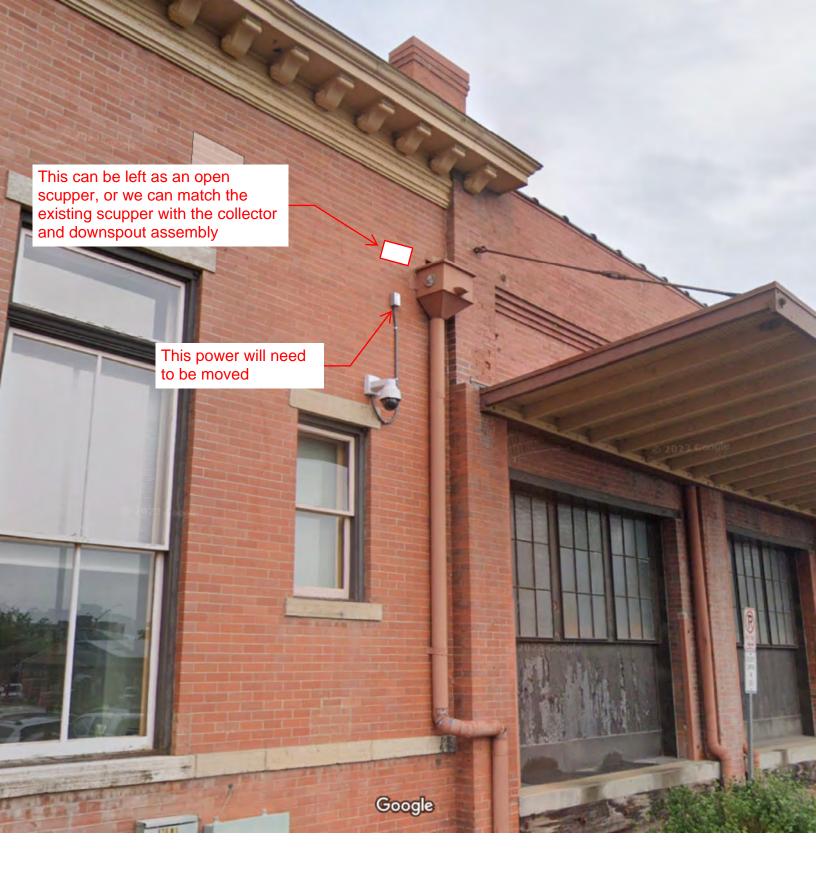
Attached is a picture of what the existing scupper looks like with a rough sketch of what would be added. I've also attached some additional photos of the roof and the inside face of the parapet wall – this is where all the deteriorated brick is located. When repairing the existing masonry we would use a standard N type mortar mix and try to match the look of the existing mortar as closely as possible. I also don't foresee us parging the interior face of the parapet wall as the roof assessment proposes.
