Evaluation of New Home Energy Efficiency

An assessment of the 1996 Fort Collins residential energy code and benchmark study of design, construction and performance for homes built between 1994 and 1999.

Summary Report

June 2002

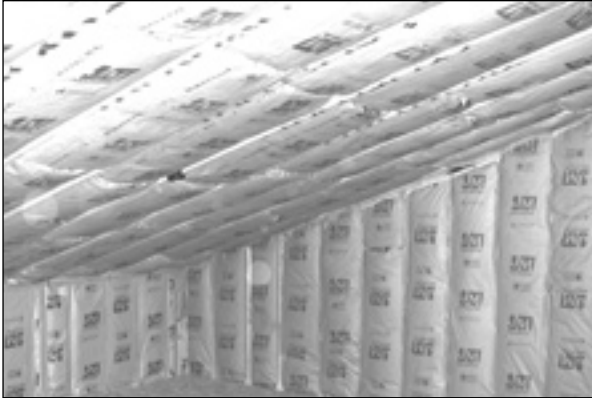
This is an example of effectively installed insulation that met code requirements. Batts filled the cavities, attained full loft, and will be in substantial contact with the wallboard.

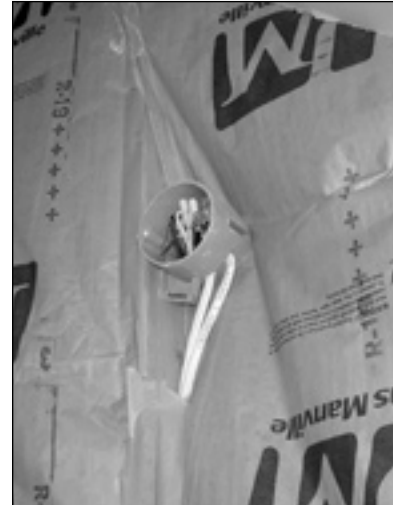
The code requires that insulation be cut to fit, without compression, around electrical and other obstructions in the insulated bay. In this case, insulation was compressed behind the box rather than cut to fit around it.

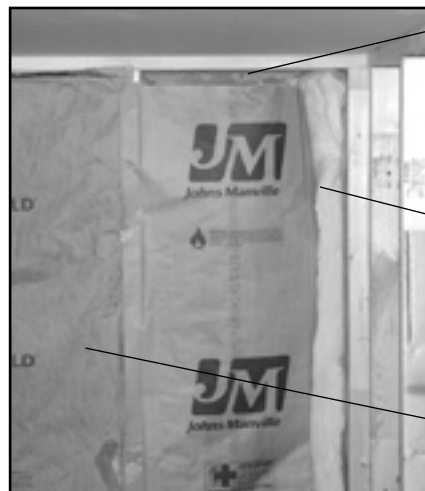
One-inch void at top of wall cavity

Batt folded rather than cut to width in non-standard-width cavity. This compressed the batt and caused air gaps

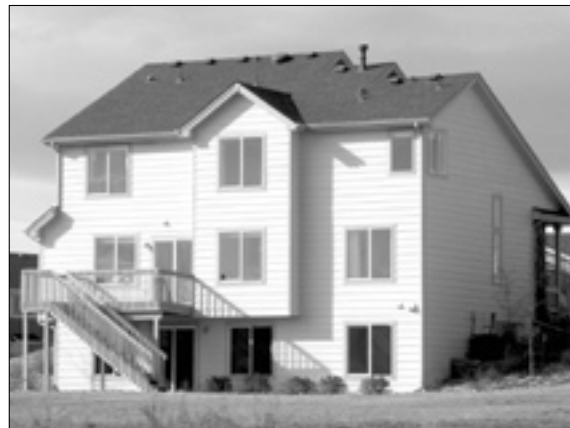
Some study homes had a lot of south-facing glass area, offering the potential for great passive solar performance. However none were designed to take advantage of the solar heat during the winter (by storing the heat) or to avoid the sun during the summer (with exterior shading). During the winter, these homes tended to have large temperature variations from one part of the house to another.

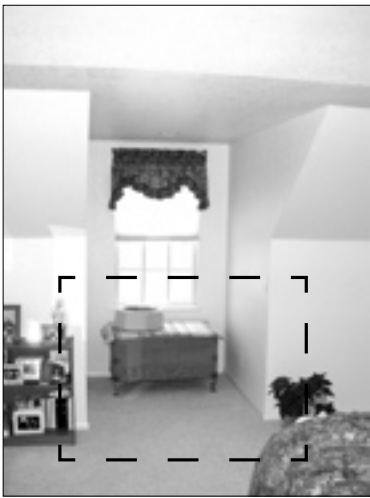
The upper level dormers and cantilever floor in the house shown above posed air sealing and insulation challenges. From the interior (conventional photo lower left, infrared photo lower right), thermal flaws showed up as cold spots (dark). These can cause discomfort and provide opportunities for moisture condensation, mildew and mold growth. The owners of this house complained that the dormers were so cold that they could not use these areas during the winter.

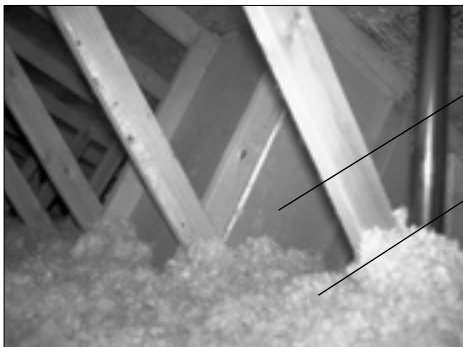
Uninsulated skylight well

Uninsulated components, such as this skylight well, were occasionally observed.

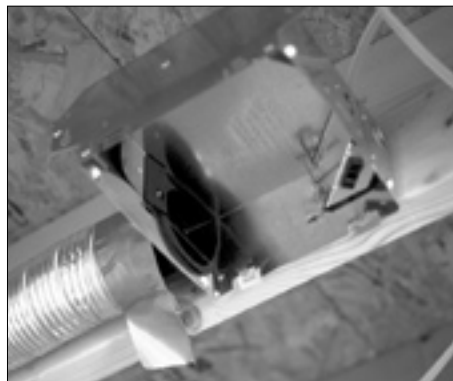
The duct venting this bath fan outdoors was only tenuously attached by tape to the fan housing. After wallboard was installed, there was no way to check or fix this connection.

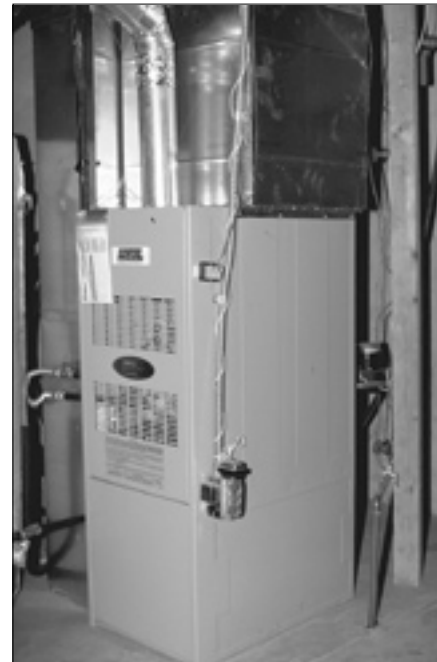
About one-quarter of study home furnaces operated near or outside of manufacturers' limits for pressure and heat rise.

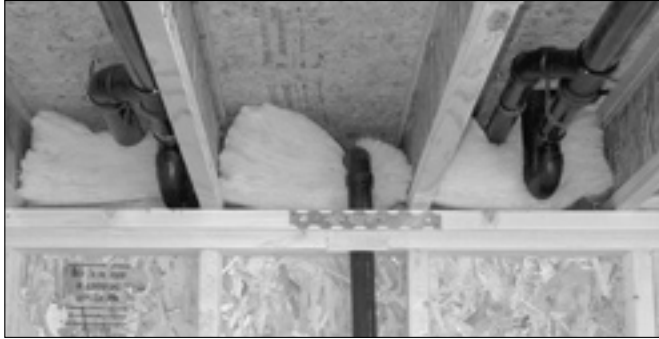
Compression of the insulation batts, voids, and the lack of contact with the subfloor above this cantilever all reduce the effective R-value of this insulation.

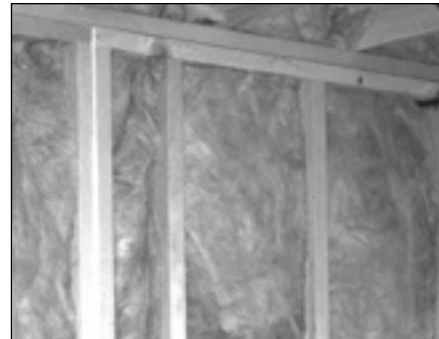
Typically-installed, unfaced fiberglass batts in a frame wall will offer reasonable performance. Note some compression of the batts in the full-width stud bays and more severe problems where a batt had to be cut to fit in a narrow cavity.

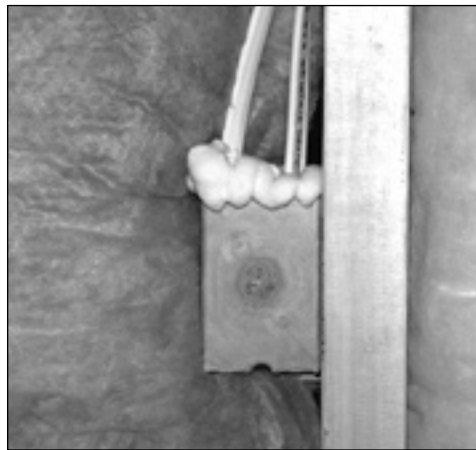
Fiberglass batts were often improperly fit around obstructions like this electrical box, creating cold spots. (This is the back of the box; code requires a minimum of R-5 insulation behind such obstructions.)

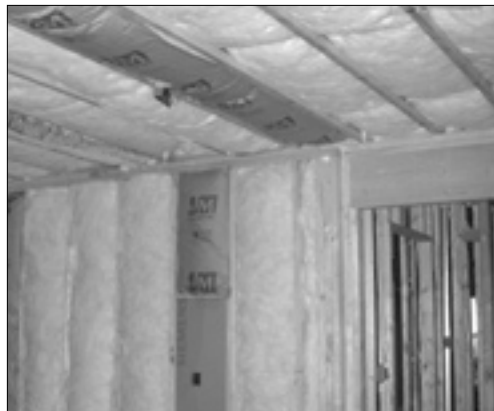
In floors over garages, R-30 batts exceeded code R-value requirements but were easier to install effectively because they were thick enough to fill the floor joist cavity completely.

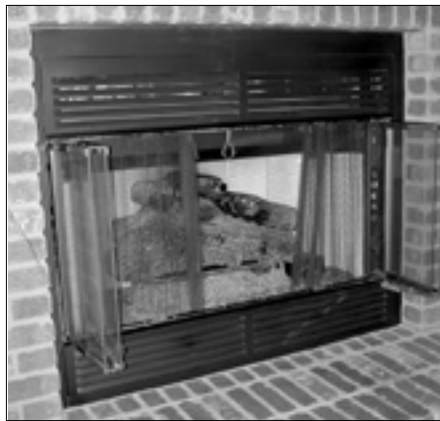
The flue, draft hood and outdoor air supply all contributed to leakage through atmospherically vented fireplaces.

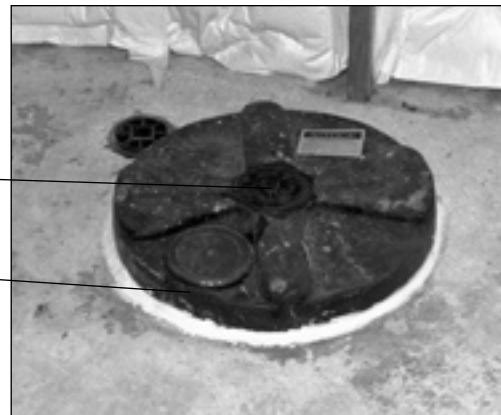
Open hole
No sealing at perimeter of cover

When air is drawn through an unsealed sump cover, it might bring with it radon, other soil gases or moisture.

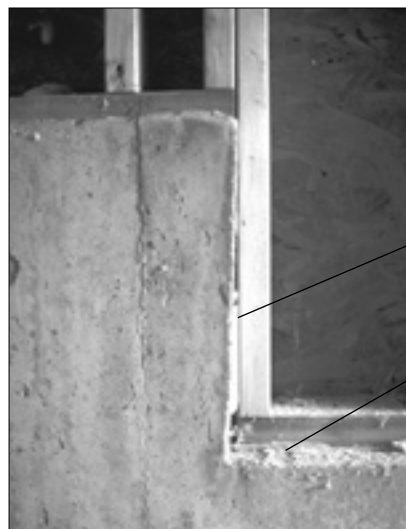
Horizontal joints between the foundation and mudsill were usually effectively sealed, but the vertical sections on a stepped foundation rarely were. In an unfinished basement, such a joint leaks directly to the outdoors.

No sealant
“Sill seal”

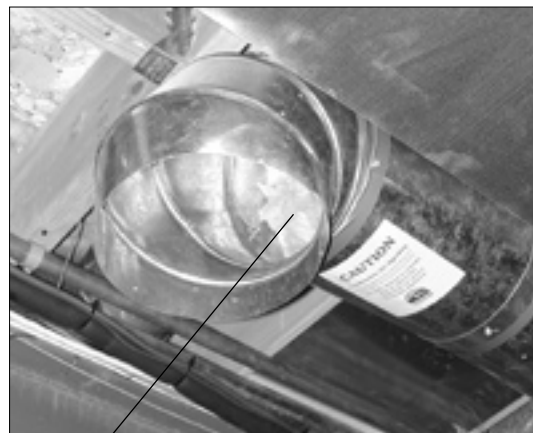
Code-required combustion air ducts, such as the one shown above, are direct openings to outside. An infrared photo of the same area (above right) demonstrates a typical winter problem: cold air is continually drawn in to replace air lost through other cracks and holes high in the house. This phenomenon contributed to cold basements and crawl spaces. In response, it was not unusual to see combustion air ducts plugged by homeowners—despite prominent labels warning against tampering with these safety devices.

Plug inserted by homeowner to stop cold draft

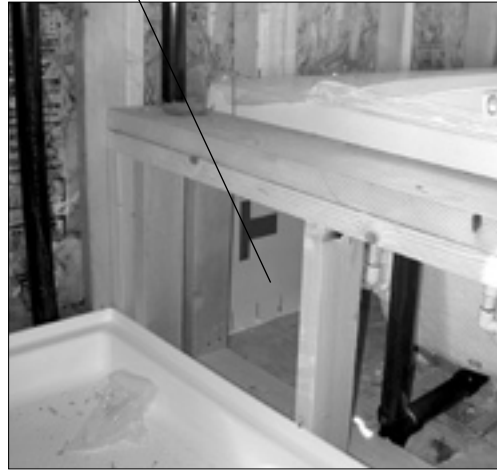
The solution is easy and inexpensive, but requires a change in construction sequence. The air barrier behind this tub was installed before the tub was set in place. This was observed in about half of the homes under construction.

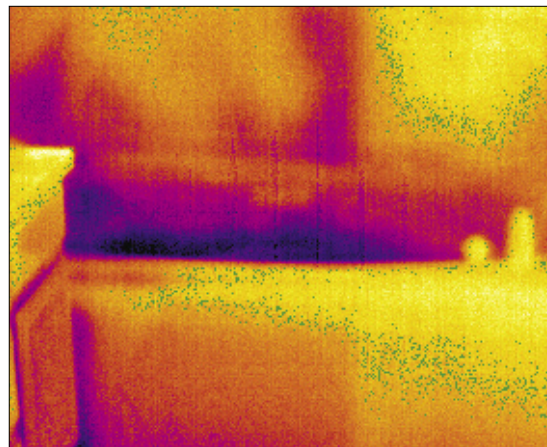
The infrared photo above shows the symptom of a missing air barrier: a cold tub. This bathtub sat against two exterior walls and over a garage. Cold outdoor air moved through or around the insulation to cool the tub. (Infrared photo taken with blower door operating.)

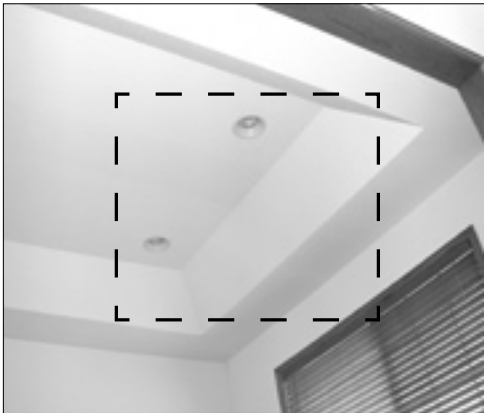
In the house shown at right, a portion of the air barrier that should isolate interior space from the porch roof was missing. As seen from the interior (conventional photo lower left, infrared photo lower right), cold air could enter the house through the joist cavity between main and upper levels. Cooling effects of this leak extended into interior partition walls at the core of the house. (Infrared photo taken with blower door operating.)

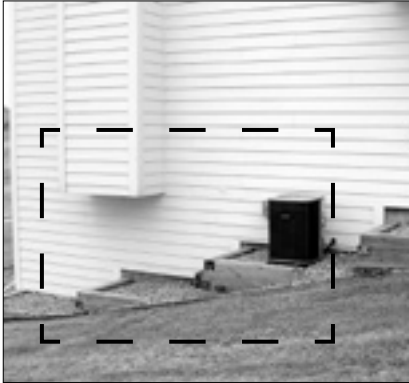
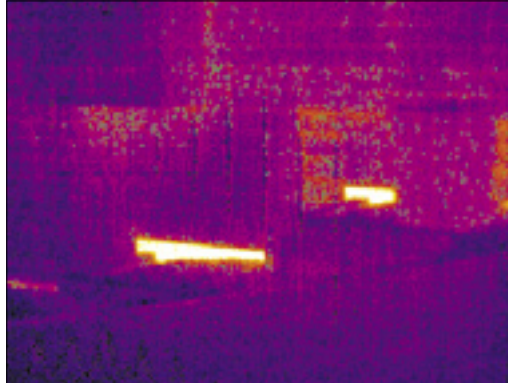
Uninsulated. Strips of concrete exposed above grade in this stepped foundation stood out as hot spots compared with the insulated frame wall and earth. Eight inches of concrete provide only about R-1 resistance to heat flow.

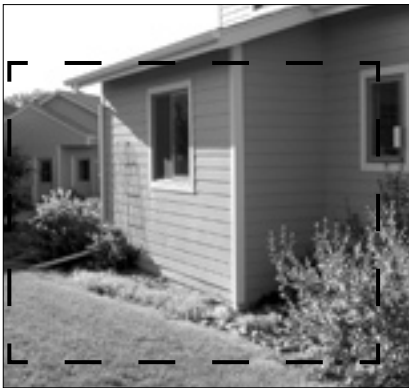
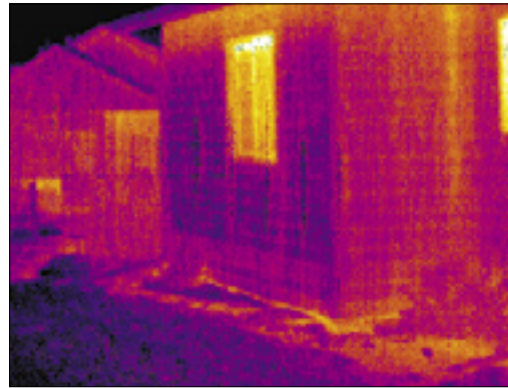
Insulated. In this house, the exposed portion of the foundation was not significantly warmer than the adjoining wall and earth.

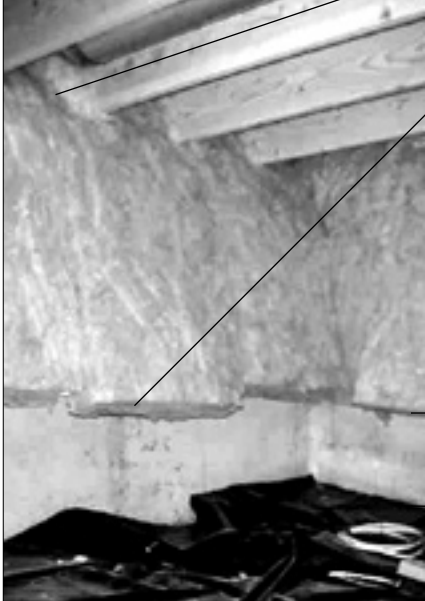
Insulation was compressed where it attached to the rim joist.

The batts hung away from the foundation by as much as 6 inches, allowing warm crawl space air to bypass the insulation.

Batts hung 18 to 24 inches short of the interior grade.

Although the code-required R-19 perimeter insulation was present in this crawl space, the rated R-value was compromised by installation flaws.

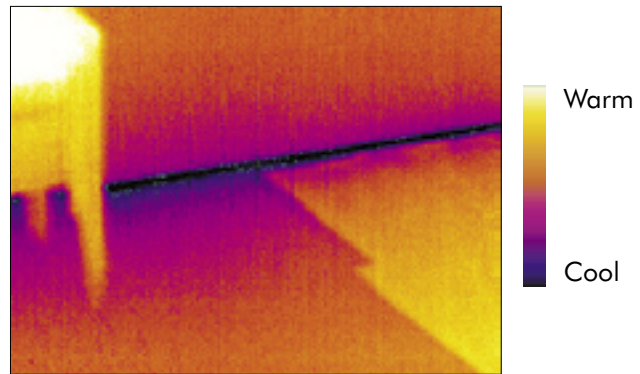
The on-grade slab edge of this walkout basement had no perimeter insulation. As can be seen in the infrared photo (right), the temperature of the slab dropped toward the edge. This translated into heat loss, cold floors and the potential for condensation.

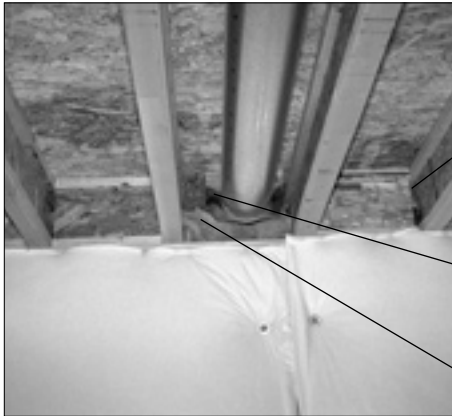
Rectangular blocking coupled with engineered "I-beam" joists left large gaps at the edges.

Blocking was removed where the heating duct penetrated the cantilever.

Insulation only filled part of the cavity.

Interior view of some cantilever problems. It is not clear whether the air barrier was intended to be at the interior blocking or at the exterior soffit.

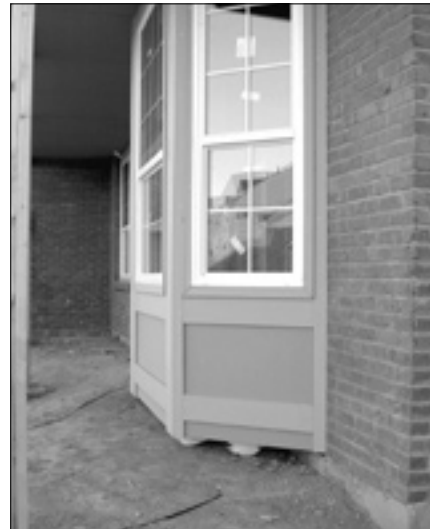
Main level cantilevers posed access challenges because they were so close to grade. There was no soffit on this one. The construction superintendent was aware of the problem and planned to dig a hole to be able to install it.

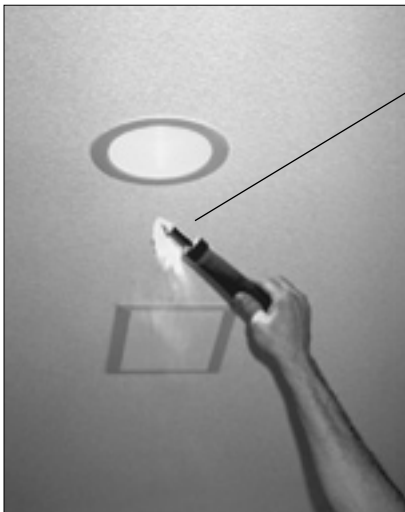
Smoke source made air movement visible.

Blower door tests often revealed large amounts of air leaking through recessed lighting located in floors with heated space above and below. This could be a symptom of leaks in the air barrier at an exterior cantilever; air moved through the floor joist cavities to exit at the light cans.

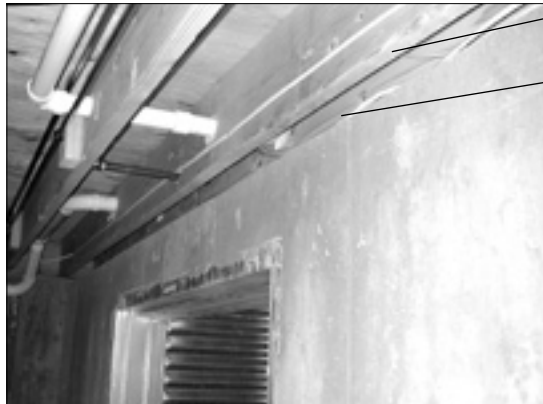
When the first floor joist was framed tight to the foundation, it left little space to insulate the rim joist. Plumbing and wiring complicated the job in this example.

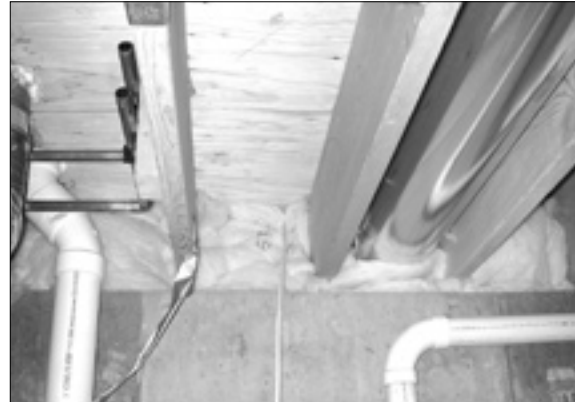
Many obstructions—such as the plumbing and ductwork shown here—made it harder to insulate rim joists effectively. Even where nothing was in the way, insulation was sometimes placed in cavities with insufficient attention to detail. Also note there was no vapor barrier to prevent moisture from reaching the rim joist.

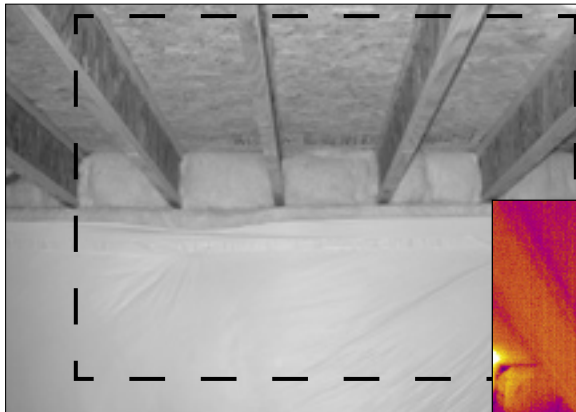
The infrared photo (right) shows the symptoms of compressed insulation and air leakage at the rim joist.

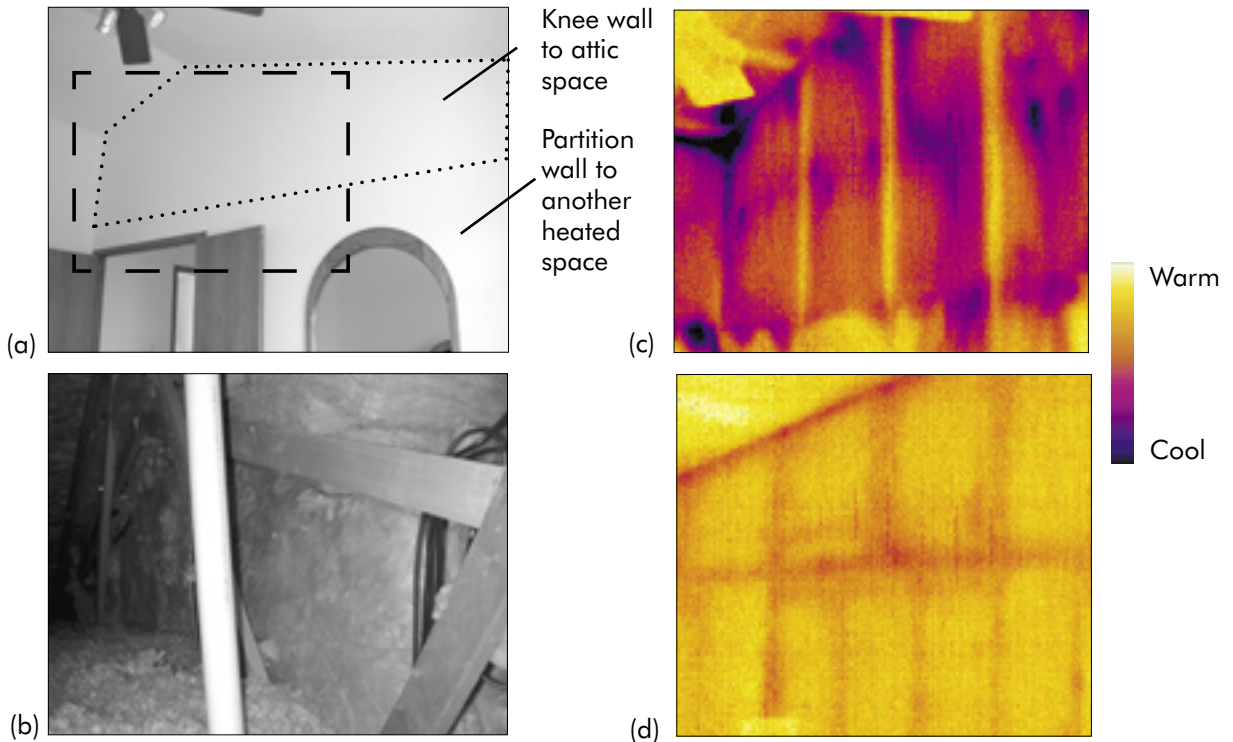
This group of photos illustrates kneewall practices and performance. Photos (a) and (b) show two views of the same kneewall. From the attic (b), the knee wall insulation appeared to be installed well. But there was a large air gap between the insulation batt and wallboard. There was also no sheathing on the attic side. There was nothing to prevent attic air from circulating and pulling heat from the gap between the insulation and wallboard. Infrared photo (c) shows an irregular temperature pattern reflecting the inconsistent thermal performance of the knee wall insulation. Note the framing was warmer than the cavities. For comparison, photo (d) shows an exterior wall in the same room. It displayed the more uniform temperature pattern of a well-insulated wall; framing was cooler than the insulated cavities.

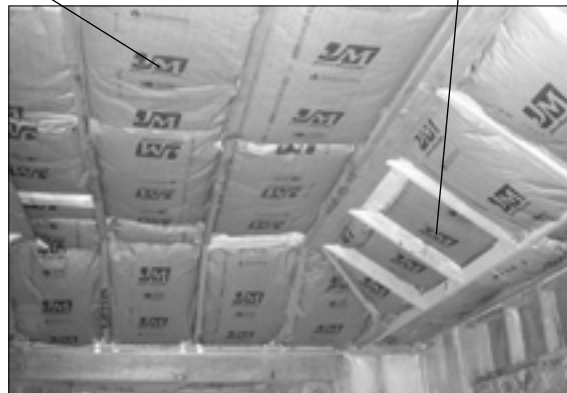
On the flat section, insulation will generally be in "substantial contact" with the wallboard (as code requires), despite small channels along the edges of each joist bay where the batts were inset stapled to the joists.

In some areas, the insulation was held back much further. This will leave gaps in which attic air can circulate between insulation and wallboard.

Vaulted and cathedral ceilings tended to have more insulation installation problems than flat ceilings.

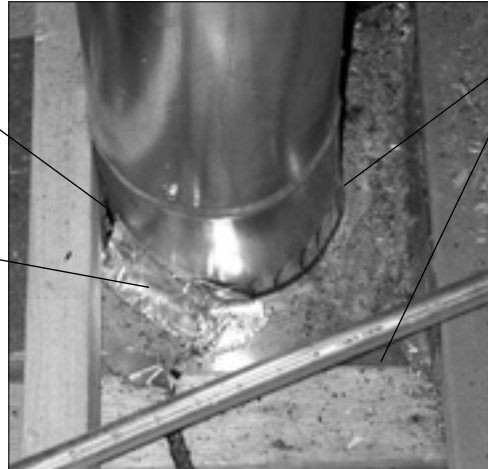
Significant gap where access to seal was difficult

Tape is a temporary seal that will probably fail in a few years.

These joints should have been fully sealed with long-lasting caulk.

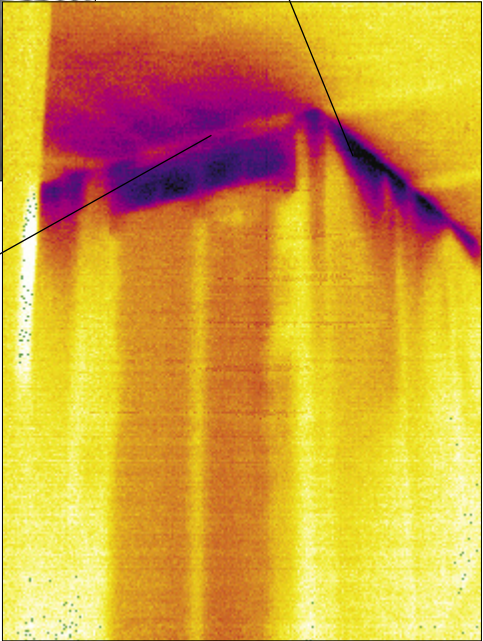
Air leaks through gaps between wallboard and framing. These gaps are skinny (1/16" to 1/8" typical) but extend many lineal feet.

Blocking above return grille and wall cavity return was very leaky

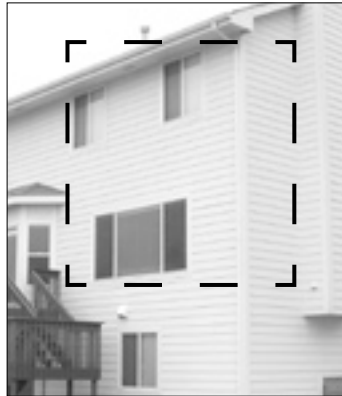
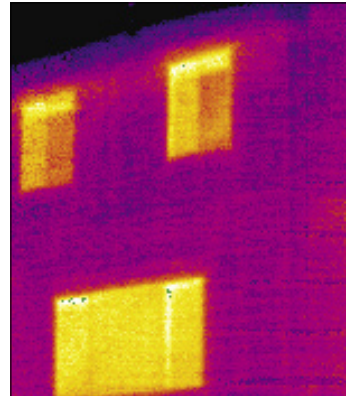
Conventional double-paned windows with wood or vinyl frames have an insulating value of about R-2, compared with a 2x4 framed wall insulated with R-13. In the infrared photo (right), windows showed up as thermal “holes” in the shell of the home.

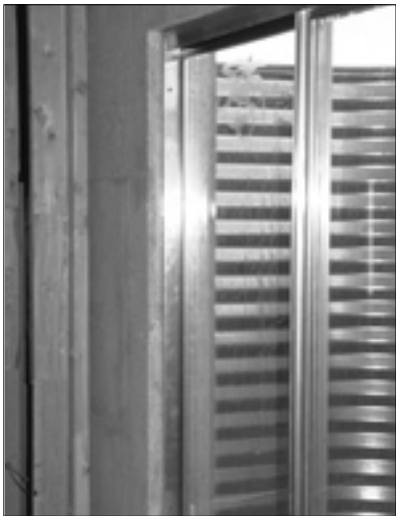
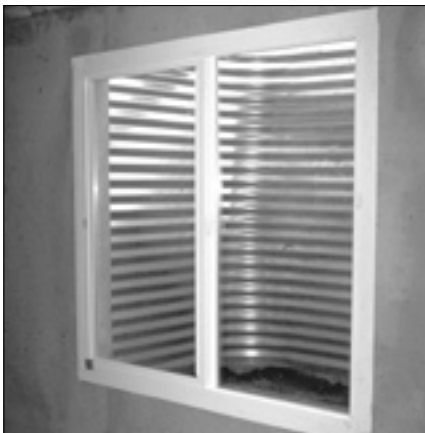
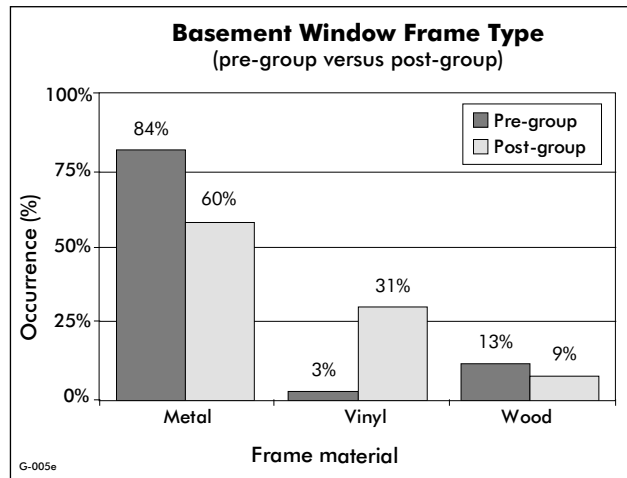
The majority of study home basement windows used metal frames. However, there was a significant increase in the use of vinyl-framed windows in post-group homes.

An aluminum frame with no thermal break, set into a steel buck poured in place with the concrete foundation (above left), offered the lowest up-front cost, yet delivered the poorest thermal performance. The use of a vinyl frame, also set into a steel buck (left), offered one step better performance.

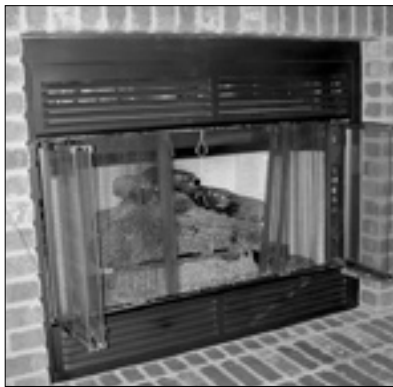
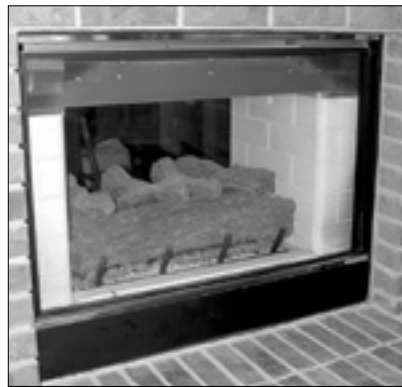
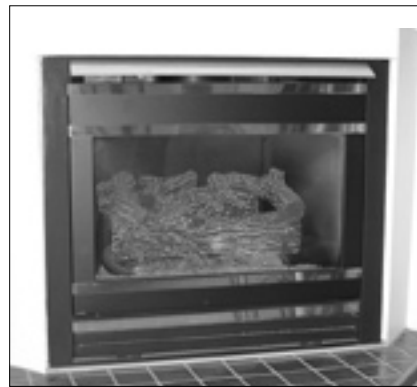
Three types of natural gas fireplaces were observed in study homes: atmospheric gas log sets with operable glass doors (left), atmospheric fireplaces with solid glass facades (center), and direct-vent units (right). The atmospheric units rely largely on house air for combustion and dilution air, whereas the direct-vent units draw all required air directly from outdoors.

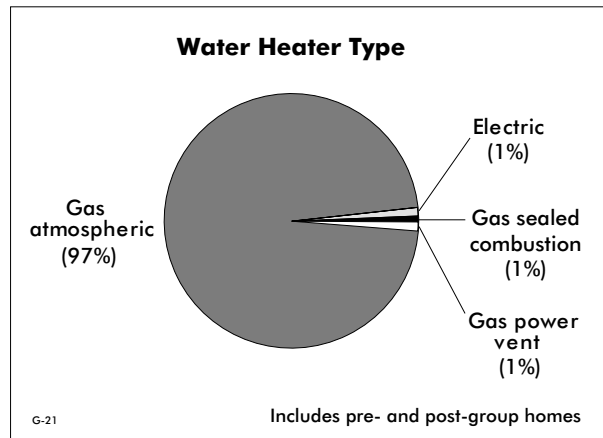
About 80% of post-group homes had no provisions to control standby heat losses from the piping in the vicinity of the water heater. This was a code violation.

Gas-fired, atmospheric water heaters were the norm, raising concerns about combustion safety.

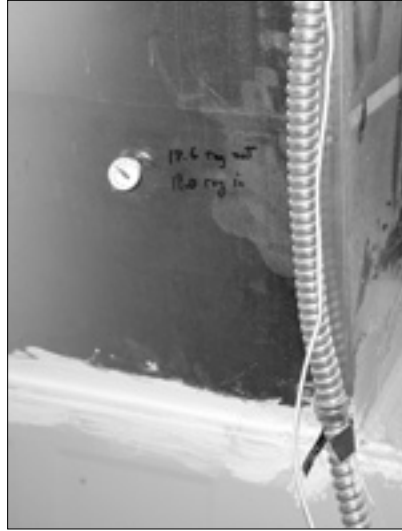
The only way to know whether a furnace is operating within the manufacturer-specified heat rise range is to measure heat rise. This test requires minimal tools and time. The testing contractor saw no evidence that heat rise had been measured on study home furnaces.

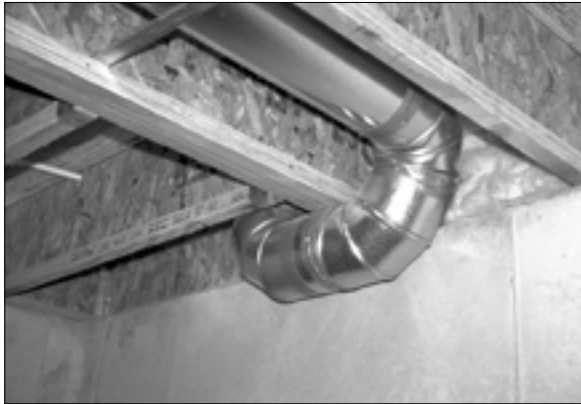
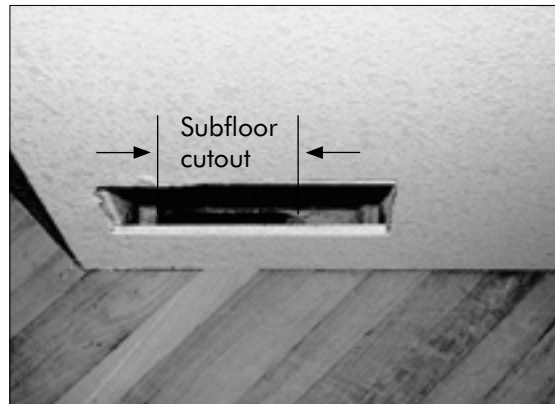
Air flow was sometimes reduced by constrictions or “choke points” at certain places in the ductwork. In the left photo, three elbows were needed to get a supply run past a structural member that could not be breached. Each elbow was equivalent to several feet of straight ductwork. The connection was made, but air flow was compromised due to large pressure drop. In the right photo, the cutout in the subfloor—that provides a path for return air back to the air handler—was much smaller than the register cutout on the wall.

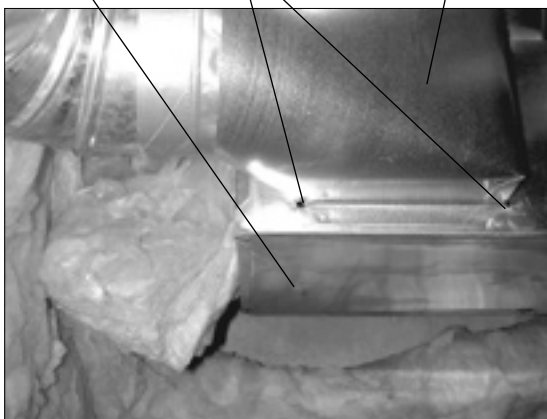
This joint between a takeoff fitting and a plenum is an example of small supply duct leaks. Some takeoffs were much leakier.

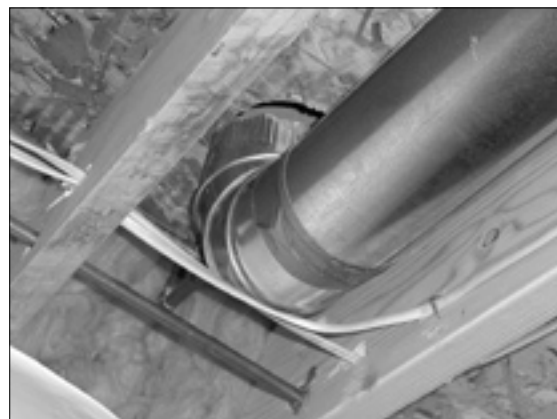
This supply duct was never connected to anything on the top end. Carpet was laid over the subfloor cutout, and the register was never installed.

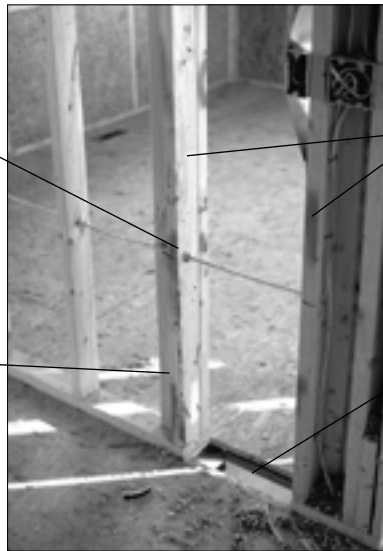
Wiring penetrations will be small leaks.

The cavity will leak everywhere there is a joint between wallboard and framing.

These wall studs formed two sides of a return duct. Wallboard will complete the other two sides.

Return air will be drawn through this cutout on its way back to the air handler.

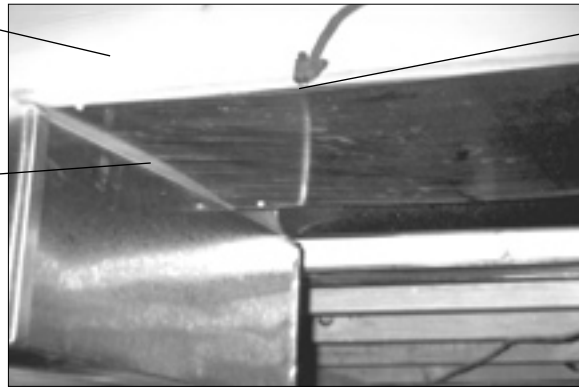
Return air was pulled through this joist cavity.

Leaky joints between sheet metal plenums and floor cavity returns

Panning did not seal to the framing.

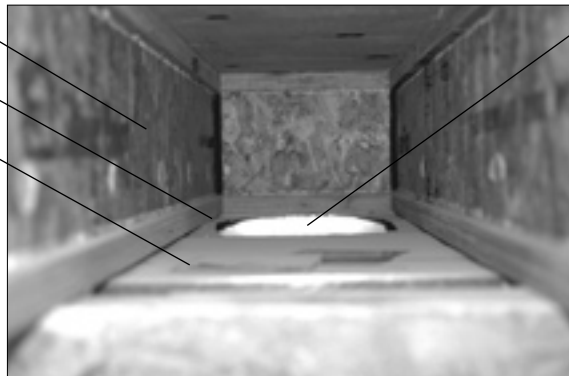
Large, unused cutout

Sometimes individual leaks were large. This sheet metal return plenum was cut open to pull air from the floor joist cavity. The return run was then moved to an adjoining cavity, but this 12" x 15" cutout was never sealed.

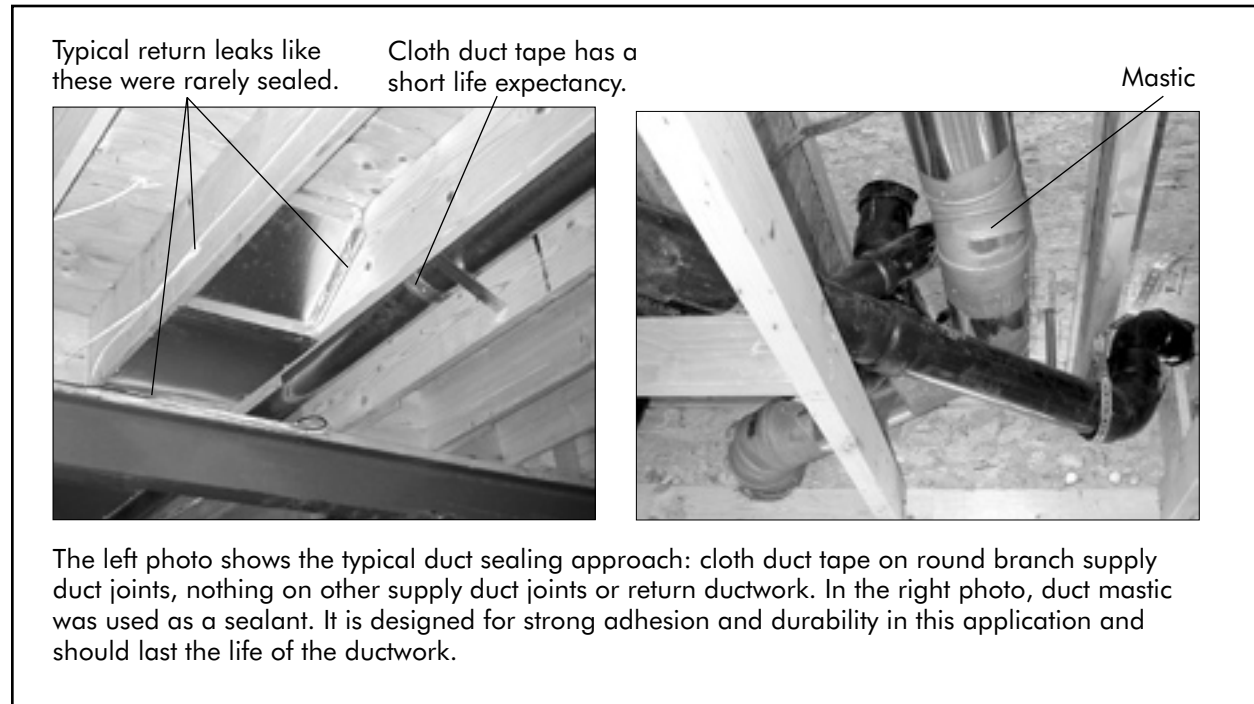
In almost all study homes, cloth duct tape was used to seal portions of the supply ductwork; in a small number of post-group homes, foil tape and/or duct mastic were used instead. In almost all homes, no sealing was observed in the rest of the system, either on the supply side or return side. The return portions of duct systems were inherently difficult to seal because of the extensive reliance on building cavities rather than dedicated sheet-metal ductwork.

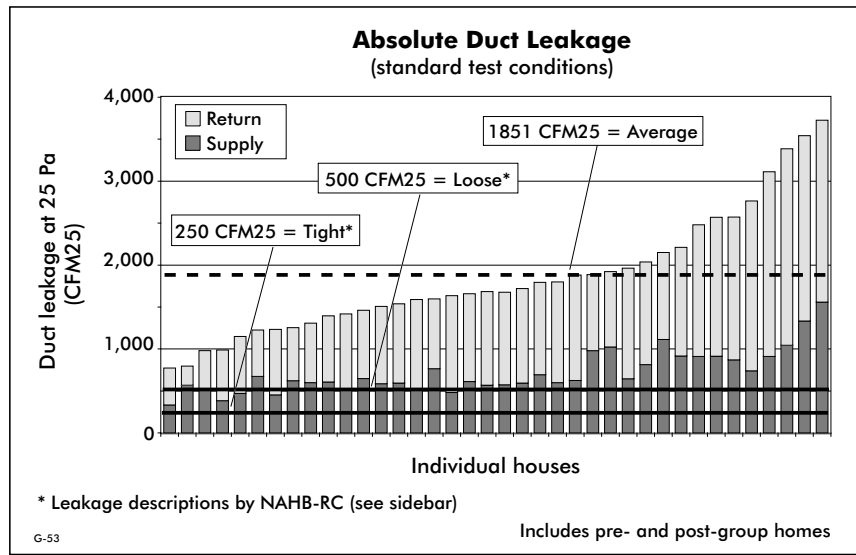
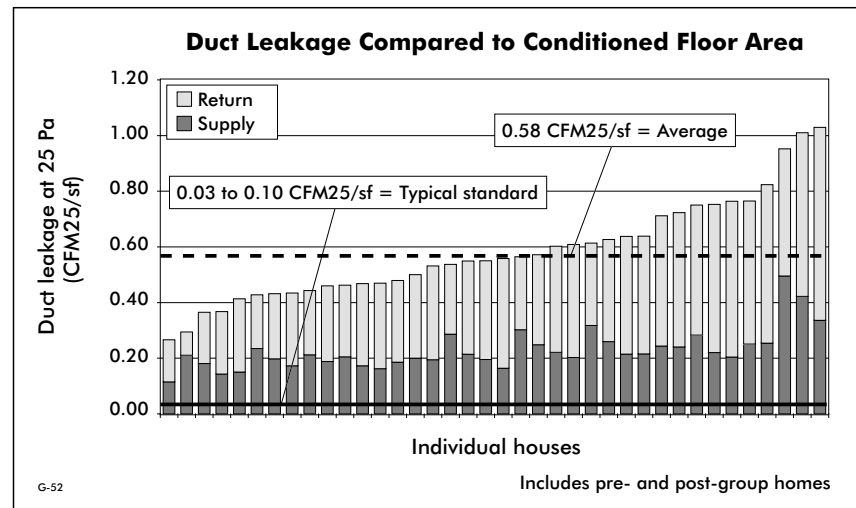
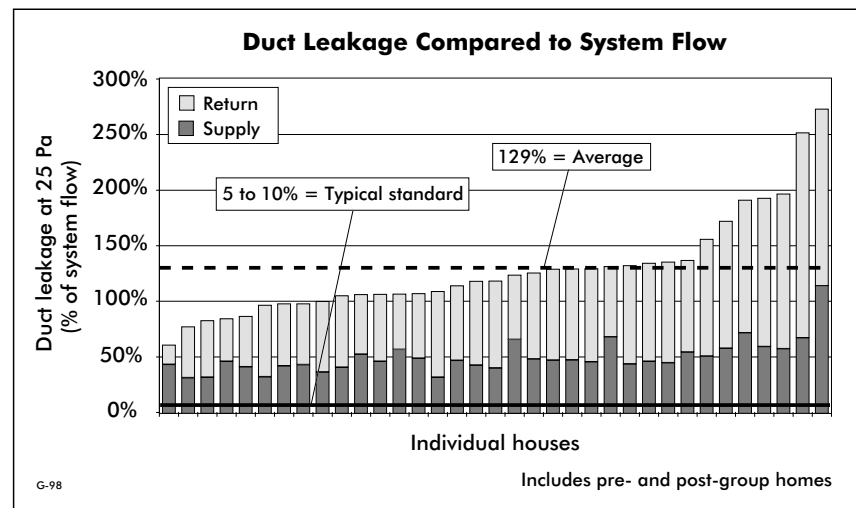
Measured duct leakage was very large in every tested home. The graphs present leakage results using three different units and compare leakage against representative standards (see sidebar on previous page). Depending on the specific unit and standard chosen, the average study home ductwork was six to 25 times leakier than the standards.

These graphs show measured duct leakage in absolute units (top), leakage compared to the size of the house (middle) and leakage compared with system air flow (bottom). Standards used elsewhere are shown for reference.

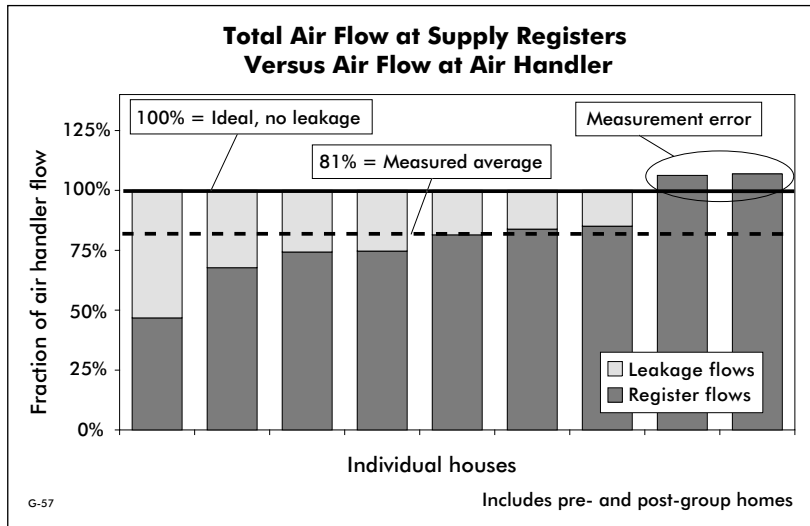
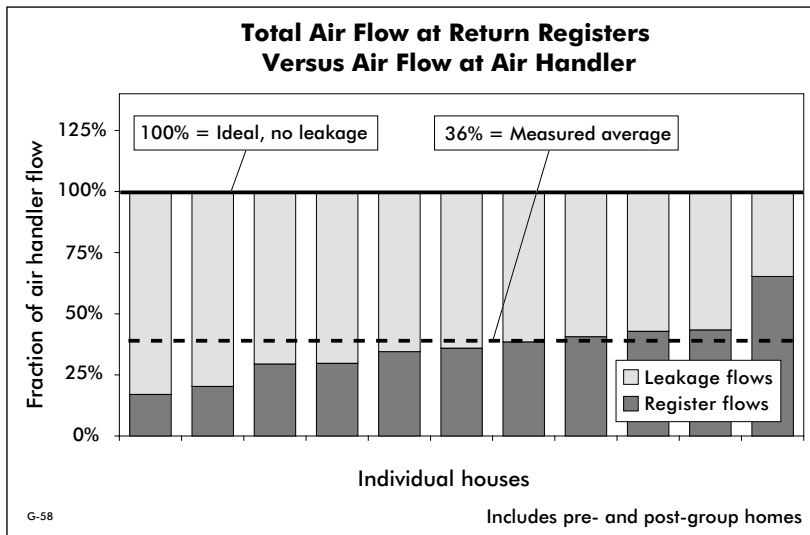
Comparison of air flows at registers versus the flow through the air handler provided further evidence of the magnitude of duct leakage.

In a subset of homes, air flows were measured at each register. The total of the individual register flows was compared with the measured flow through the air handler. On average, about 80% of the flow through the air handler reached supply registers, while only about one-third of the air handler flow was drawn from return registers (the balances were made up via leakage).

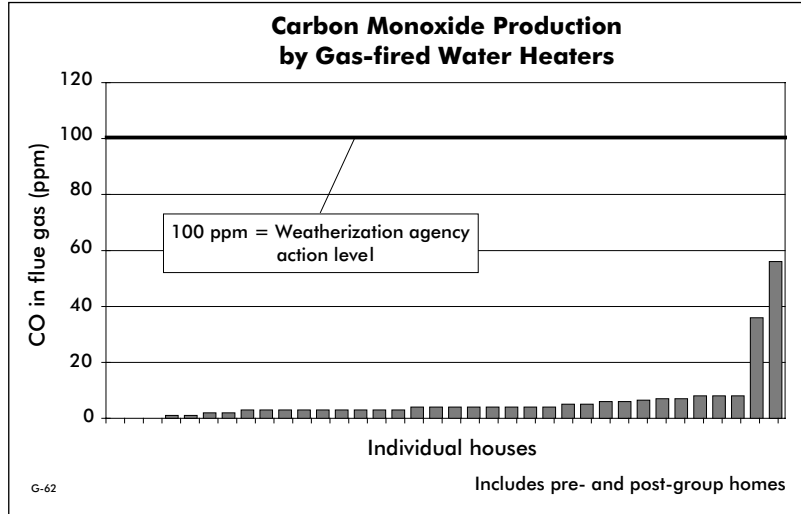
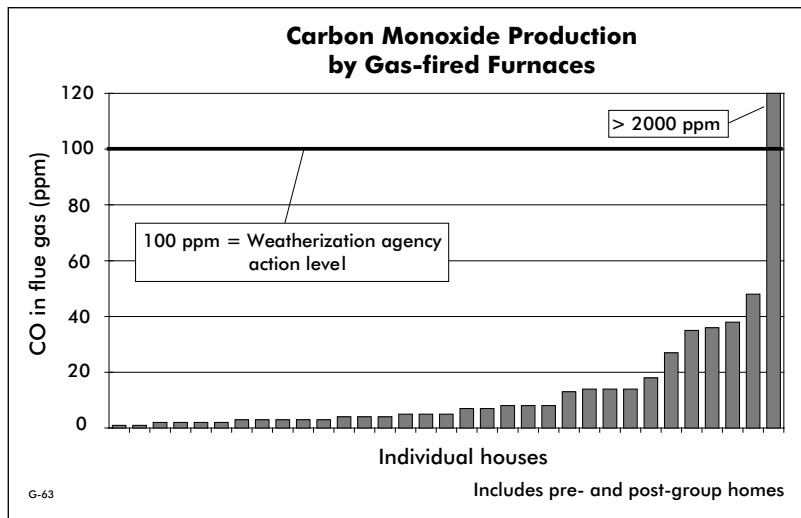
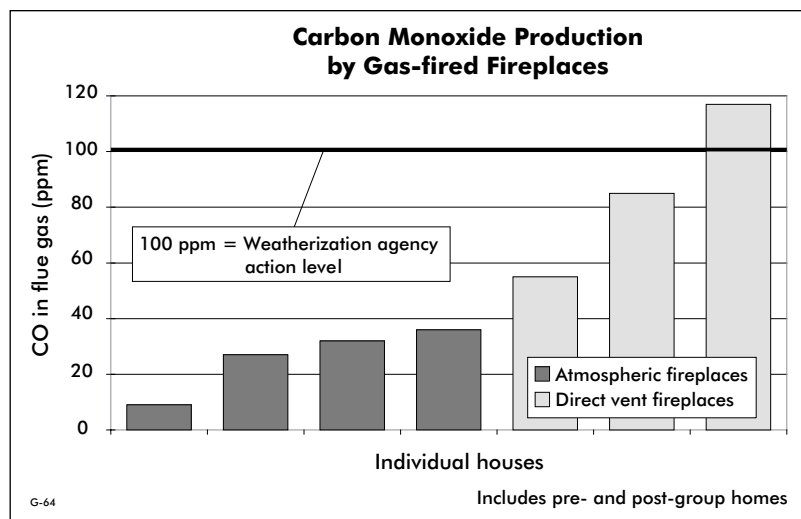
Under normal operating conditions, carbon monoxide production by most water heaters, furnaces and fireplaces was well below levels of concern. A few units stood out with higher carbon monoxide levels. Note that water heaters, furnaces and fireplaces are all vented to outdoors.

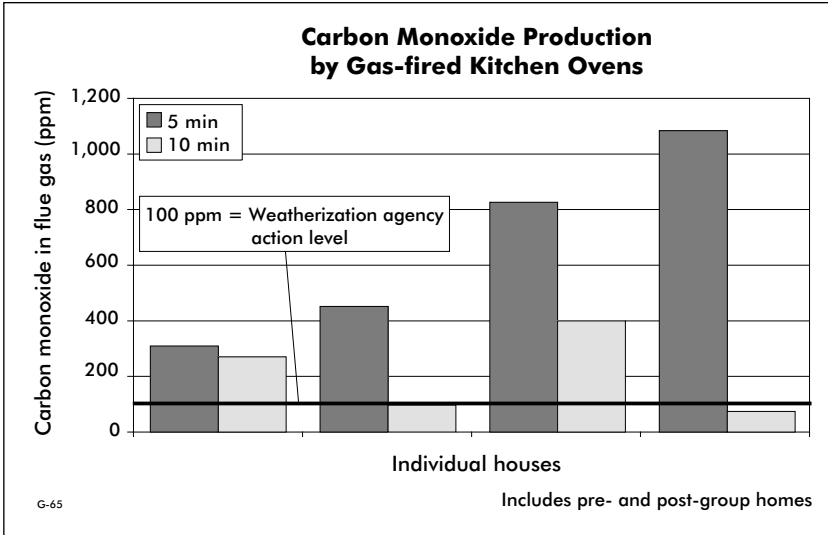
Carbon monoxide production by gas ovens was highest in the first few minutes of operation. After the burner had been on for 10 minutes, carbon monoxide levels had dropped significantly yet remained high enough to be a concern in three of four units. Note that all combustion products from gas ovens were exhausted into the houses and that only one in 11 study homes with gas ovens had a vented range hood.

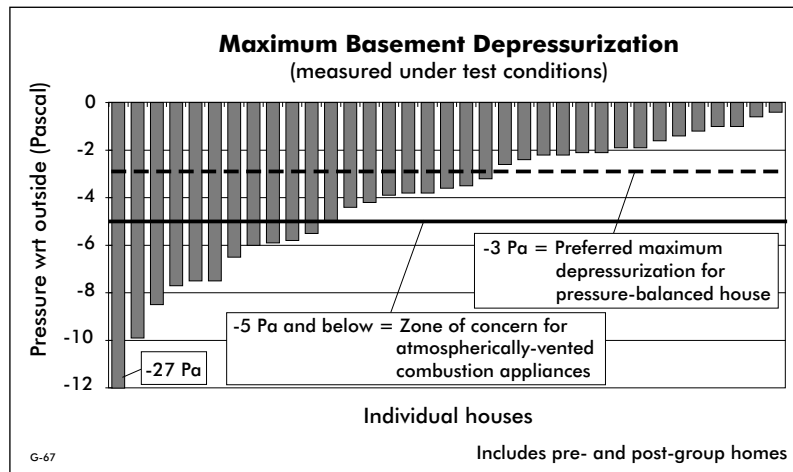
Under test conditions, all basements were depressurized with respect to outdoors. These negative pressures were of the same order of magnitude as the measured draft pressures in water heater and furnace flues, raising concerns about the abilities of these appliances to successfully remove combustion products from the house.

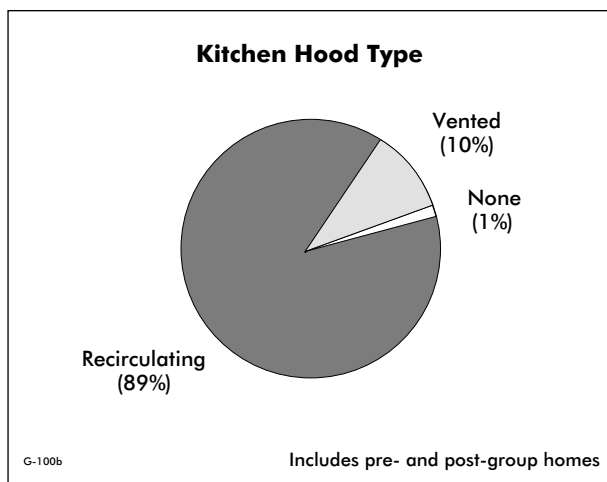
Few homes had vented hoods, even when gas ovens were present. A recirculating range hood coupled with an over-the-stove microwave oven was typical. This type of hood provided some degree of filtration but did not exhaust pollutants outdoors.

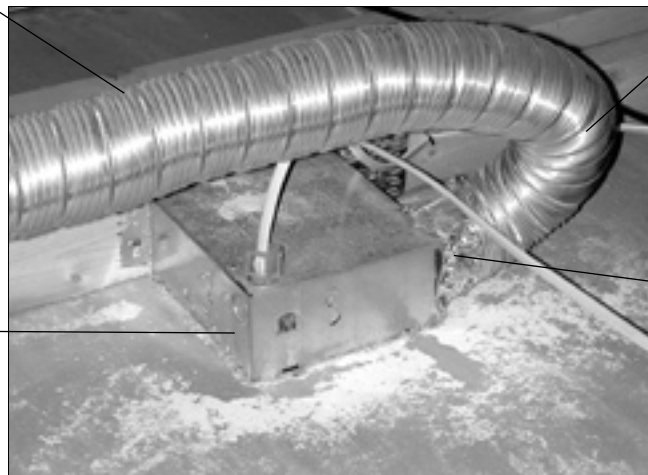
The fans were all low-cost units that garnered many noise complaints.

The tape that connected the duct to the fan housing had almost completely failed even before the attic was insulated.

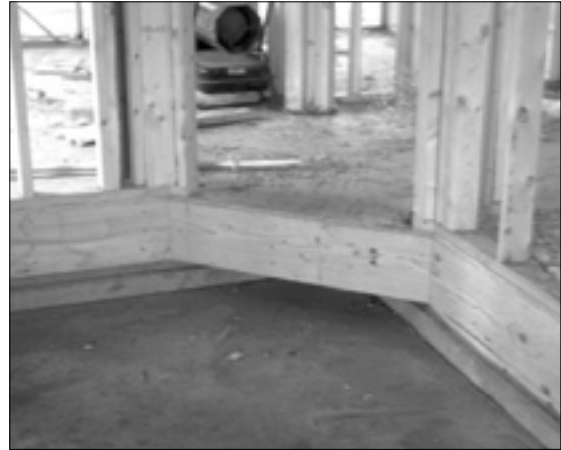
Many holes were observed between garages and houses, providing pathways for garage pollutants to move into the living spaces. This corner cantilever was liable to be a big leak because it was difficult to access to seal.

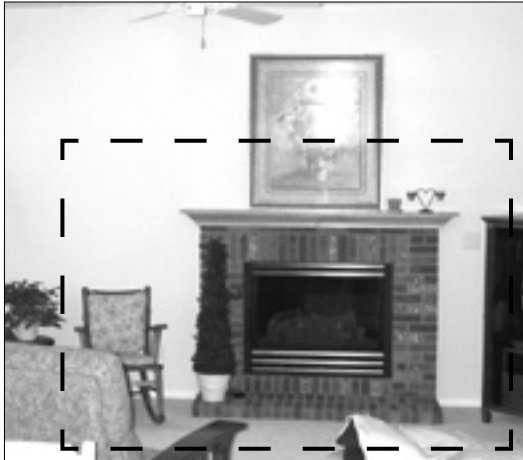
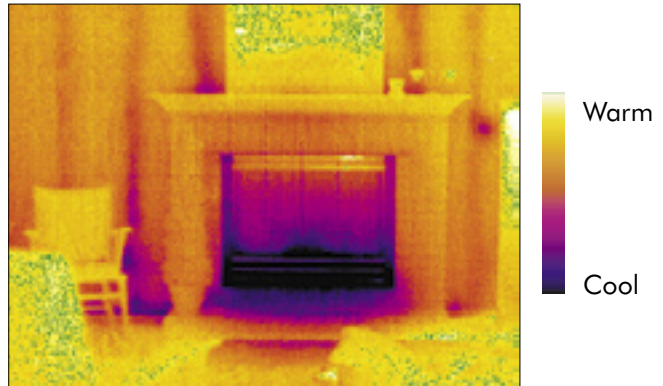
The owners of this house complained about drafts that made their living room uncomfortably cold. The infrared photo (right) shows the cold air that leaked around the fireplace unit. (This was a direct-vent fireplace, so there were no leaks between the room and the vent; all leakage was due to an incomplete air barrier in the cavity enclosing the unit.)

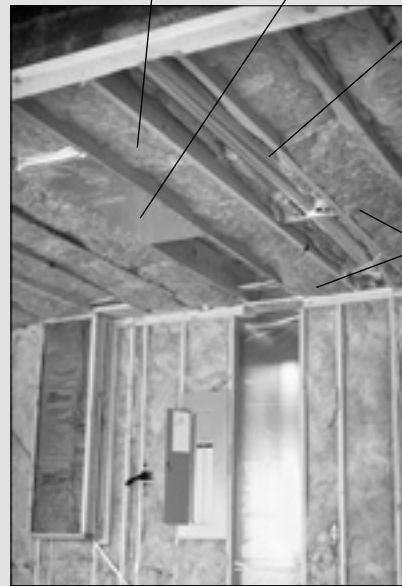
No insulation at return duct
 Six-inch thick, R-19 insulation supported insecurely against the subfloor in a deeper cavity
 Insulation difficult to install effectively around ductwork

Insulation has drooped away from floor above, leaving air space between them.

Flaws in floors built over garages contributed to poor comfort in living spaces above.
