Evaluation of New Home Energy Efficiency

An assessment of the 1996 Fort Collins residential energy code and benchmark study of design, construction and performance for homes built between 1994 and 1999.

Summary Report

June 2002

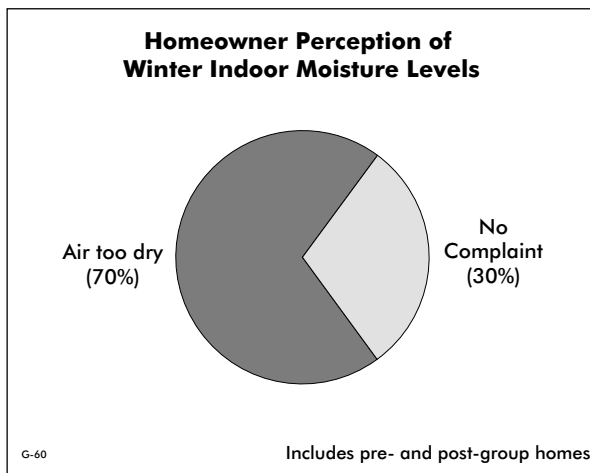
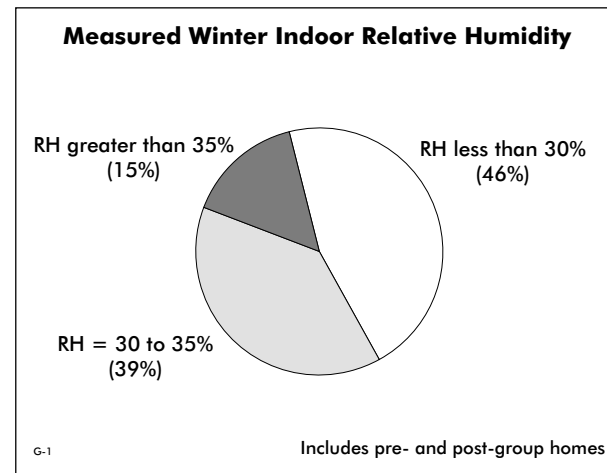
Dry indoor air during the winter was a common comfort complaint, borne out by humidity measurements.

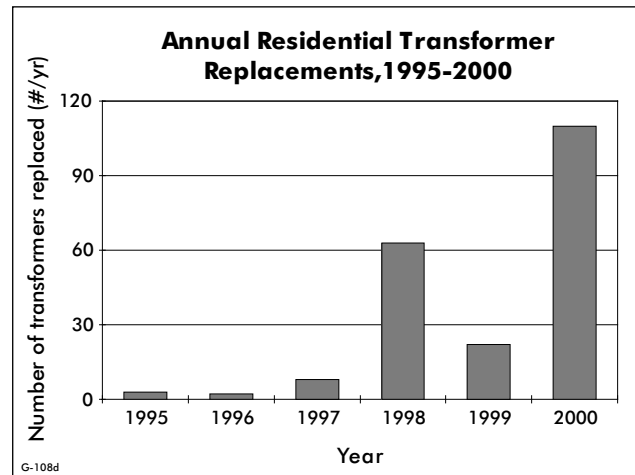
The graph shows the number of Fort Collins Utilities residential distribution transformers replaced each summer, beginning in 1995, due to overloading. Prior to 1998, a few transformers failed every summer, but the number was so small that it was not viewed as a significant issue. In the relatively hot summer of 1998, though, more than 60 transformers failed. Since then, the number

Larger homes and the increasing prevalence of residential air conditioning have caused the need to replace many distribution transformers since 1998. In response, Fort Collins Utilities increased transformer sizing criteria in 2001.

of failed transformers has remained high, varying in response to climate extremes.

Fort Collins Utilities staff responsible for planning and maintaining the electric distribution system attribute the increase in number of transformer replacements to a combination of larger homes with more electrical loads and the increasing prevalence of central AC. They believe—and the correlation with temperature supports—that AC is the largest factor.

Second, a program was established to preemptively replace transformers in neighborhoods with large AC loads with larger transformers, if loading indicators suggest the existing transformers are at risk of failure. Both changes have increased the cost of delivering power.

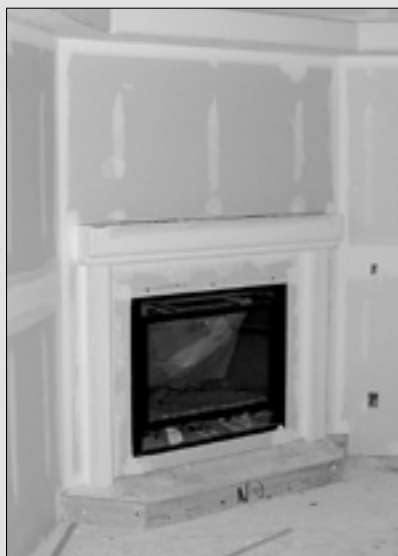
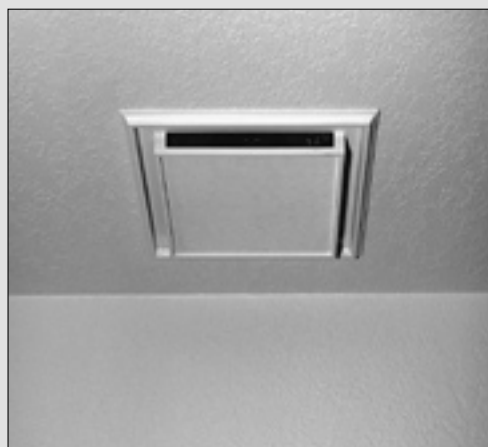
Many things are literally invisible behind the wallboard in a finished home: most of the framing, air sealing, wiring, plumbing, ductwork and insulation. For example, there is no way to see whether the insulation and air barrier were properly installed behind the fireplace or whether the bath fans were effectively vented.

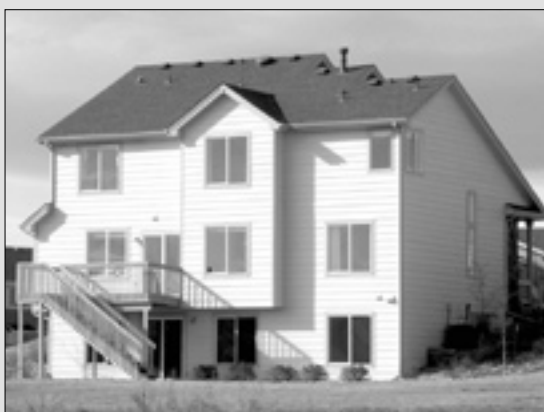
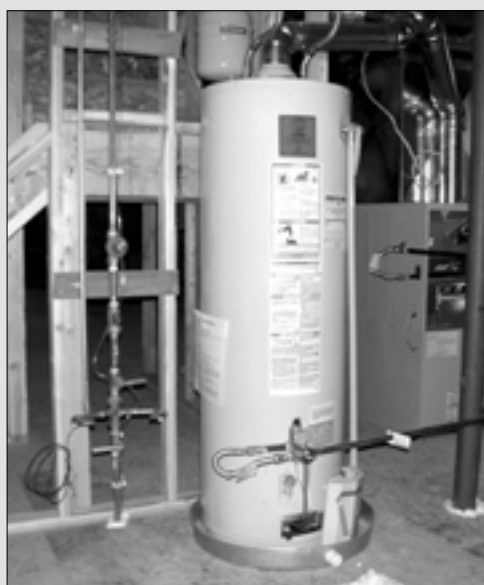
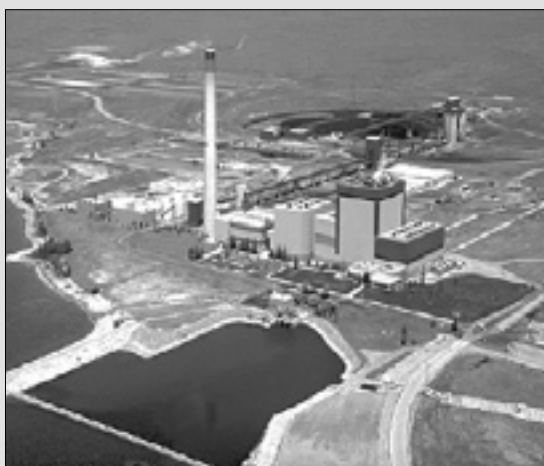
Many other aspects that are not hidden also receive little consideration in the purchase process. For example, little thought goes toward the type or solar orientation of windows, architectural features that need special attention, the efficiency or combustion safety of the water heater, or the impacts of design and construction decisions on the region's power supply needs.
