Lincoln Corridor Plan A Great Street for a Great Neighborhood Phase 1 - Vision Appendix A

TRANSPORTATION INVENTORY

Transportation Inventory

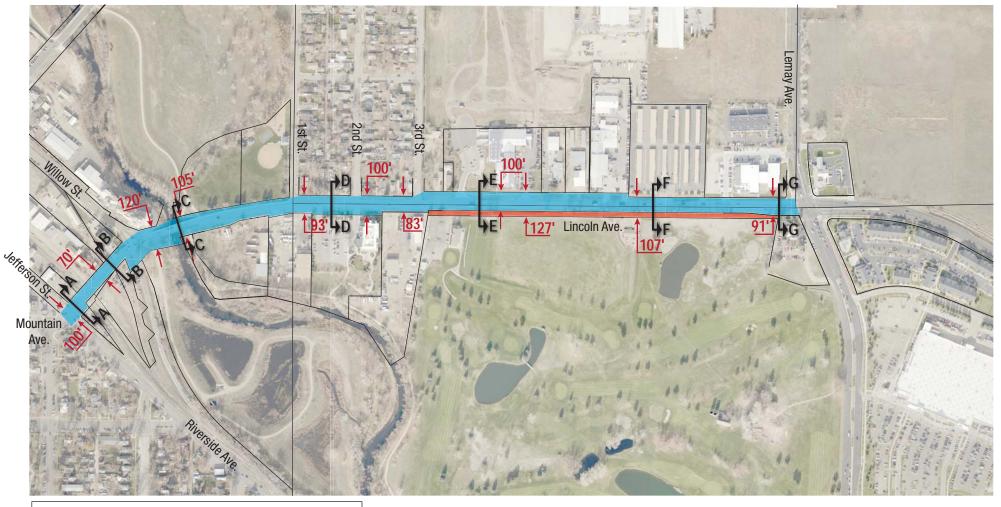
Figure 1. Right of Way and Cross-Section Locations

The existing ROW along Lincoln Avenue generally varies from 70 feet to about 100 feet. The Woodward Governor development will dedicate an additional 27 feet of ROW along the south edge of Lincoln Avenue between 3rd Street and just to the west of Lemay Avenue.

Existing Right-of-Way (ROW)

Cross Section Locations (refer to Figure 2A and 2B)

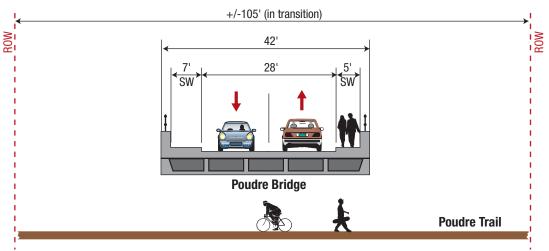
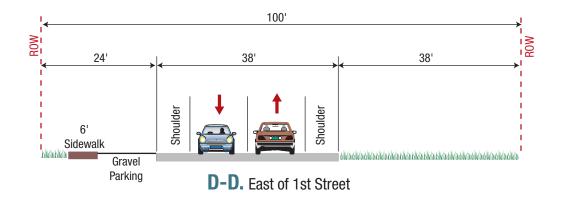
Figure 2A Cross-Sections

B-B. West of Willow Street and Union Pacific Railroad (East Tracks)

C-C. Poudre River Bridge and Bike Trail Underpass

All Cross-Sections are Looking East

Figure 2A & 2B. Cross-Sections

The Lincoln Avenue cross-section varies along the ¾ mile corridor. One vehicular travel lane in each direction and bike lanes exist along the length of the corridor; turn lanes are provided at the larger intersections with Jefferson Street/Riverside Avenue and Lemay Avenue. While curb and gutter are provided for short segments, most of the corridor has a more rural feel which includes the Coy Ditch along the Woodward Governor property.

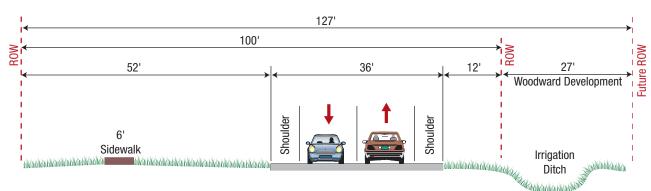
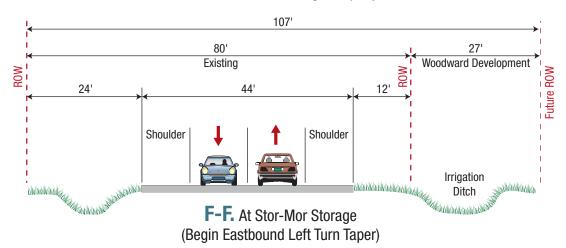
Figure 2B Cross-Sections

E-E. At Odell Brewing Company

G-G. West of Lemay Avenue

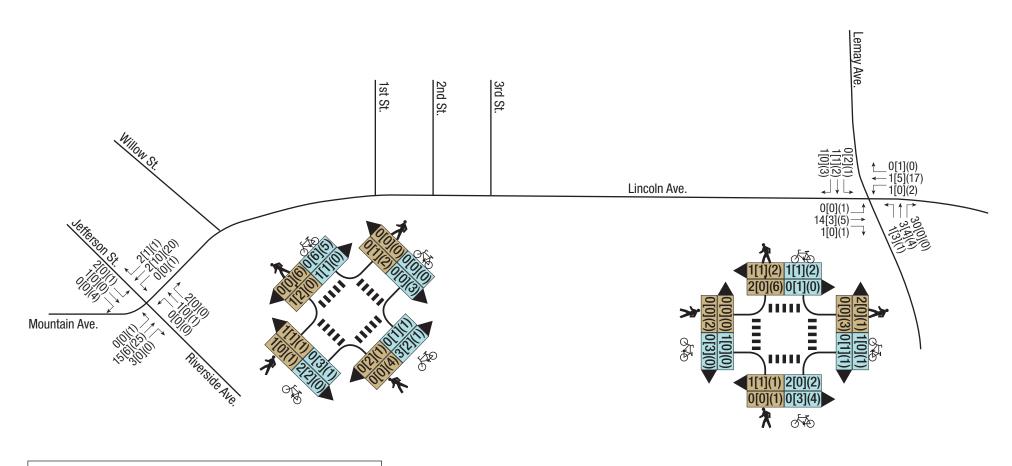
Figure 3 Bicycle and Pedestrian Volumes

X[Y](Z) AM[Noon](PM) Bicycle Turning Movements in Bike Lanes

Figure 3. Bicycle and Pedestrian Volumes

Bicycle volumes along Lincoln Avenue are moderate, with approximately 25 bicyclists using the corridor during the morning and afternoon peak hours. The peak bicycling direction is eastbound in the morning and westbound in the afternoon. Pedestrian activity at both ends of the corridor (at Jefferson Street/Riverside Avenue and at Lemay Avenue) is relatively low (≤ 6 in any hour).

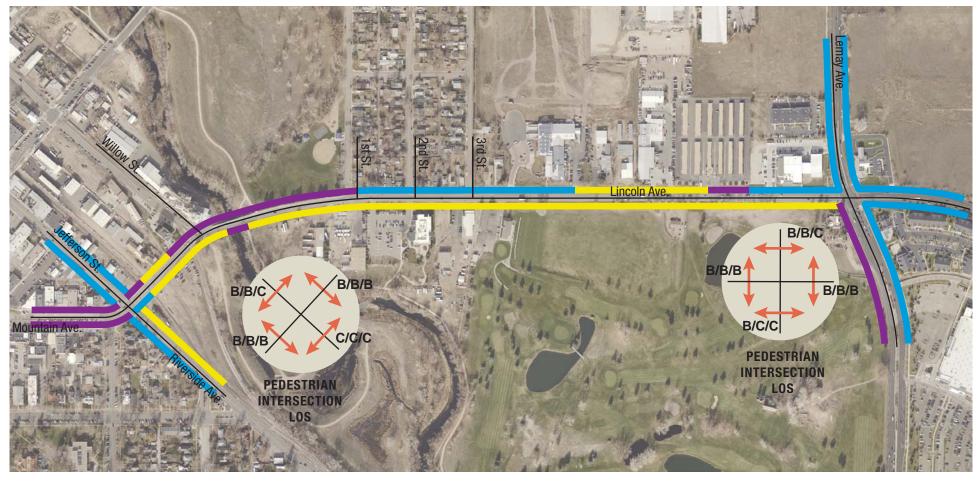
Figure 5
Existing Pedestrian Levels of Service

SOURCE: HCM Pedestrian Segment and Intersection LOS Methodology

Figure 5. Existing Pedestrian Levels of Service

Pedestrian levels of service (LOS) reflect the comfort experienced by pedestrians as they walk along a street. Conditions that affect pedestrian segment LOS include the width of the sidewalk, buffer separation, amenities, and the speed and volume of adjacent traffic. Where sidewalks are provided, the pedestrian LOS is good (LOS C or better). The pedestrian intersection LOS is based on the level of delay and interaction with turning vehicles. The pedestrian intersection LOS at the two signalized intersections is good (LOS C or better).

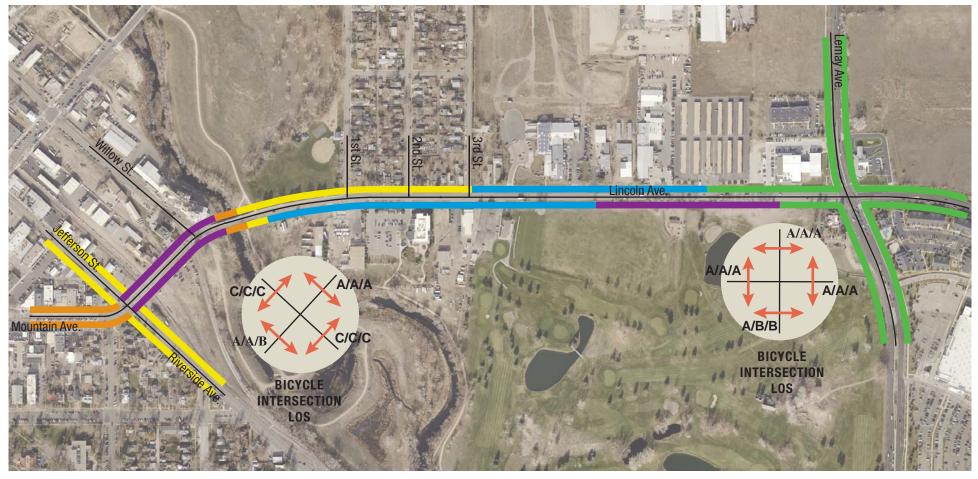
Figure 7
Existing Bicycle Levels of Service

SOURCE: HCM Bicycle Segment and Intersection LOS Methodology

Figure 7. Existing Bicycle Levels of Service

Bicycle LOS is based on the comfort bicyclists experience when riding the corridor which can be affected by the presence and width of bike lanes, on-street parking encroachment, and the speed and volume of adjacent traffic. The bicycle segment LOS on the Lincoln Avenue corridor is generally good (LOS C or better), but is LOS E on the Poudre River bridge where the bike lanes end, LOS D adjacent to the residential neighborhood due to the influence of on-street parking, and LOS D to the west of 1st Street where the bike lane in the westbound direction is very narrow.

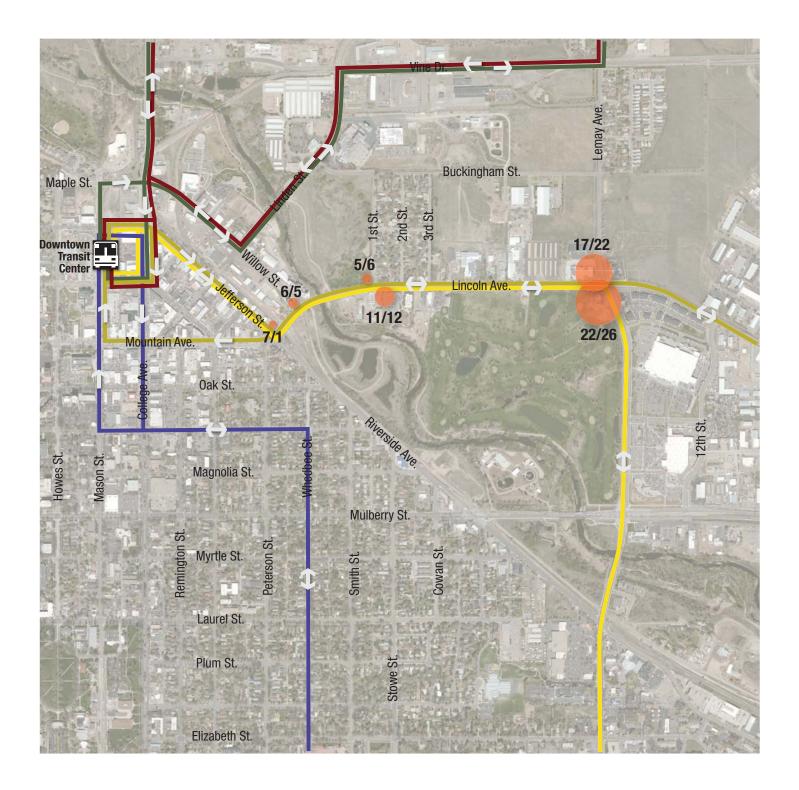
Figure 9
Transit Boardings and Alightings

WEEKDAY/SATURDAY BOARDINGS and ALIGHTINGS

Figure 9. Transit Boardings and Alightings

The weekday and Saturday boardings and alightings for each of the stops along Lincoln Avenue (serving Routes 5 and 14) show the highest concentration of transit boadings/alightings at the intersection of Lincoln Avenue and Lemay Avenue. Boardings and alightings along Lincoln Avenue account for approximately five percent of the Route 5 total ridership and approximately ten percent of the Route 14 total ridership.

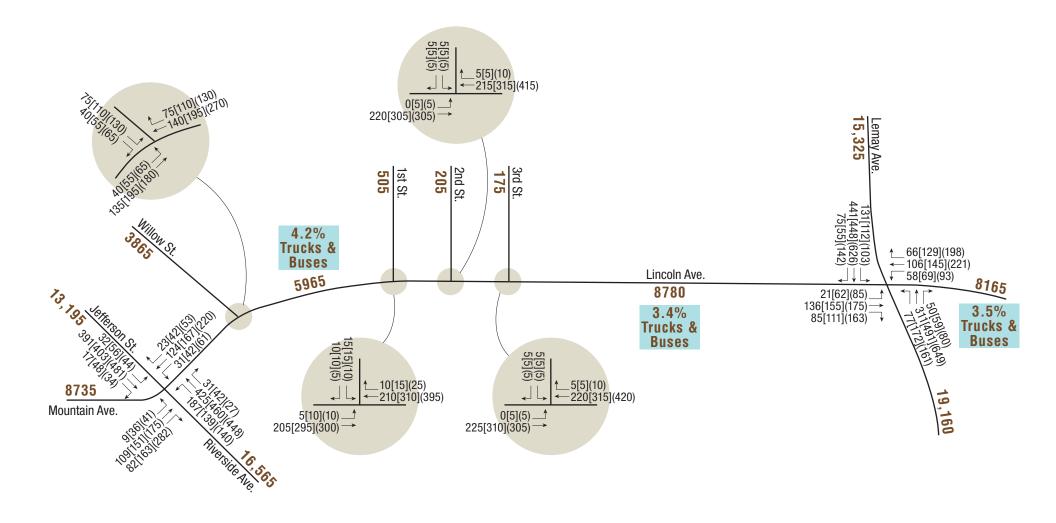
Figure 12 Existing Traffic Volumes

XXXXXX AM[Noon](PM) Peak Hour Traffic Volumes

Figure 12. Existing Traffic Volumes

Lincoln Avenue currently carries approximately 6,000 vehicles per day (vpd) on the west end of the corridor and approximately 8,800 vpd on the east end. Morning, noon, and afternoon peak hour turning movements are used to assess the existing traffic operations. Several of the existing land uses, as well as

planned redevelopment, along the corridor rely on large trucks to import and export goods to their sites. The western portion of the corridor carries approximately 4.2 percent heavy vehicles (trucks and buses), while the eastern portion carries approximately 3.4 percent. These heavy vehicles will need to be safely accommodated in any improvements made to the Lincoln corridor.

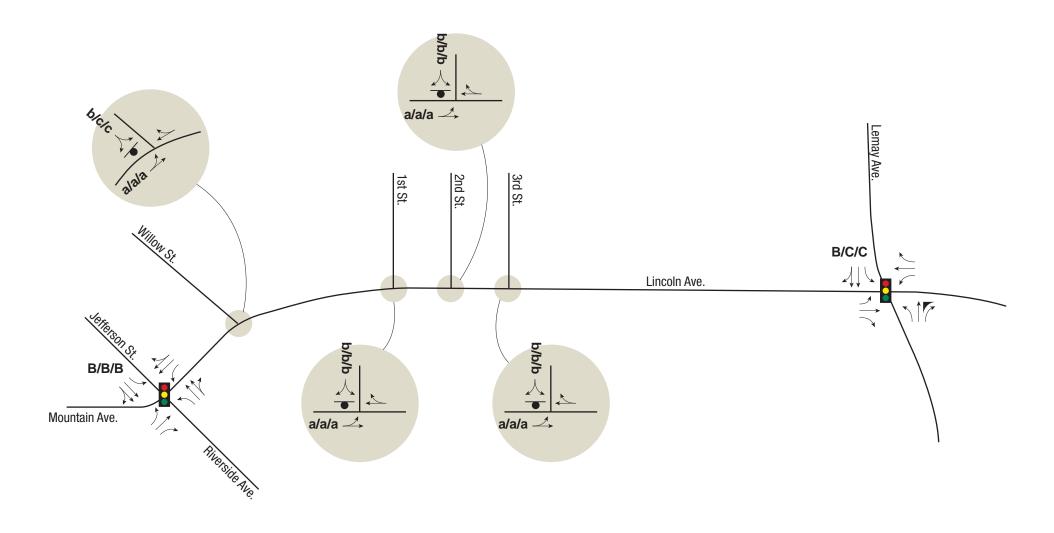
Figure 13
Existing Levels of Service
and Lane Geometry

X/X/X AM/PM Peak Hour Signalized Intersection Level of Service

Figure 13. Existing Levels of Service and Lane Geometry

The two signalized intersections (Lincoln Avenue/Jefferson Street/Riverside Avenue and Lincoln Avenue/Lemay Avenue) operate well, with acceptable levels of delay for vehicular travel. The stop sign controlled intersections at Willow Street, and 1st, 2nd, and 3rd Streets also work well, with minimal delay for side street turning traffic.

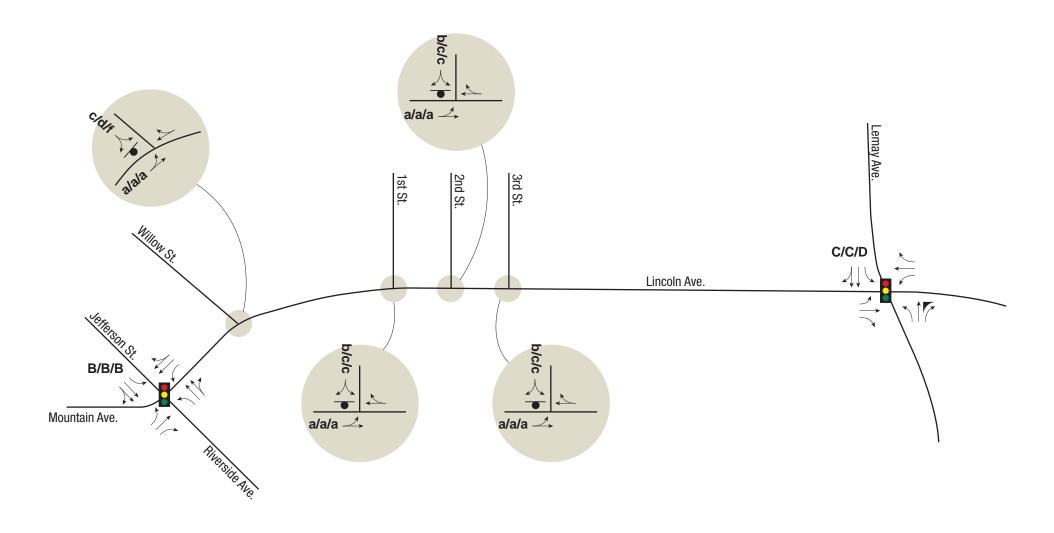
Figure 15 2035 No Action Projected Levels of Service

X/X/X AM/PM Peak Hour Signalized Intersection Level of Service

Figure 15. 2035 No Action Projected Levels of Service

Using the forecasted traffic volumes for 2035, and assuming no improvements to the corridor (No Action), the intersections of Lincoln Avenue with Jefferson Street/Riverside Avenue, Lemay Avenue, and 1st, 2nd, and 3rd Streets would continue to operate at acceptable levels of service.
