# HISTORIC REVIEW FINDINGS – Land Use Code 3.4.7 125 S. COLLEGE AVENUE

125 S. College Avenue, LLC 125 S. College Avenue Fort Collins, CO 80524

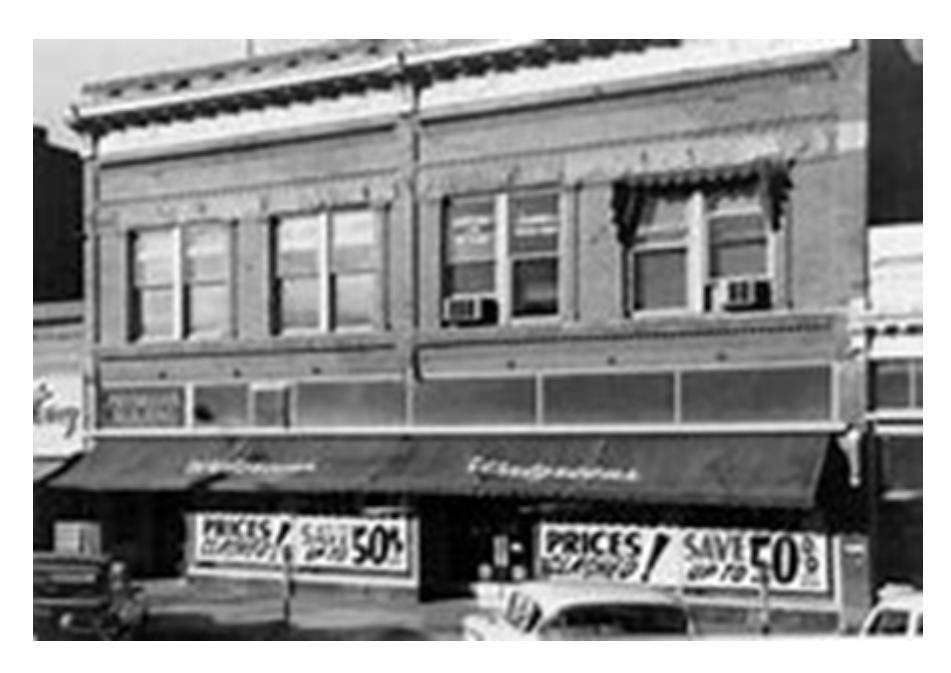
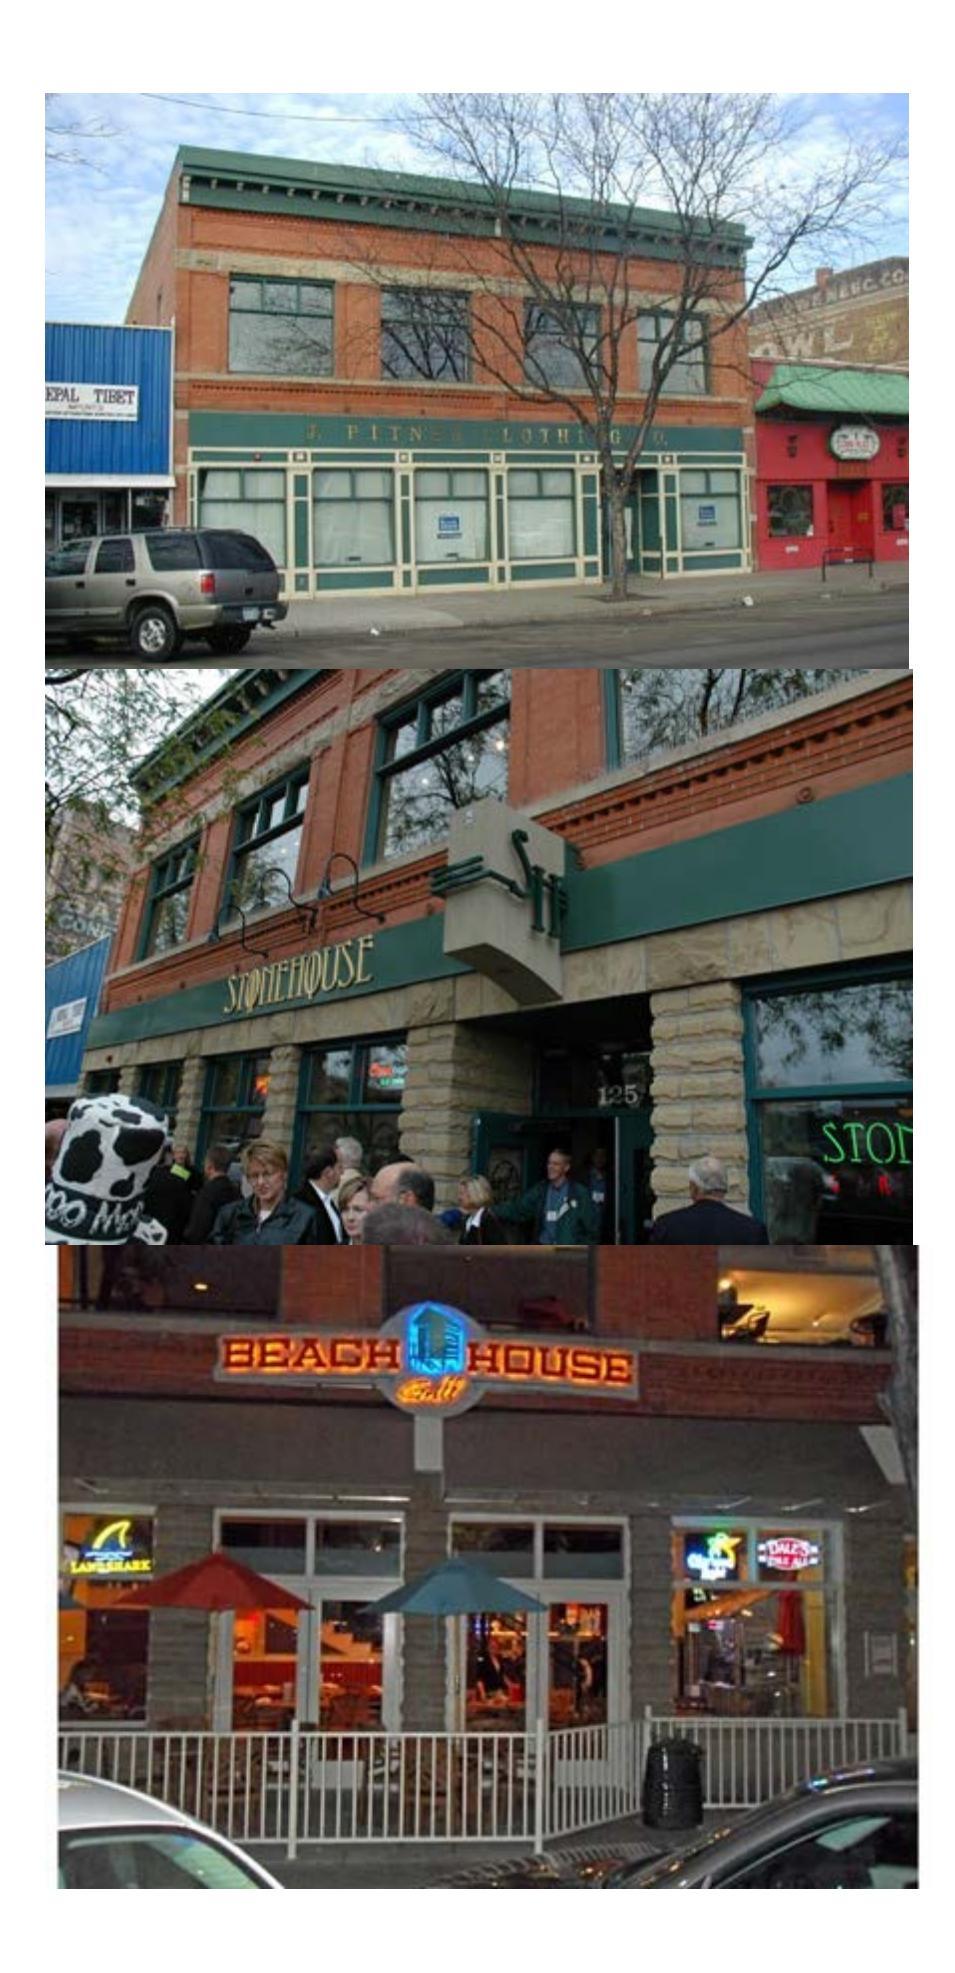
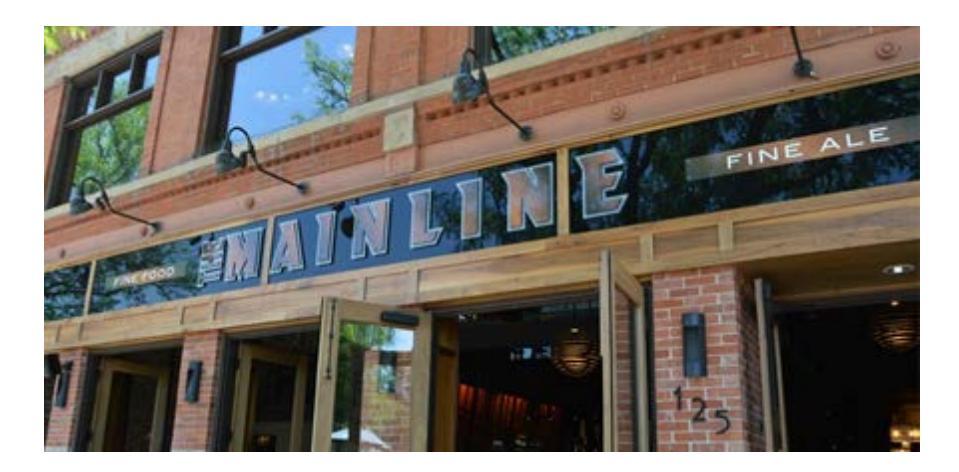
As you can see from the photos below, the building façade has been remodeled several times in recent history. None of those renovations have included transom windows. In-fact, I believe the 6 panels above the awning in the photo of Walgreens are not transom windows but are solid panels made of metal. Note the reflection in the 2nd floor windows and the total lack of any reflection in the 6 panels. We believe that the proposed modifications will be bringing the "sign band" portion of the façade back to an original metal band, closely resembling the building when it was a drug store.

Thanks for swift reply – for some reason, the image you provided from the FC History Connection didn't show up in my catalog search last week (I'll add that to our survey file for this building). I agree it's metal paneling so please disregard Item 1 below. On Item 2, I'll respond ASAP. Cheers!
